Structural Assessment of the USS Yorktown CV-10

Prepared for:

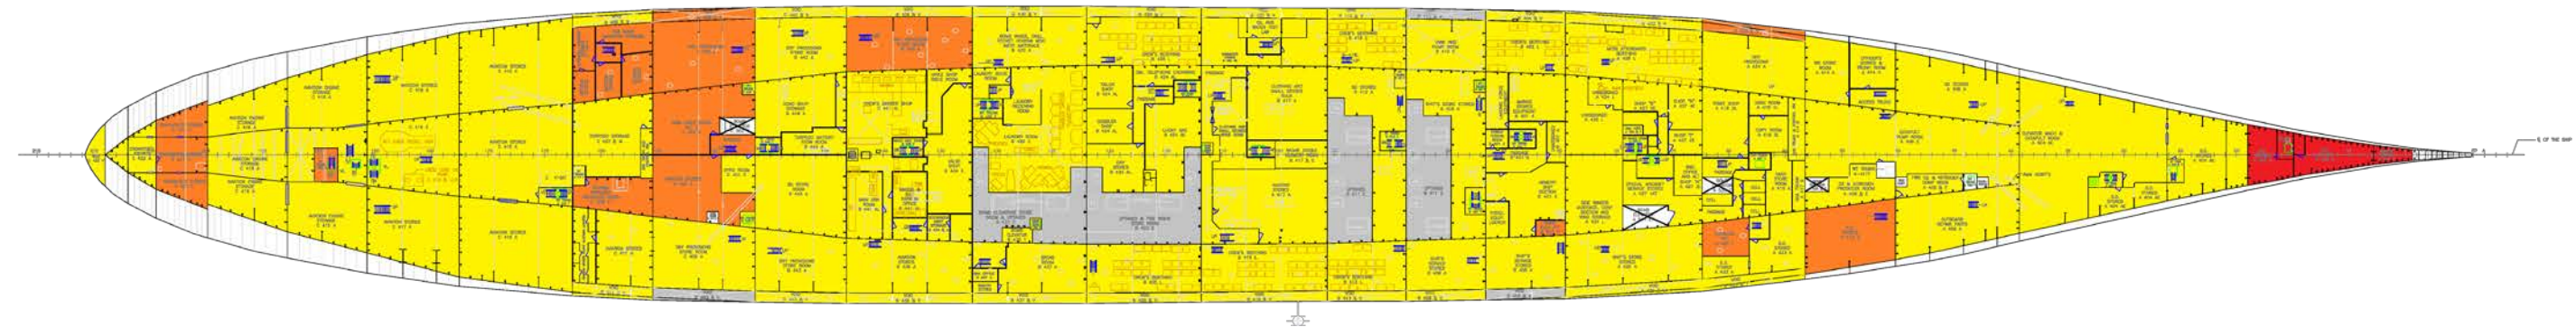
Figure 2.1 Overall view of 4th Deck

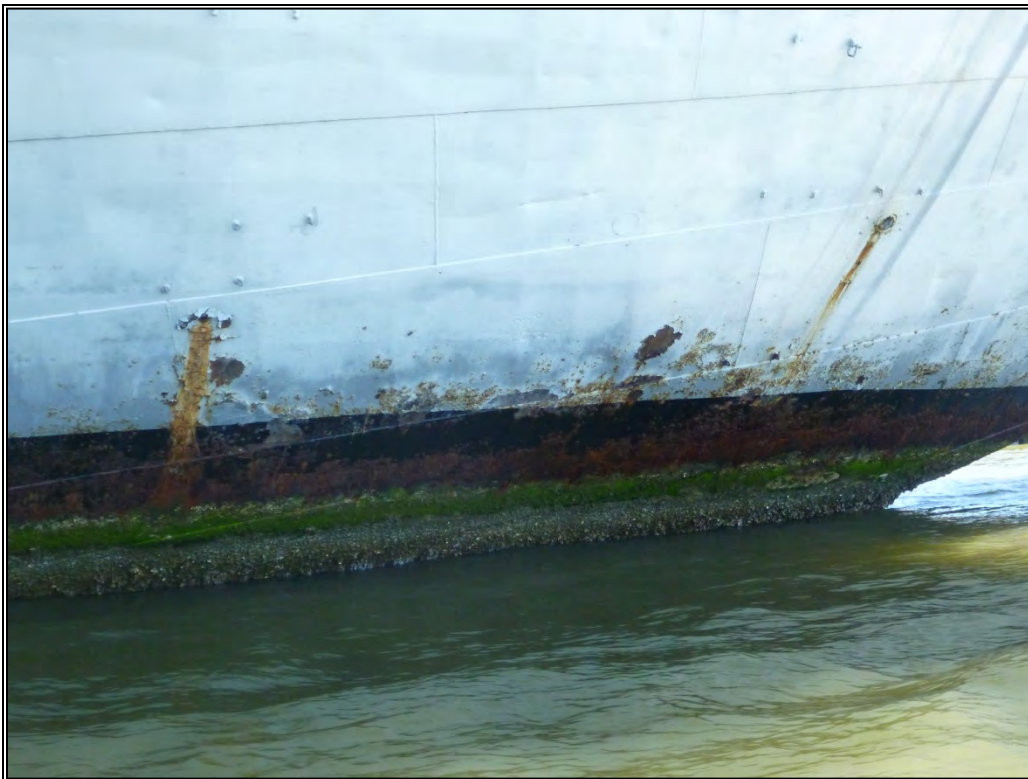
Figure 3.8 View of typical marine growth and pack rust on hull.

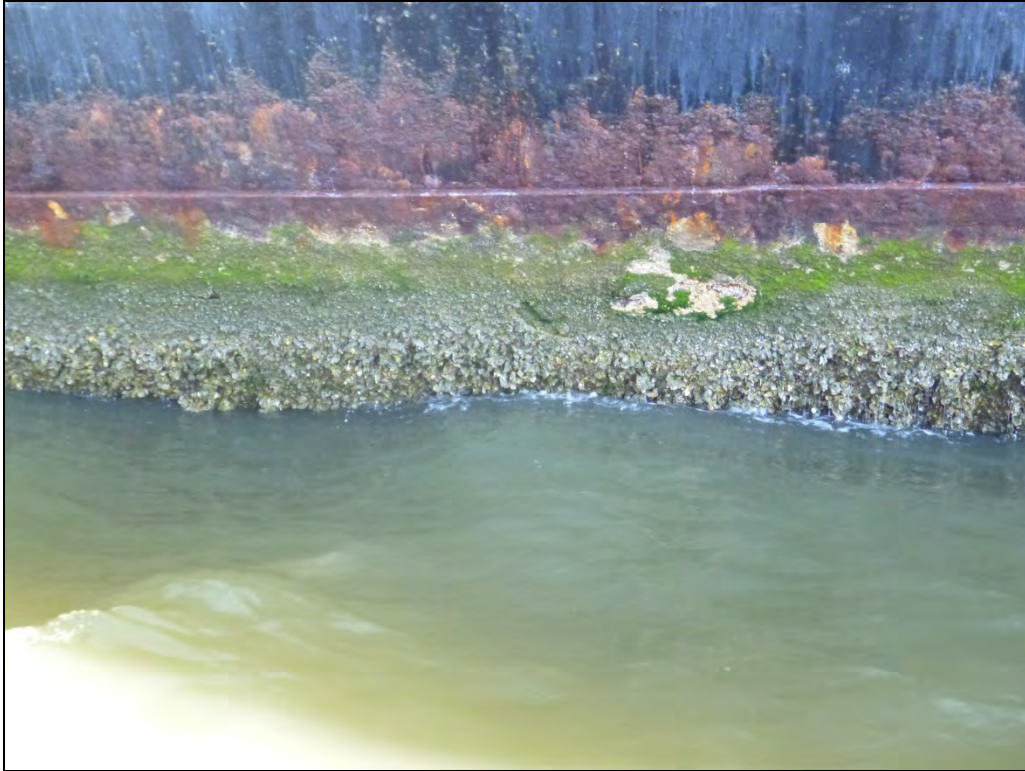
Figure 3.9 Close-up of typical marine growth and pack rust on hull.

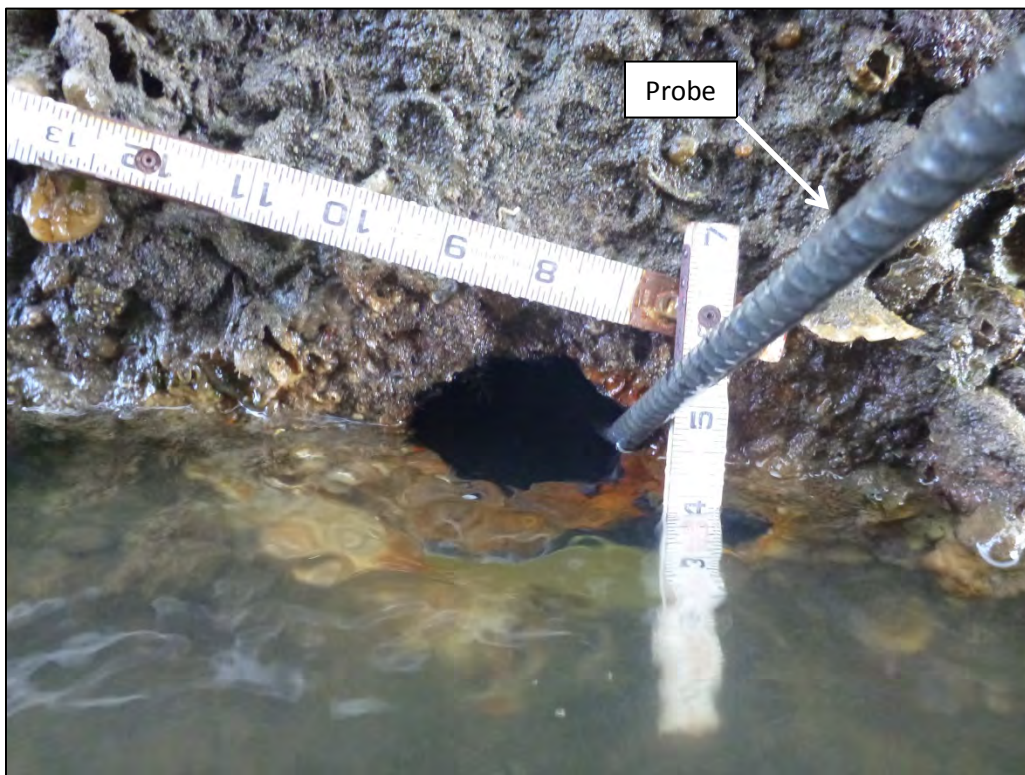
Figure 3.10 View of corrosion hole in port side hull.

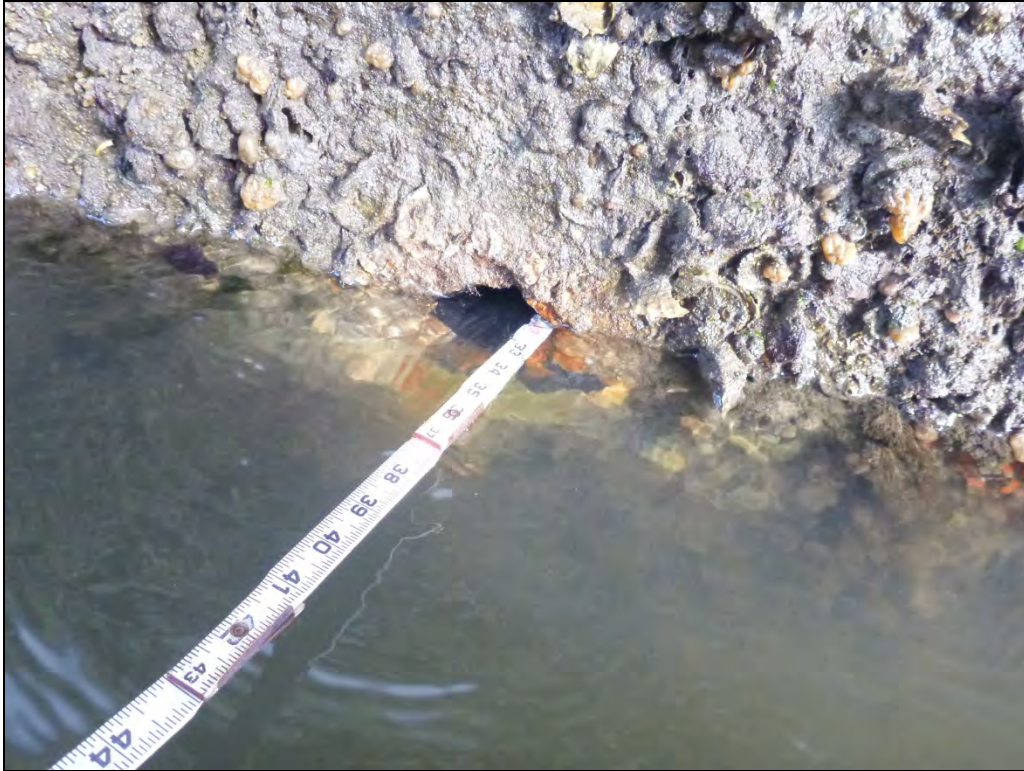
Figure 3.11 View of corrosion hole in port side hull.

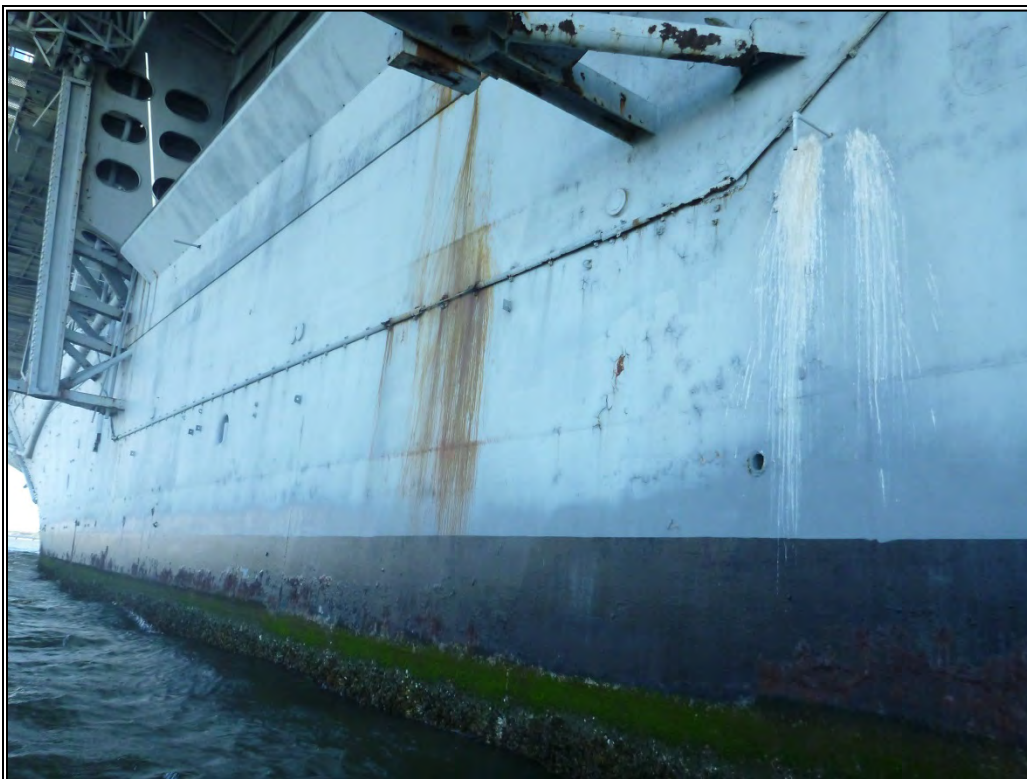
Figure 3.12 View of failed conduit cover, section was protruding vertically from the channel bottom.

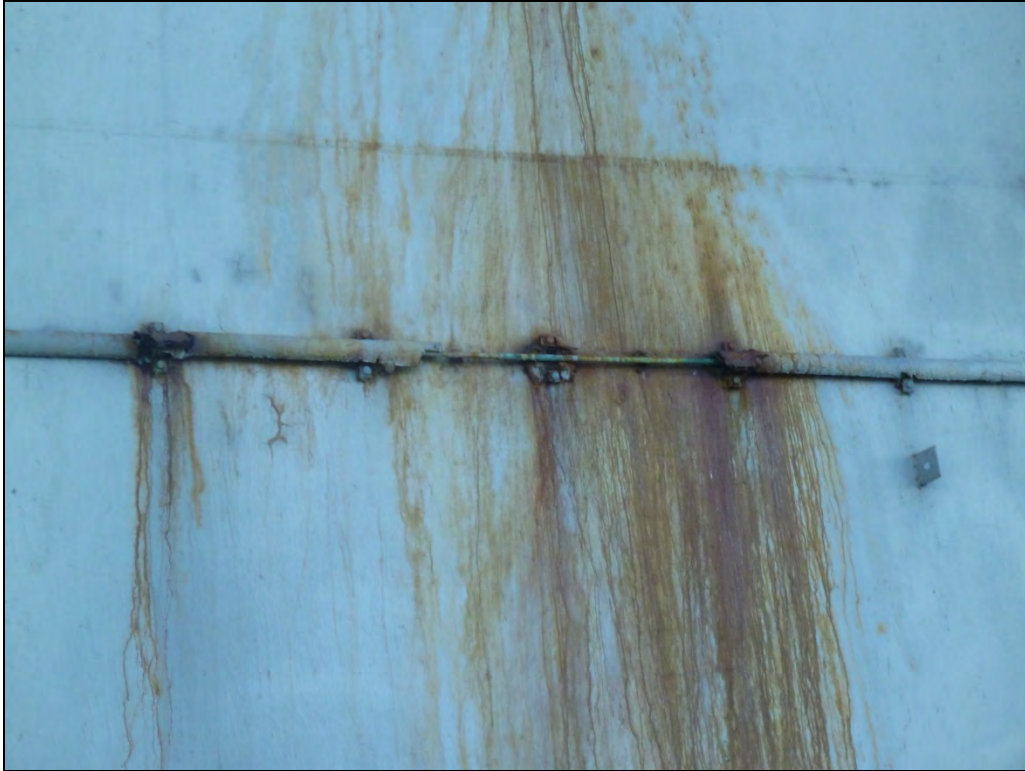
Figure 3.13 Close-up of corroded conduit cover.

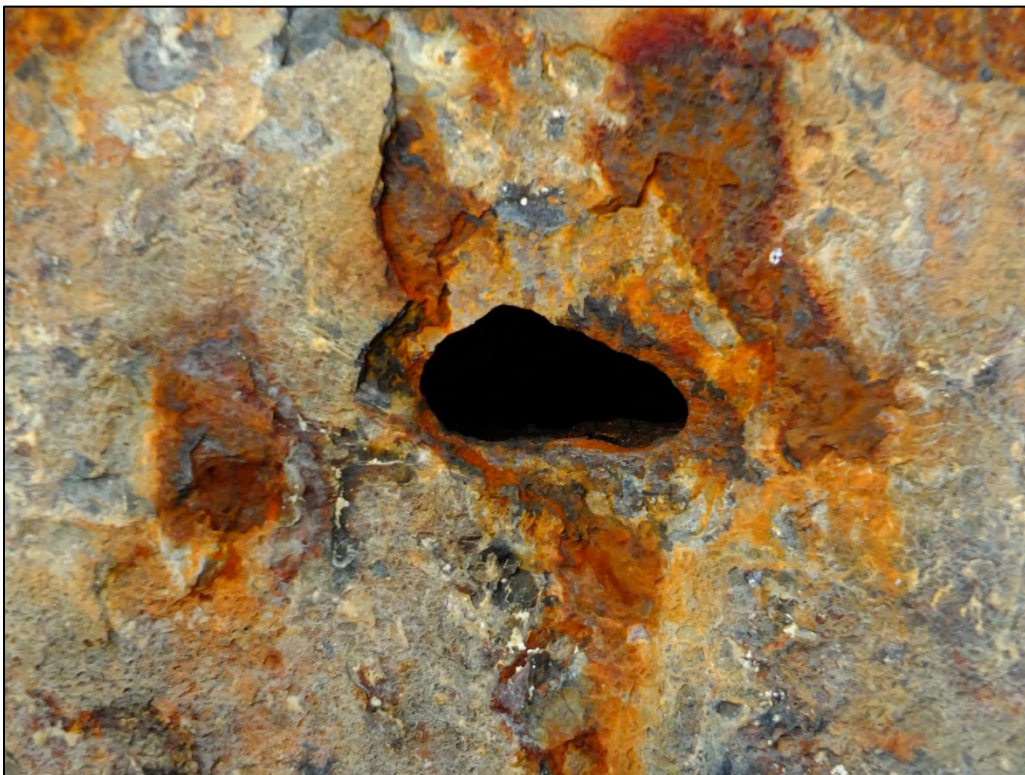
Figure 3.14 Hole in hull in splash zone, starboard side.

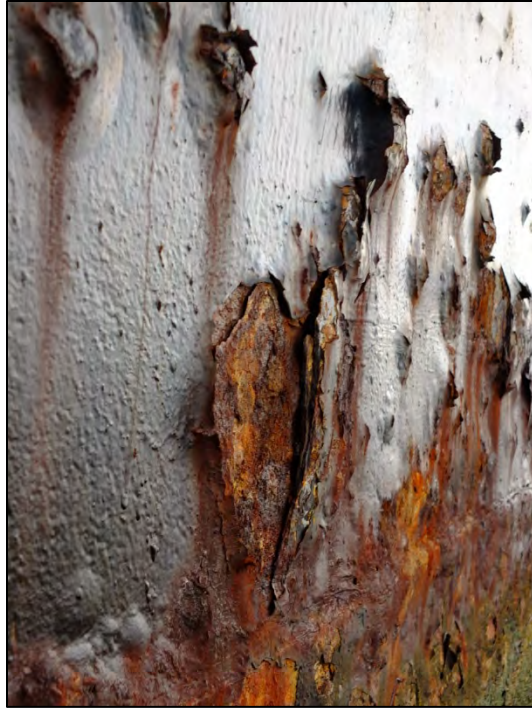
Figure 3.15 Detail of pack rust in splash zone, port side.

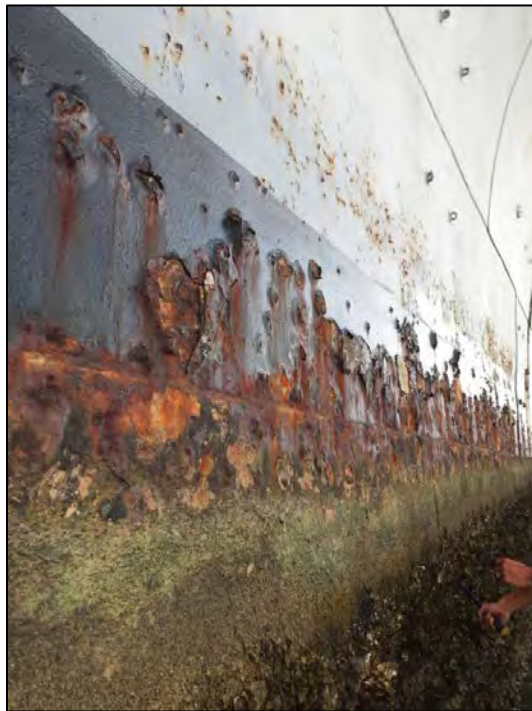
Figure 3.16 Heavy corrosion and pack rust in splash zone, port side.

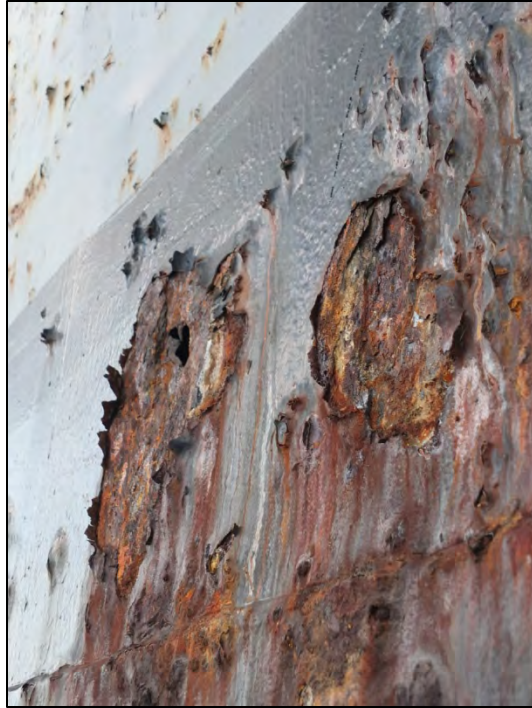
Figure 3.17 Pack rust and hole in hull in splash zone, port side.

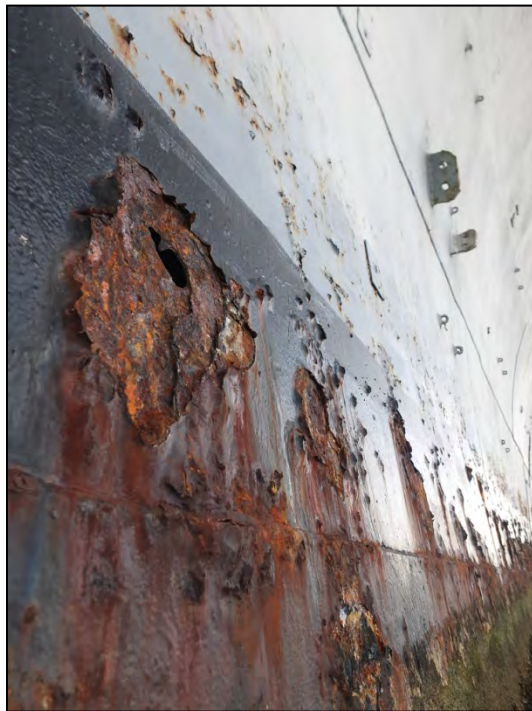
Figure 3.18 Hole in hull in splash zone, port side.

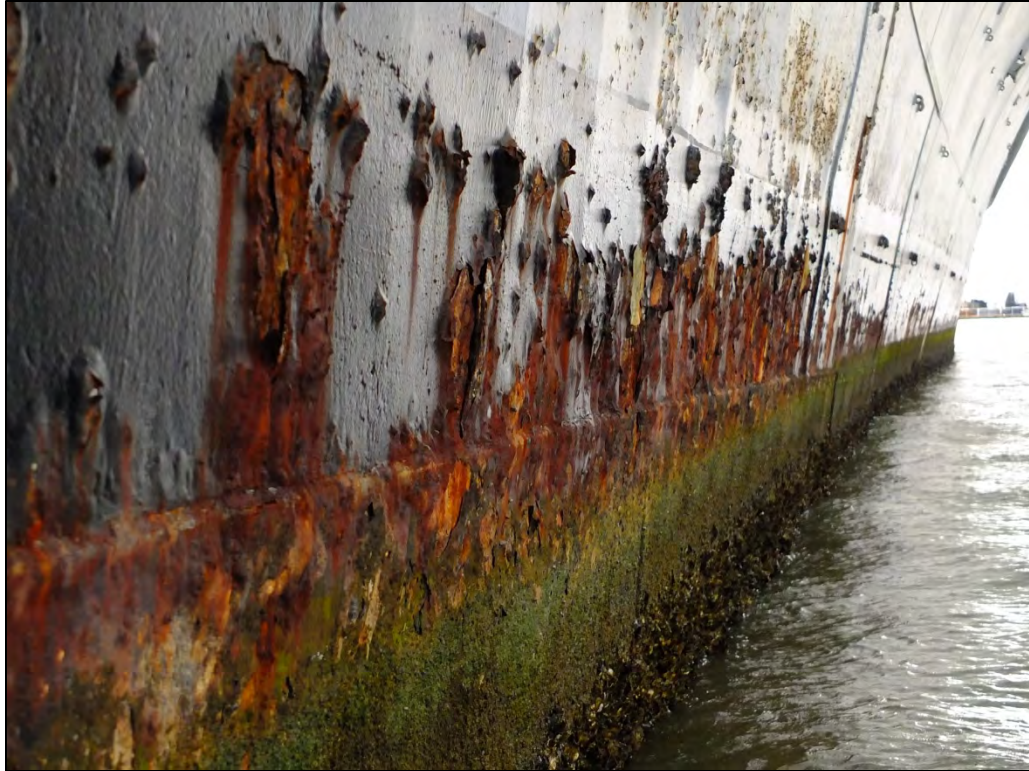
Figure 3.19 Severe corrosion and pack rust in splash zone, port side.

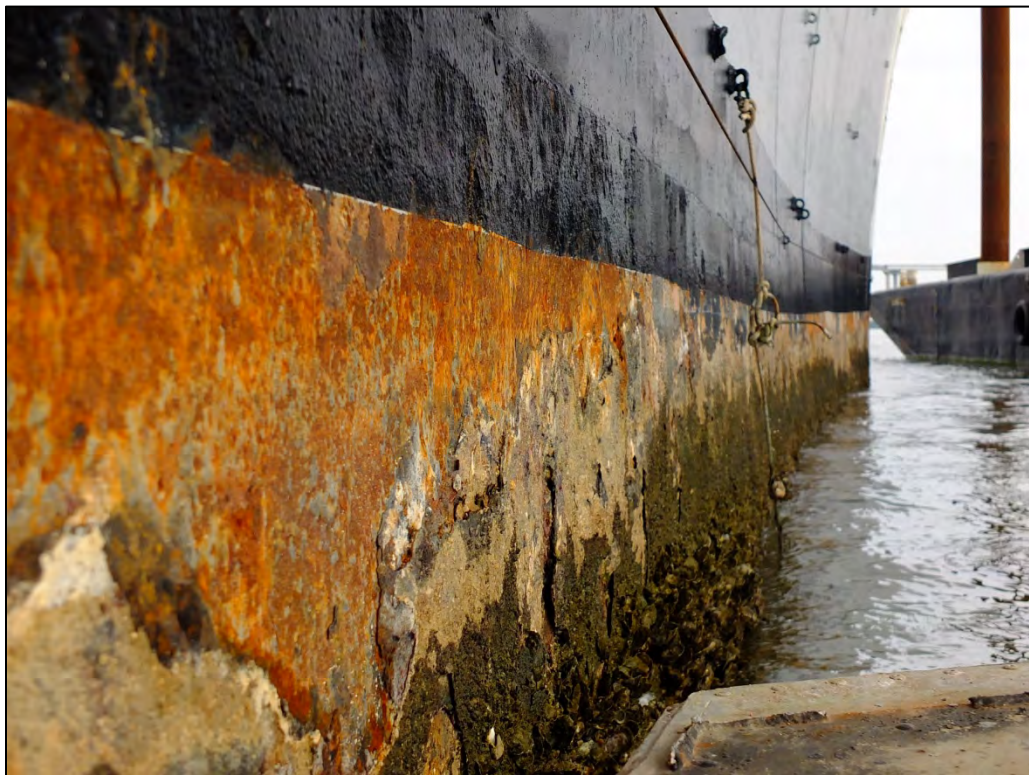
Figure 3.20 Recently cleaned and painted areas of splash zone, starboard side.

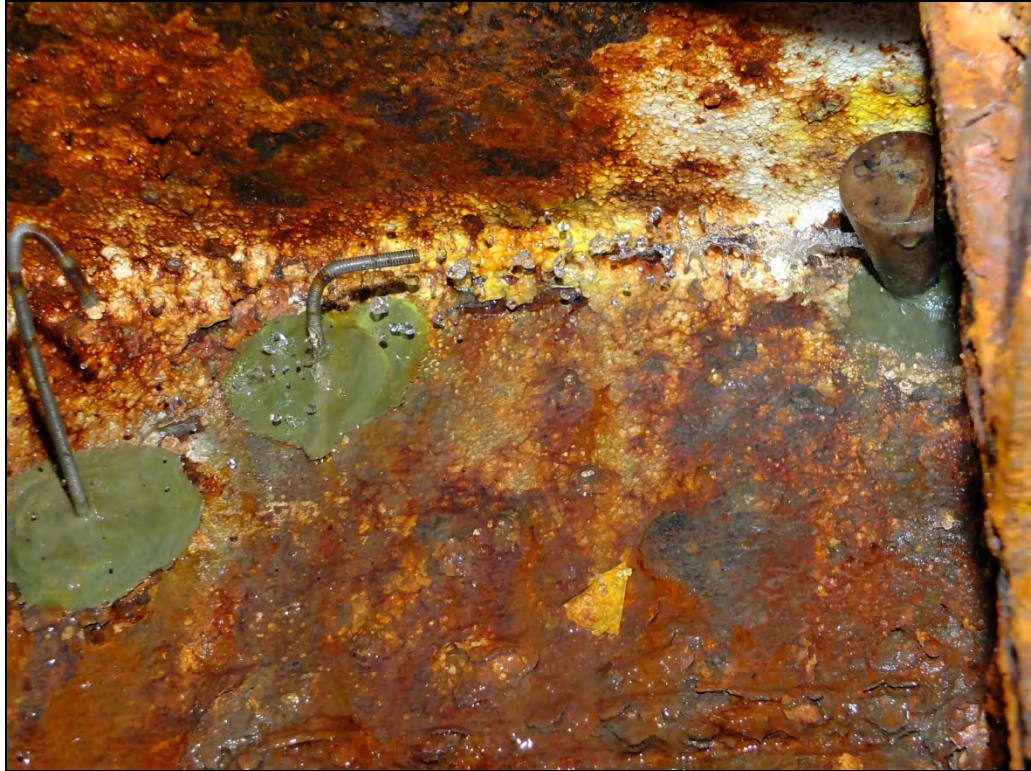
Figure 3.21 Interior view of patches and damage control plug below waterline.

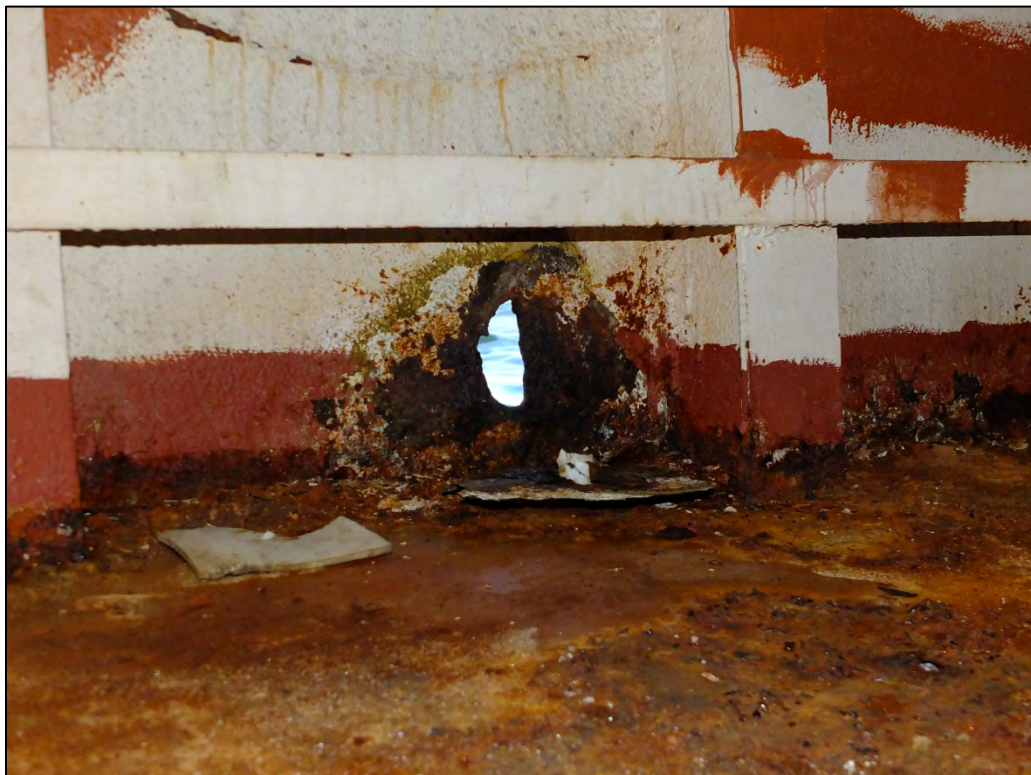
Figure 3.22 Interior view of hole in hull above waterline.

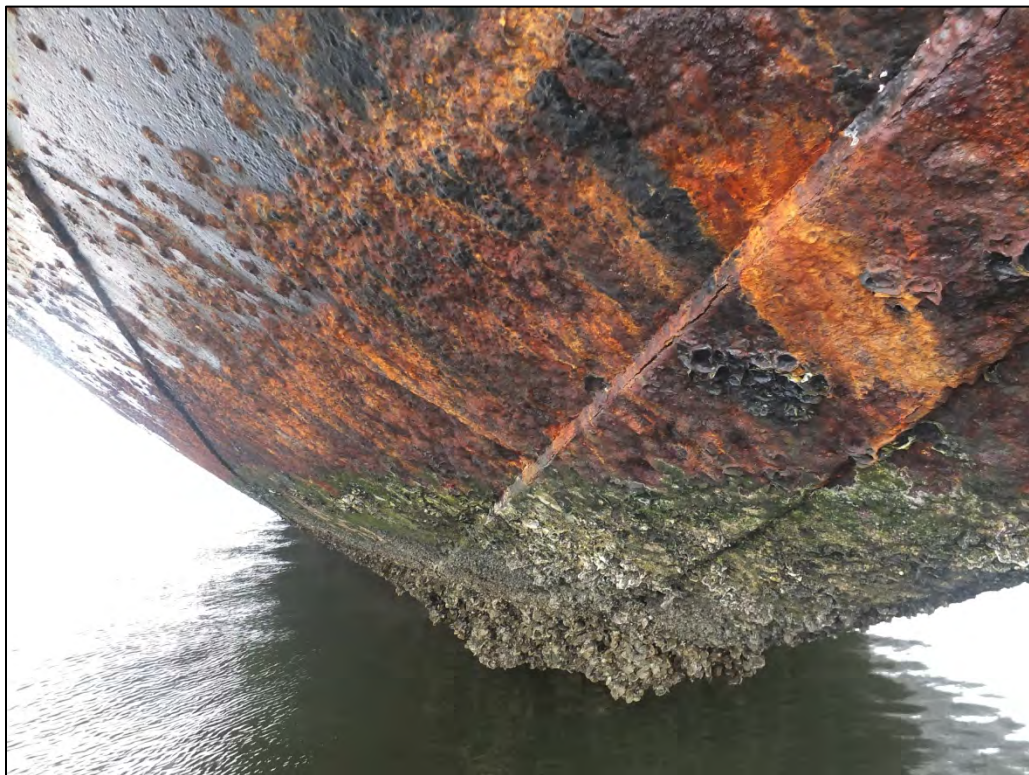
Figure 3.24 Heavy corrosion and pack rust in splash zone, stern area.

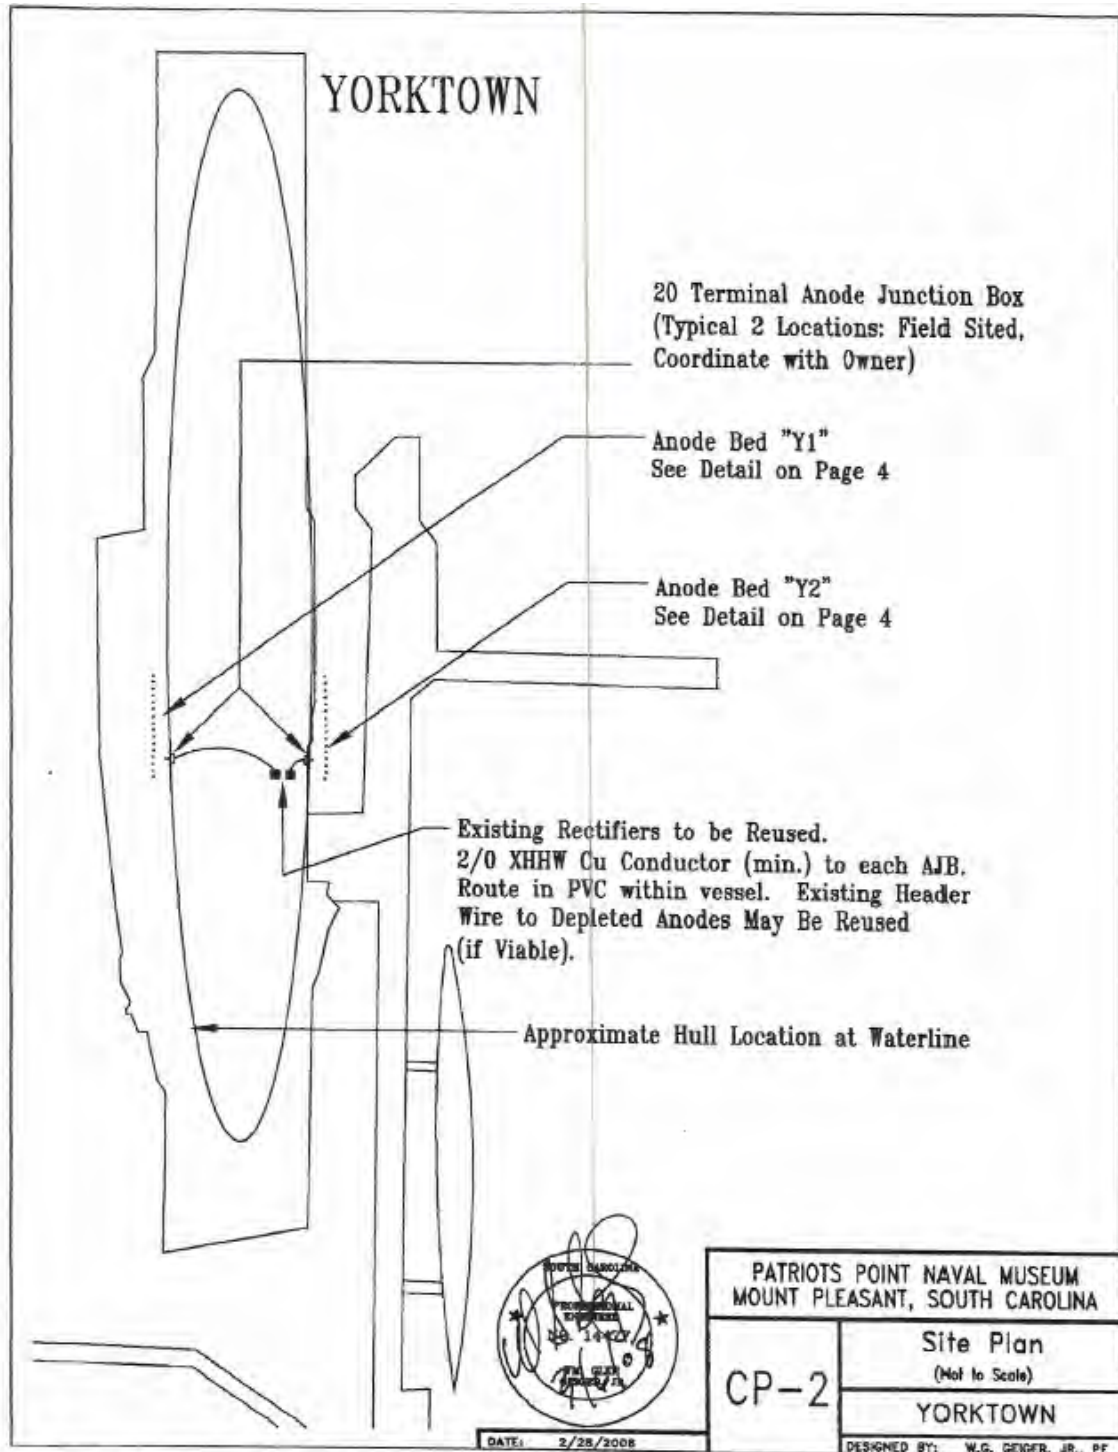
Fig. 1. General Arrangement of existing cathodic protection system for YORKTOWN.

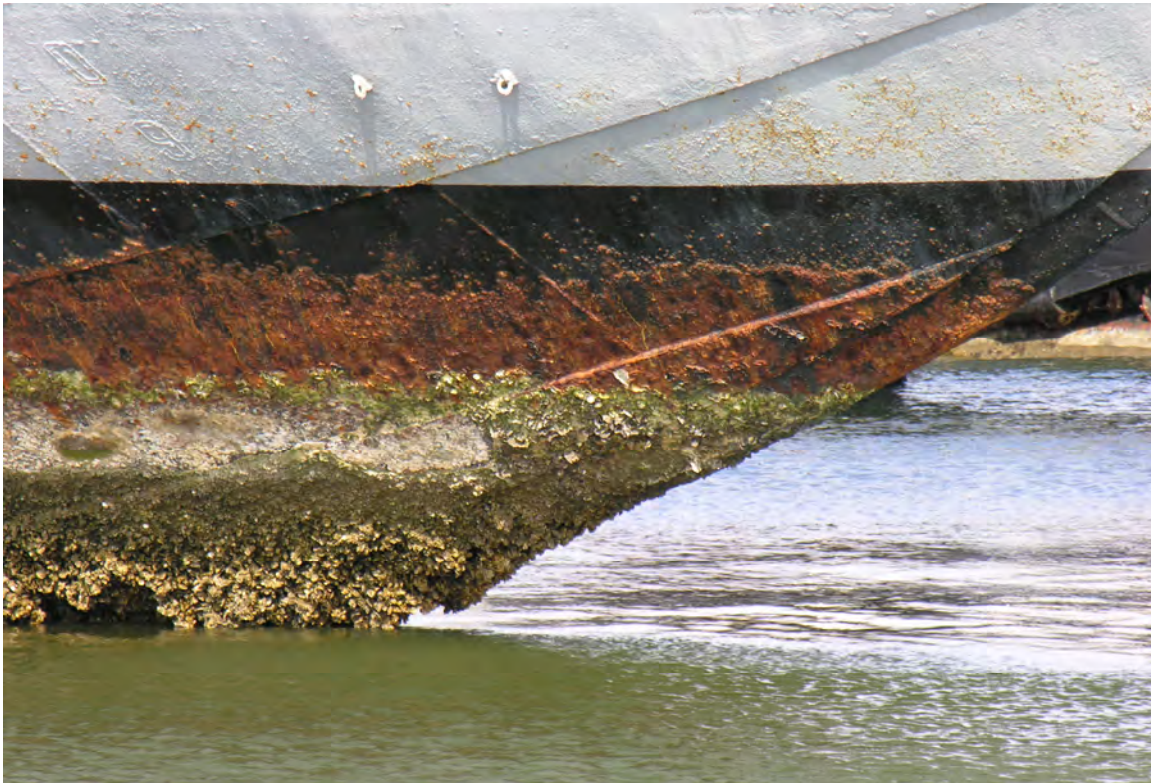
Detail of wind/waterline at stern/counter.

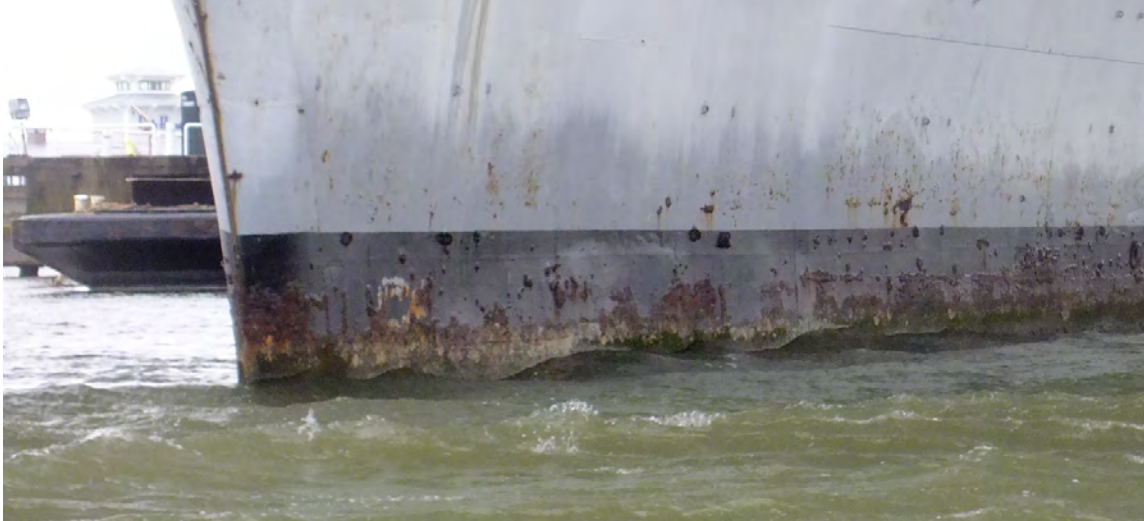
Port bow at wind/waterline.

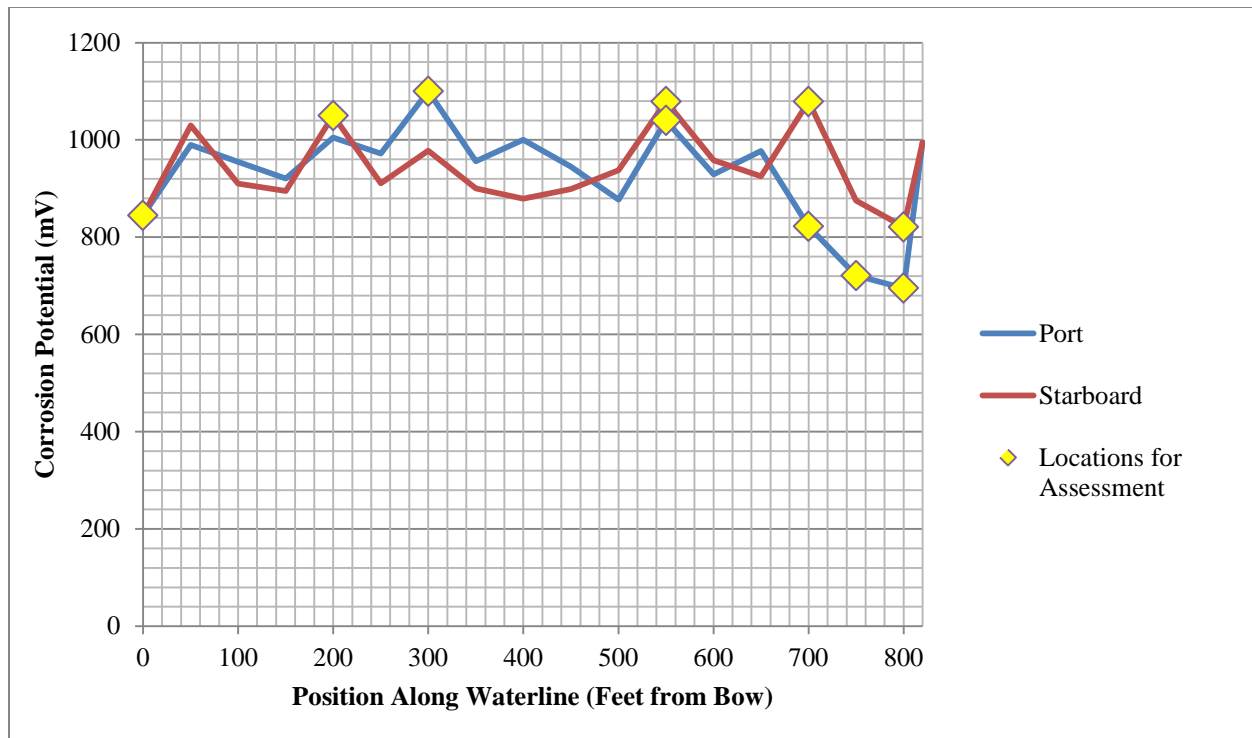
Figure 1 Corrosion Potential Survey Readings (Cathodic Protection System On)

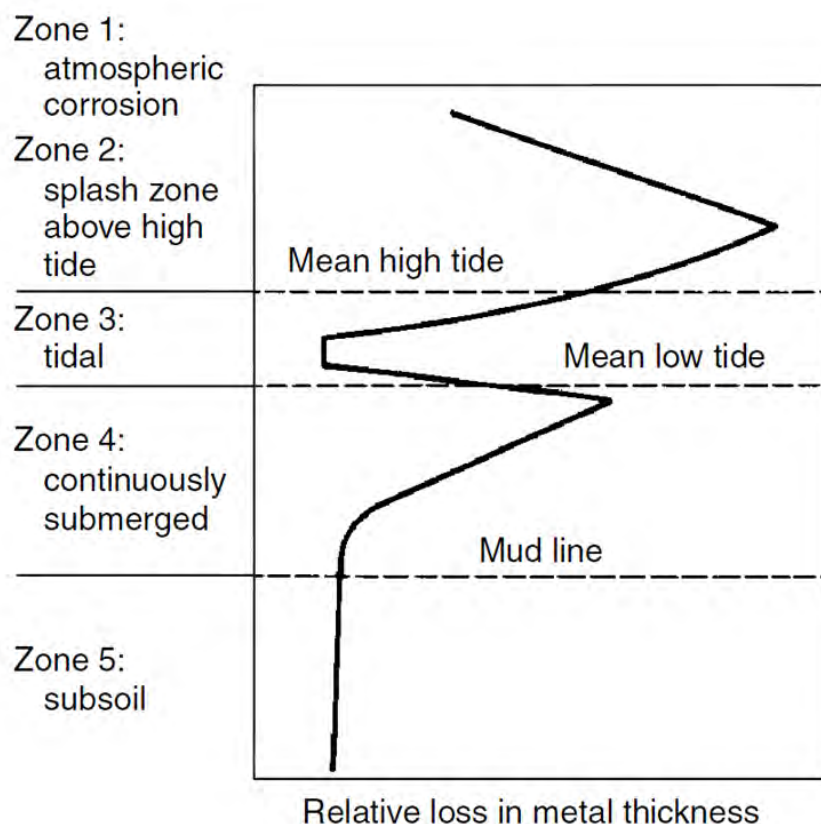
Figure 2 Exposure Zones for Marine Environments (Reference 6)

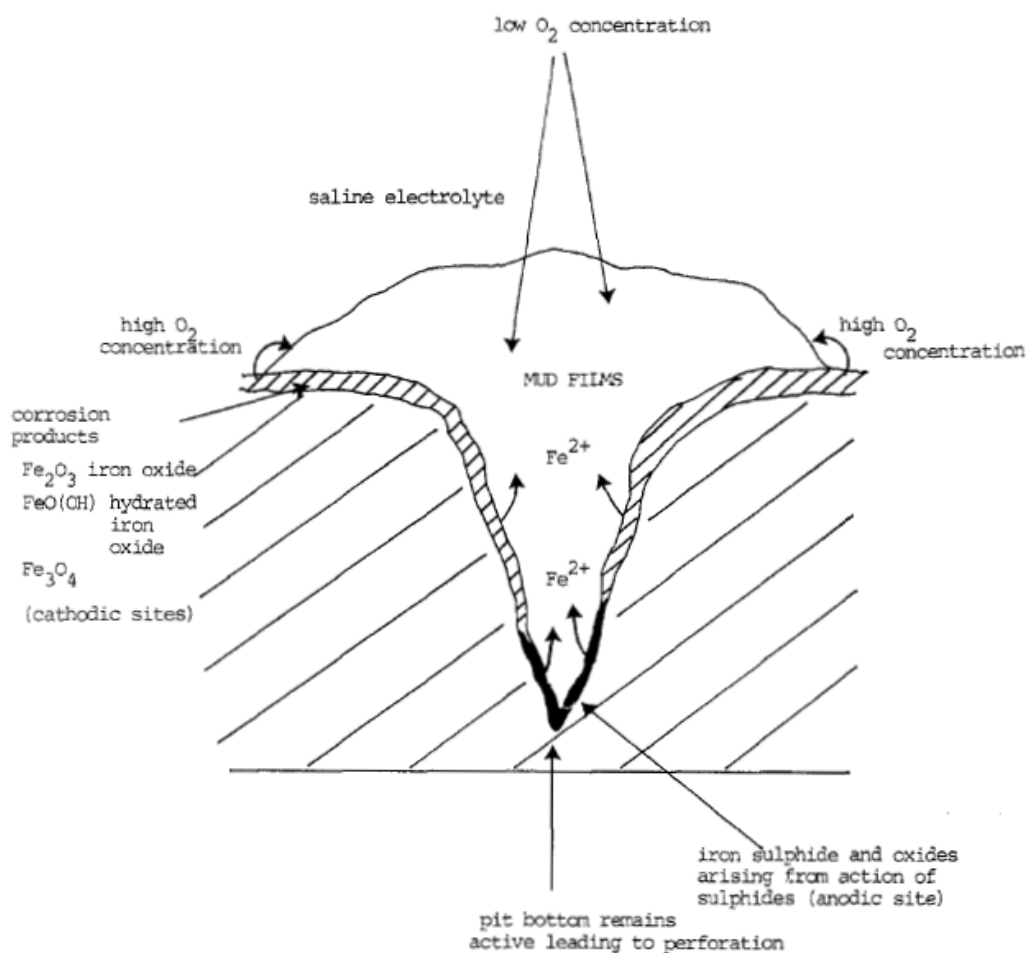
Figure 3. Carbon Steel Corrosion Under A Mud Deposit In Aerated Seawater (Reference 10)

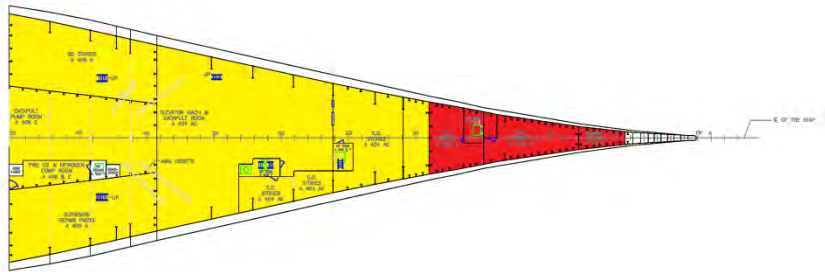
Figure 1.1 Overall view of 4th Deck

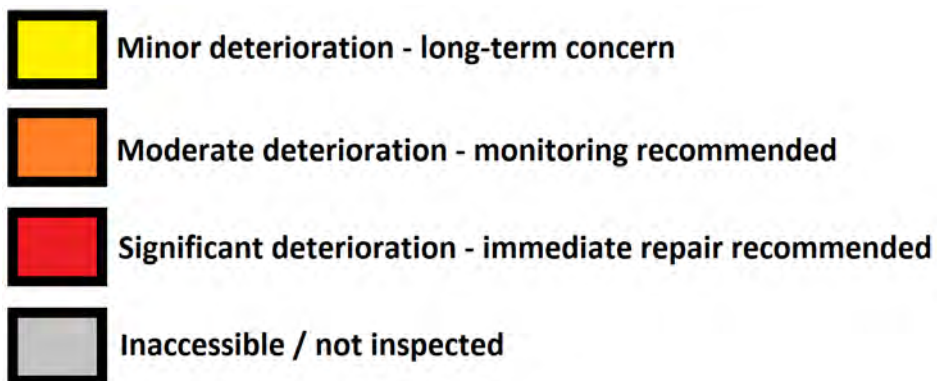
2. Purpose and Scope

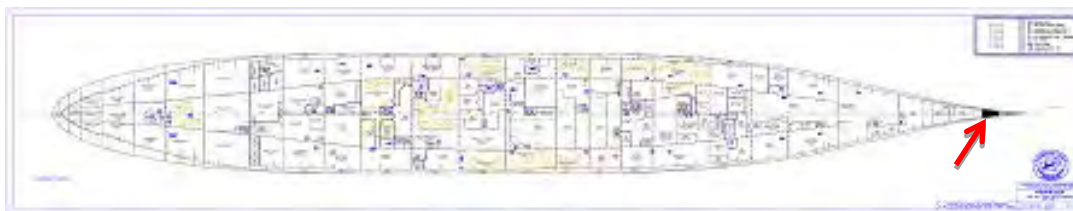
Figure 3.1 Location of compartment A 401 A

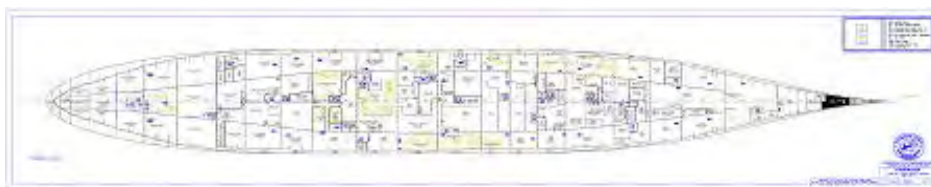
Figure 3.3 Location of compartment A 402 A

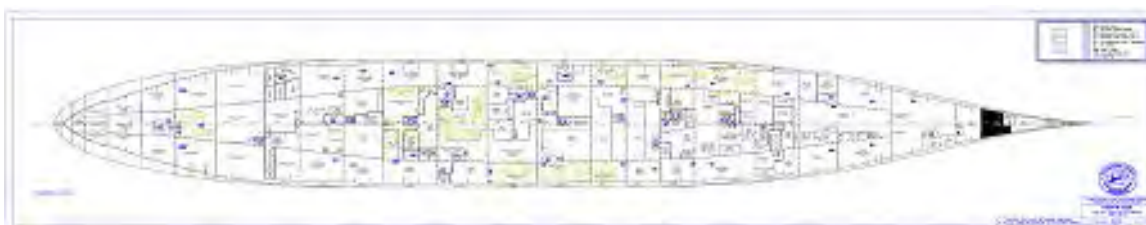
Figure 3.5 Location of compartment A 403 A

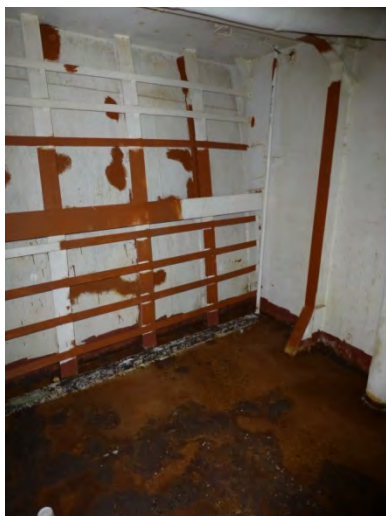
Figure 3.6 A-403A, showing badly corroded deck and standing water from DC plugs to port.

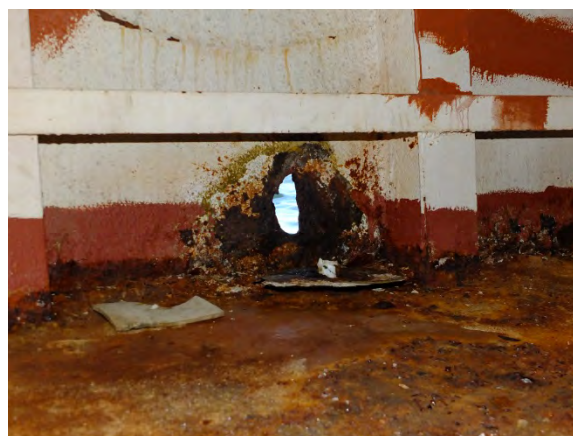
Figure 3.7 Failed patch and open hole in outer hull, compartment A 403 A

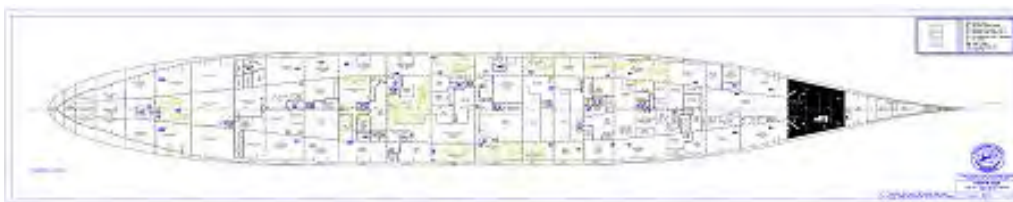
Figure 3.8 Location of compartment A 404 E

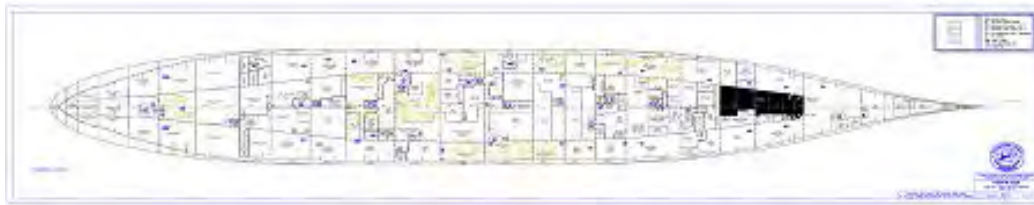
Figure 3.12 Location of compartment A 406 E

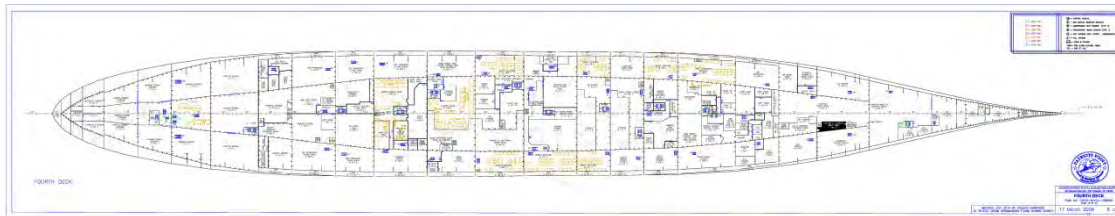
Figure 3.16 Location of compartment A 406 E

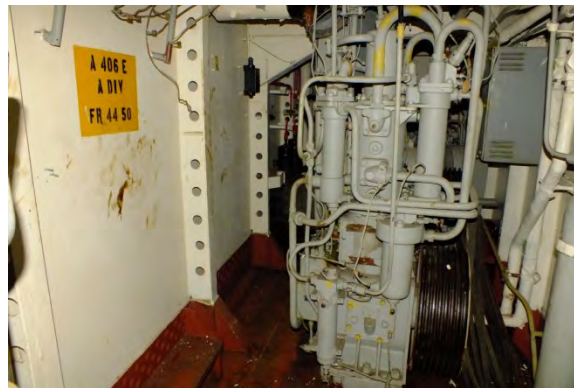
Figure 3.17 Overall view of compartment A 406 E

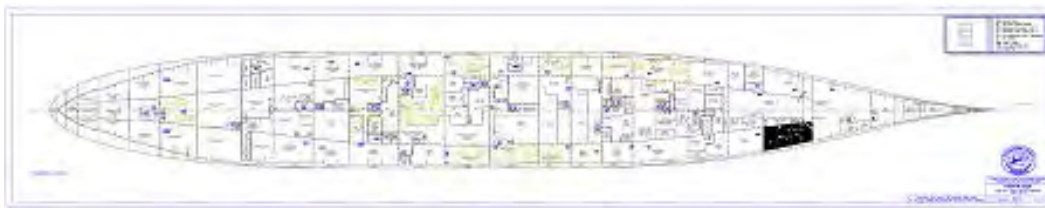
Figure 3.18 Location of compartment A 409 AE

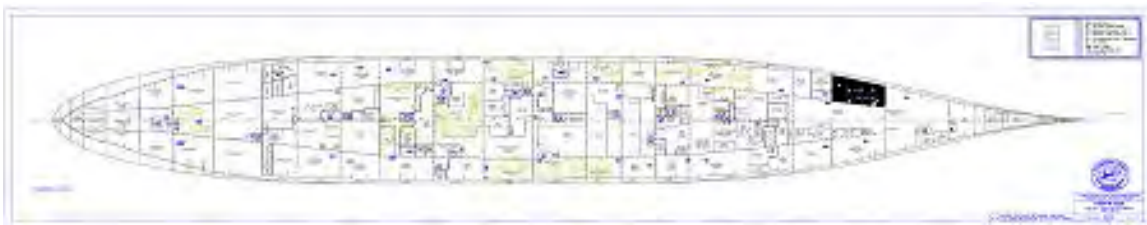
Figure 3.22 Location of compartment A 408 A

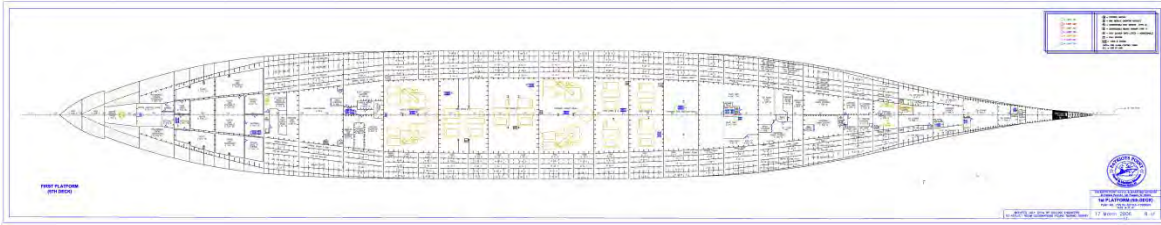
Figure 4.1 Location of compartment A 501 A Boatswain's Stores

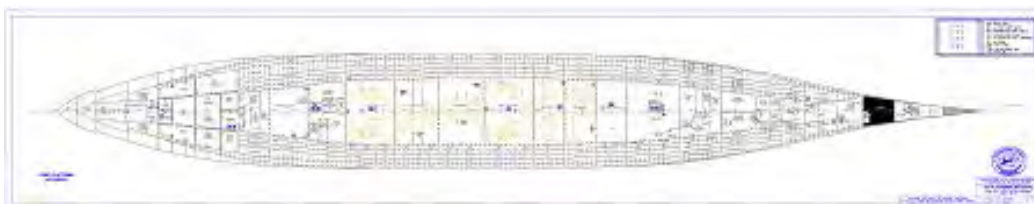
Figure 4.6 Location of compartment A 504 A

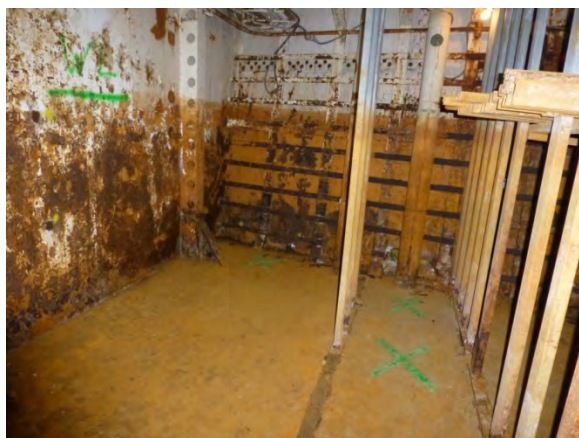
Figure 4.7 General condition of A-504A.

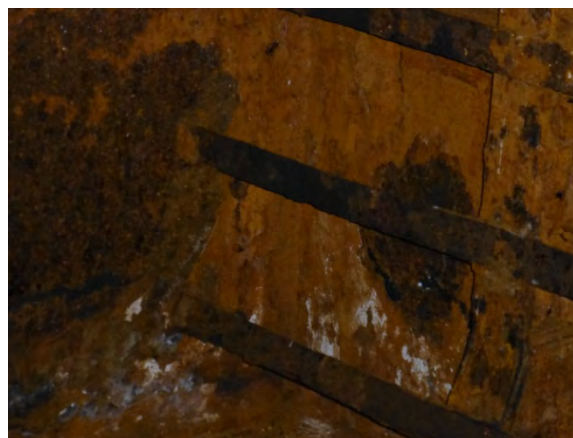
Figure 4.8 Heavy corrosion at forward corner to starboard.

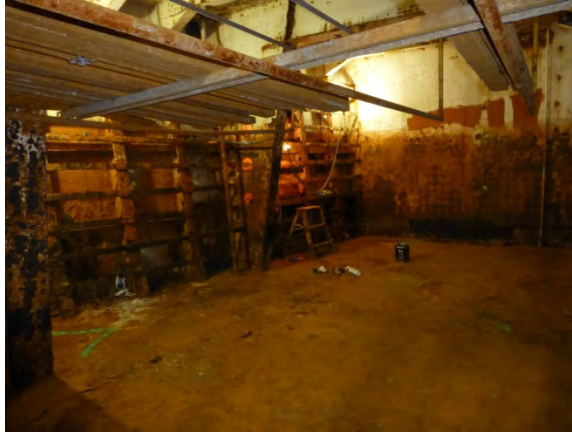
Figure 4.9 A-504A, looking forward to port.

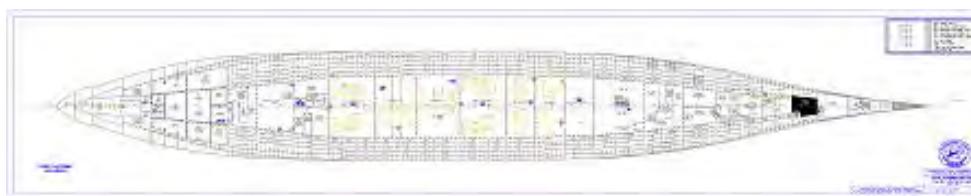
Figure 4.10 Location of compartment A 505 A

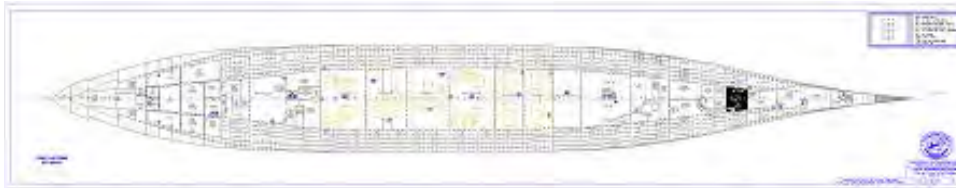
Figure 4.14 Location of compartment A 509 M

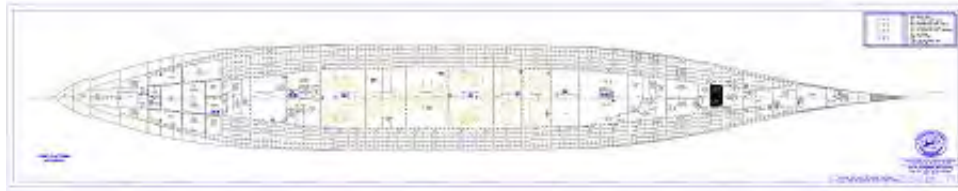
Figure 4.16 Location of compartment A 516 M

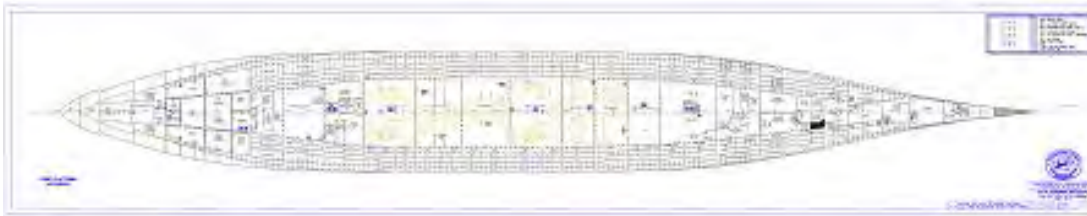
Figure 4.19 Location of compartment A 517 A
