Structural Assessment of the USS Yorktown CV-10

Prepared for:

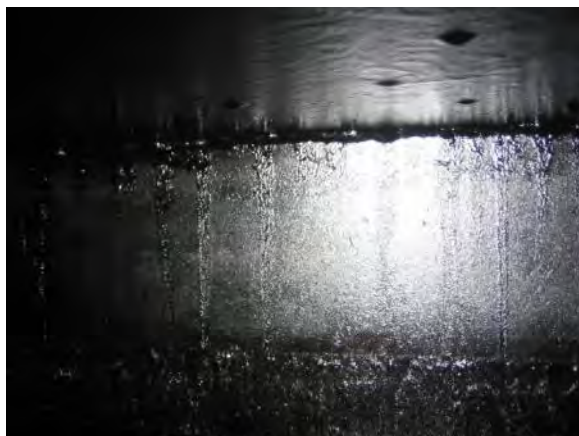
Figure 11.50 "Side of outer ballast B-23F with oil coated and no corrosion on starboard side section FR 92"

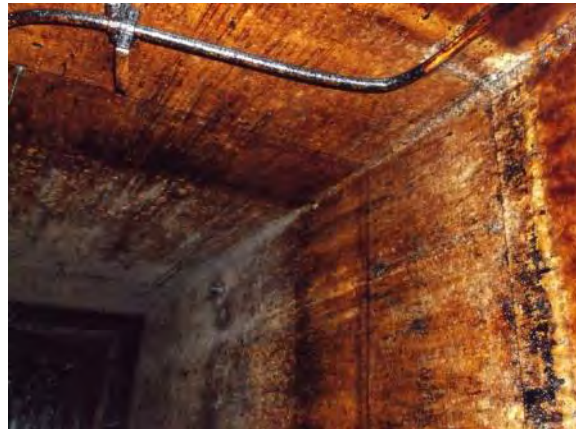
Figure 11.53 "Bottom and sides of inner void B-26V with oil coated and no corrosion on port side section FR 96"

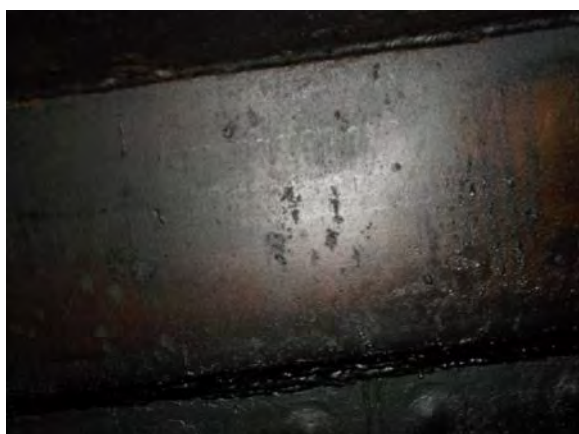
Figure 11.51 "Side of outer skin B-23.5F with oil coated and no corrosion on starboard side section FR 92"

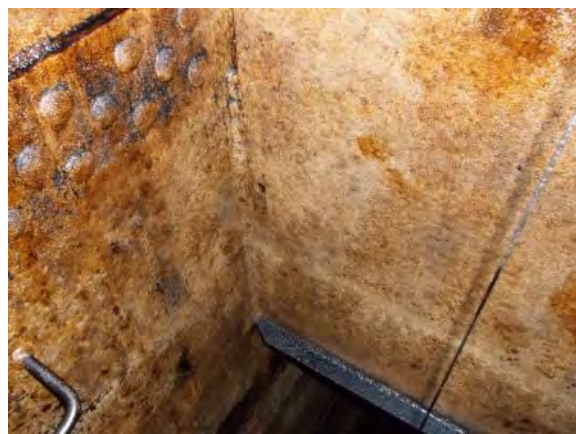
Figure 11.54 "Front corner of inner ballast B-30V with oil coated light surface corrosion on port side section FR 96"

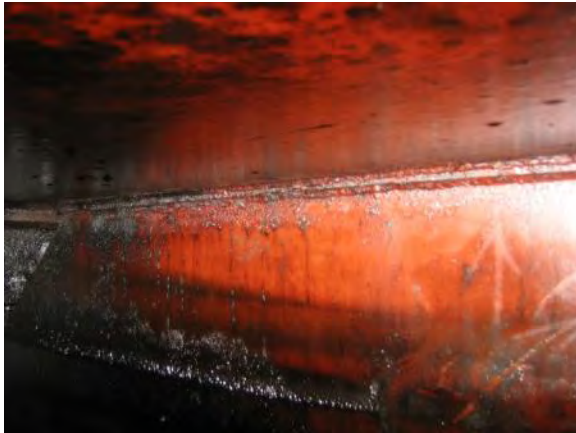
Figure 11.55 "Front corner of outer ballast B-31F with oil coated and light corrosion on starboard side section FR 96"

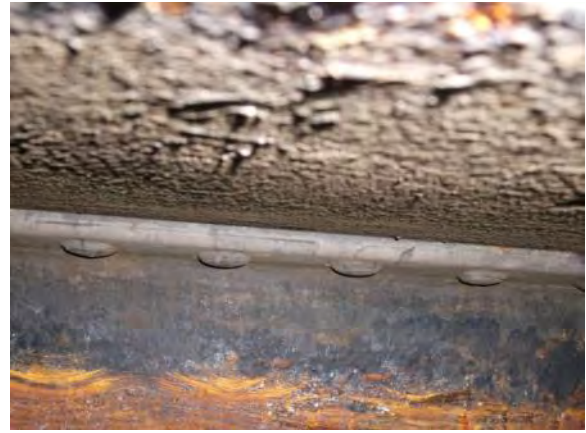
Figure 11.58 "Side of inner ballast B-38V with oil coated and light surface corrosion on port side section FR 103"

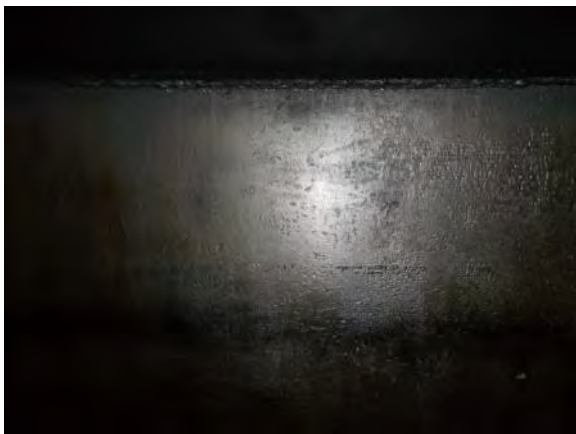
Figure 11.56 "Side of outer skin B-31.5F with oil coated and no corrosion on starboard side section FR 96"

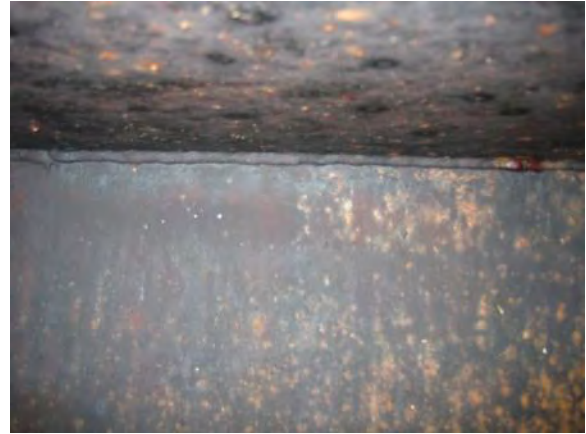
Figure 11.59 "Side of outer ballast B-39F with oil coated and light corrosion on starboard side section FR 103"

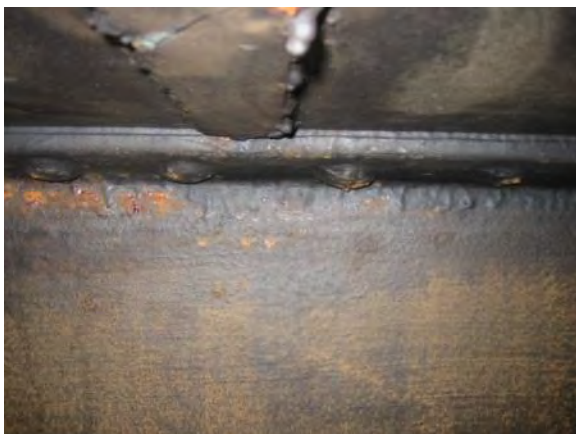
Figure 11.57 "Side of inner ballast B-37V with oil coated and no corrosion on starboard side section FR 103"

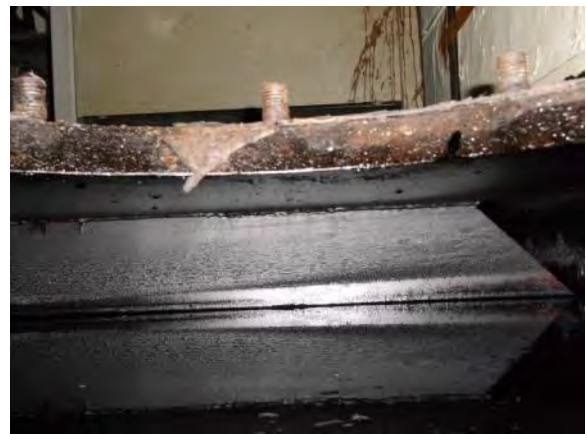
Figure 11.60 "Back corner of outer ballast B-40F mostly full of water and no corrosion on port side section FR 103"

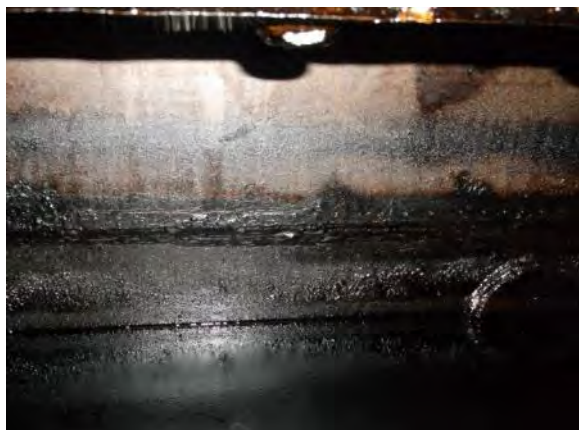
Figure 11.61 "Side of outer skin B-40.5F mostly full of water and no corrosion on port side section FR 103"

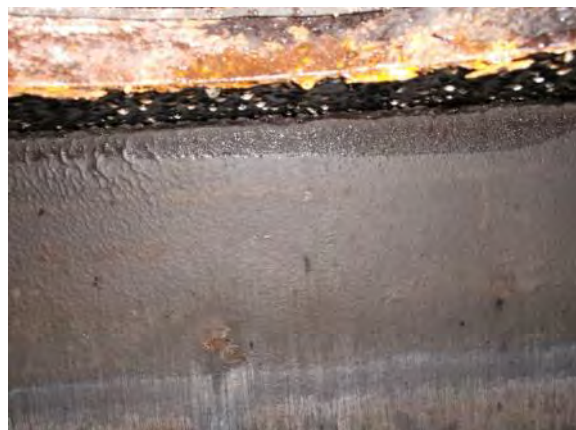
Figure 11.64 "Side of inner ballast B-46V with oil coated and no corrosion on port side section FR 106"

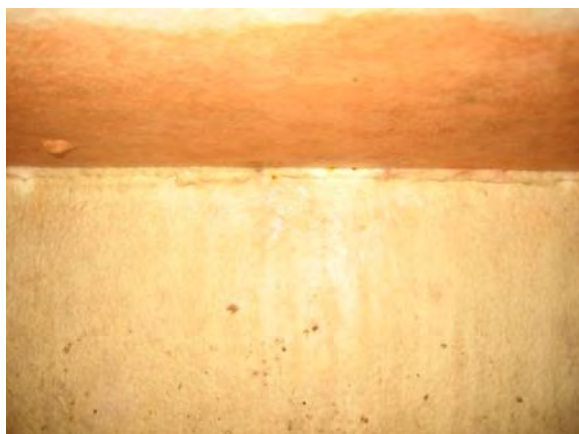
Figure 11.62 "Side of inner ballast B-43V with oil coated and no corrosion on starboard side section FR 106"

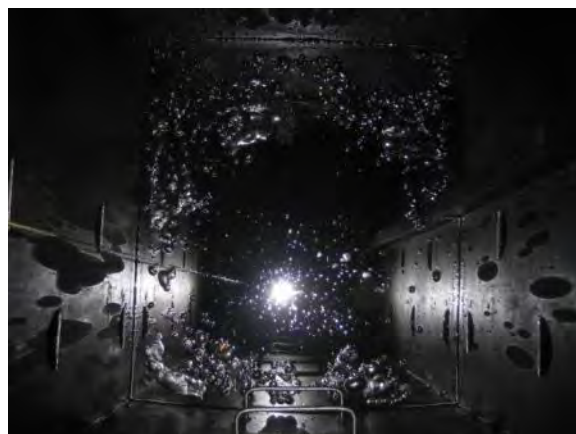
Figure 11.65 "Sides of outer ballast B-47F with oil coated and partly full of water on starboard side section FR 106"

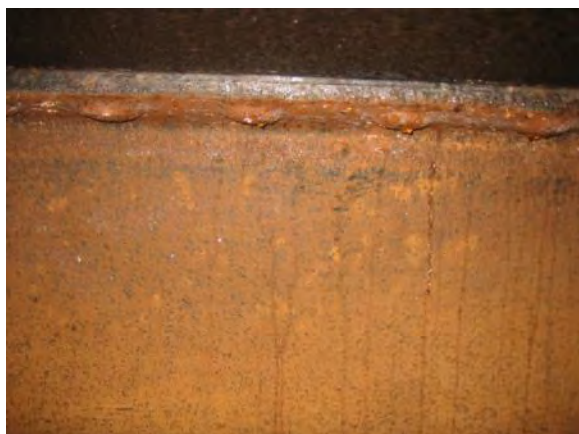
Figure 11.63 "Side of inner ballast B-45V with light surface corrosion on starboard side section FR 106"

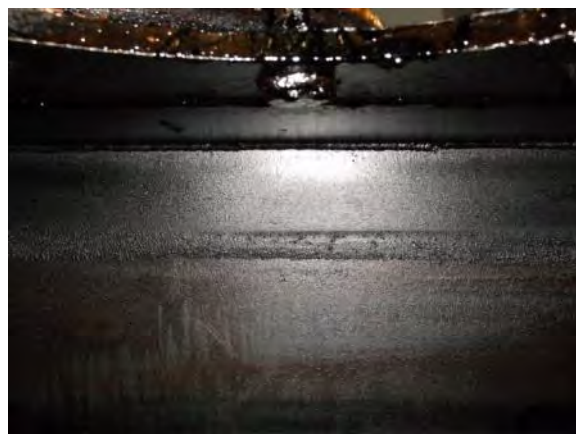
Figure 11.66 "Side of outer skin B-47.5F with oil coated and no corrosion on starboard side section FR 106"

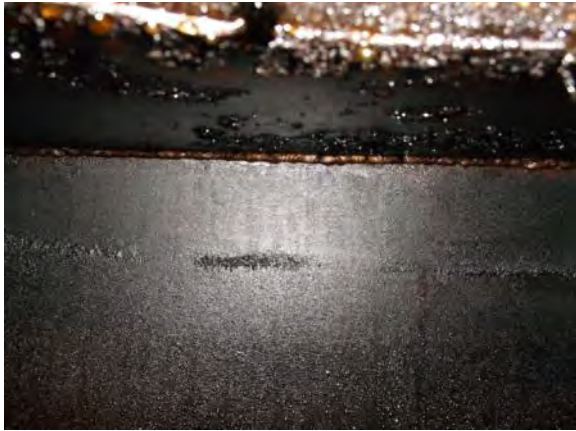
Figure 11.67 "Side of outer ballast B-48F with oil coated and no corrosion on port side section FR 106"

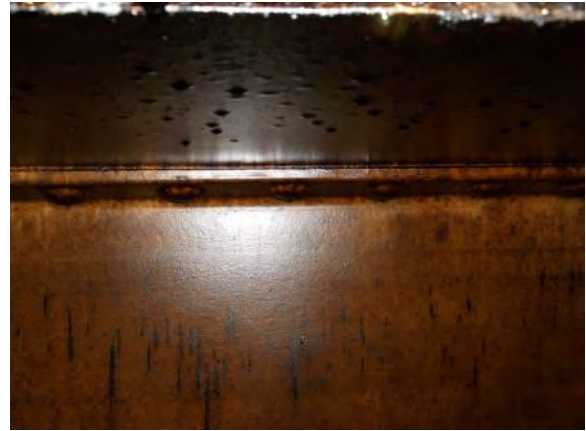
Figure 11.70 "Side of inner ballast B-54V with oil coated and no corrosion on port side section FR 113"

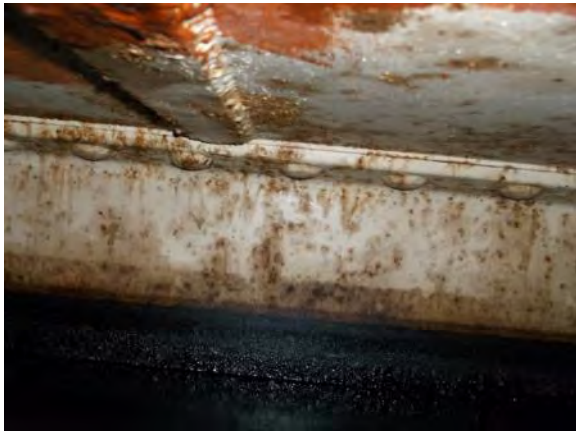
Figure 11.68 "Side of inner void B-50V with oil coated and light surface corrosion on port side section FR 113"

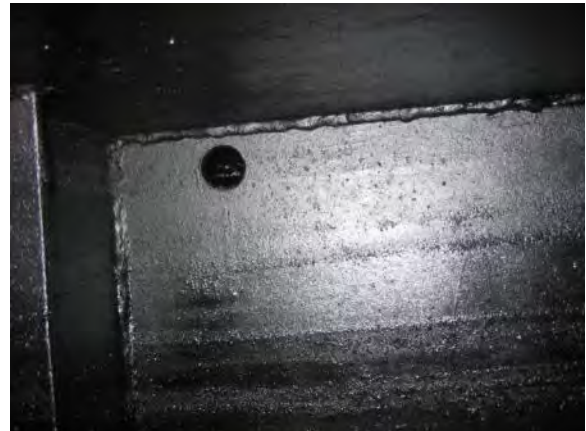
Figure 11.71 "Back corner of outer ballast B-55F with oil coated and no corrosion on starboard side section FR 113"

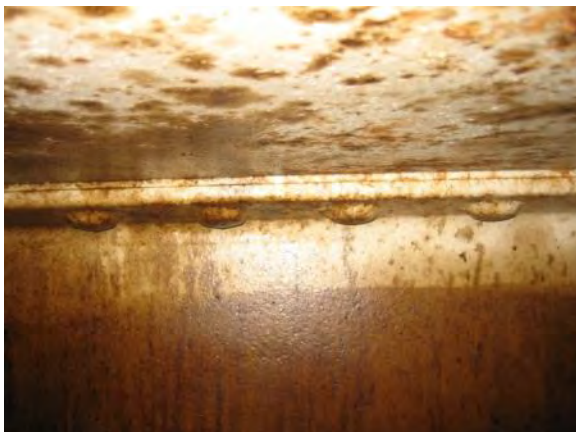
Figure 11.69 "Side of inner ballast B-53V with oil coated and light surface corrosion on starboard side section FR 113"

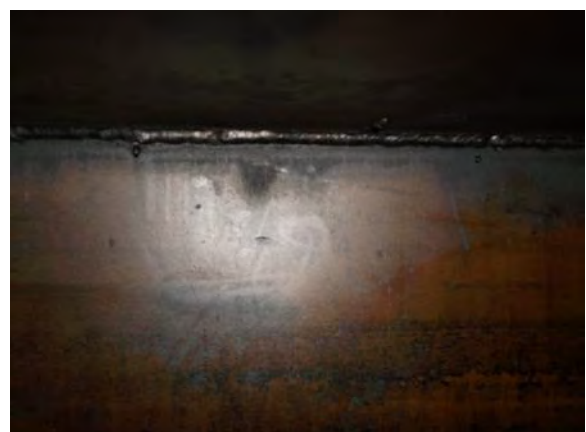
Figure 11.72 "Side of outer skin B-55.5F with oil coated and no corrosion on starboard side section FR 113"

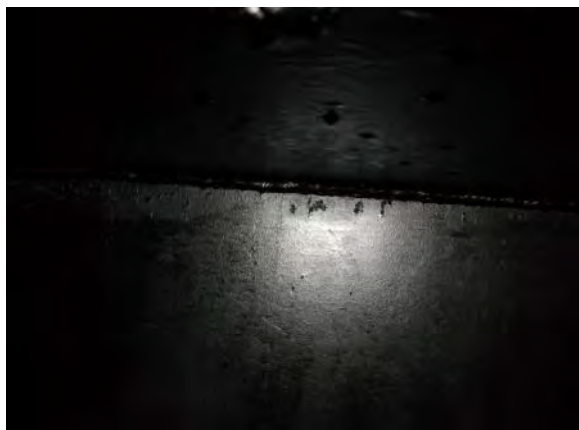
Figure 11.73 "Side of outer skin B-56.5F with oil coated and no corrosion on port side section FR 113"

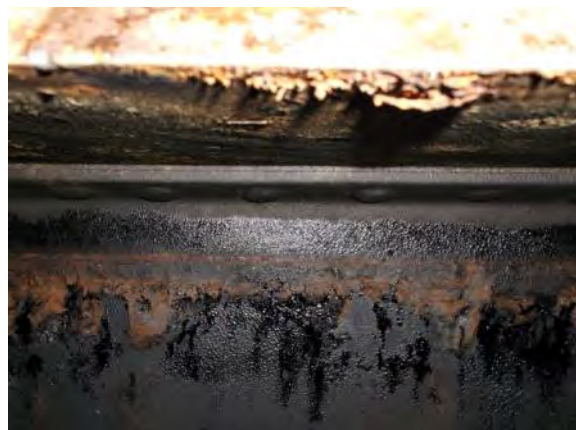
Figure 11.76 "Side of inner ballast B-62V with oil coated and no corrosion on port side section FR 119"

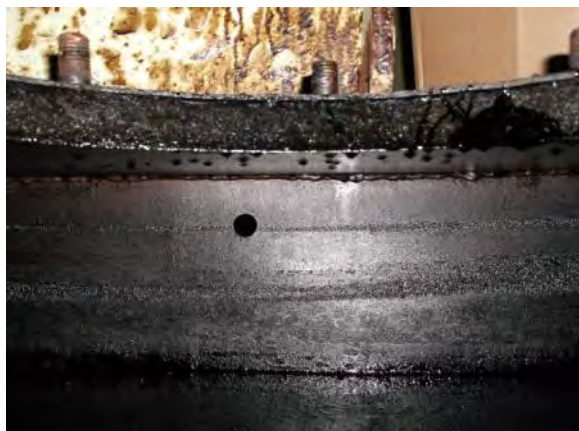
Figure 11.74 "Side of inner ballast B-56F with oil coated and partly full of water on port side section FR 113"

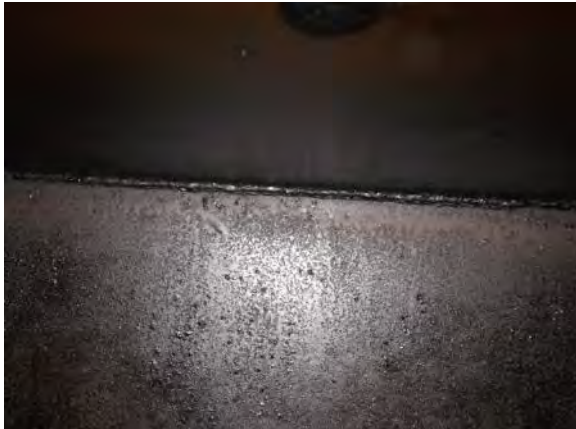
Figure 11.79 "Side of outer skin B-64.5F with oil coated and no corrosion on port side section FR 119"

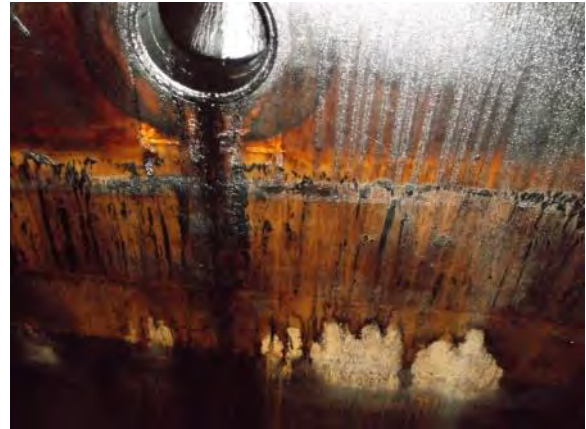
Figure 11.82 "Side of outer skin B-71.5F with oil coated and minor corrosion on starboard side section FR 123"

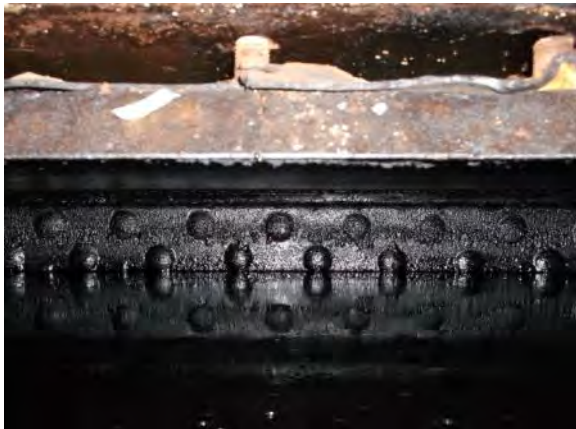
Figure 11.80 "Side of outer ballast B-64F with oil coated and mostly full of water on port side section FR 119"

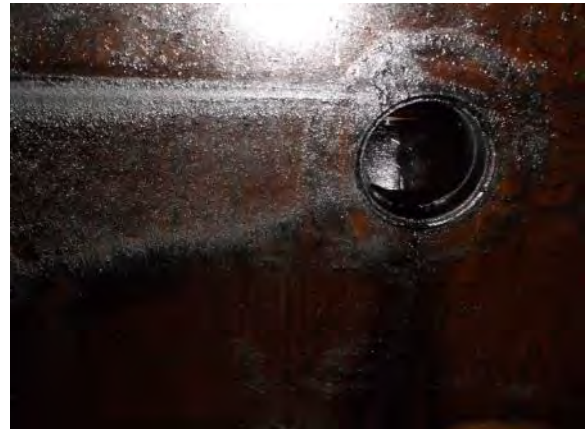
Figure 11.83 "Side of outer skin B-72.5F with oil coated and no corrosion on port side section FR 123"

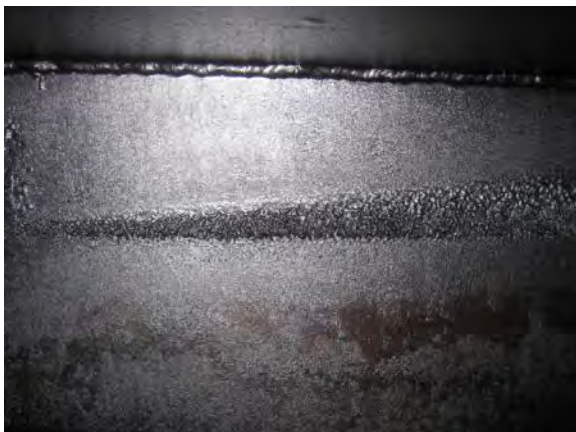
Figure 11.81 "Side of outer ballast B-71F with oil coated and no corrosion on starboard side section FR 123"

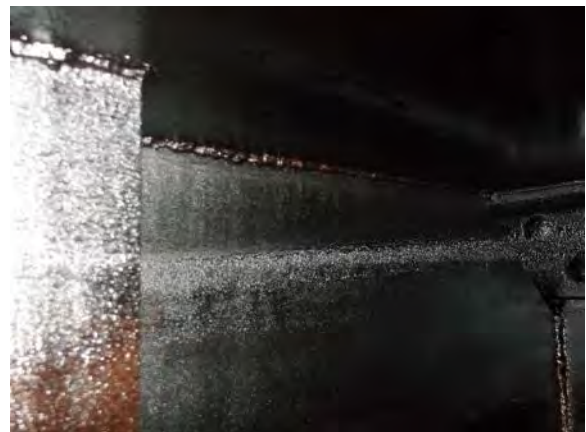
Figure 11.84 "Back corner of outer ballast B-72F with oil coated and no corrosion on port side section FR 123"

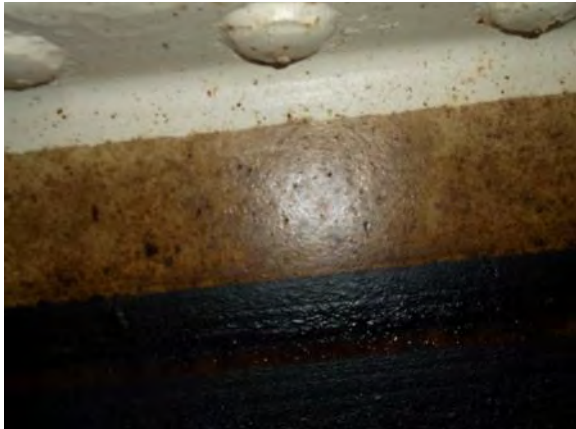
Figure 11.85 "Side of inner void B-74V with oil coated and minor corrosion on port side section FR 128"

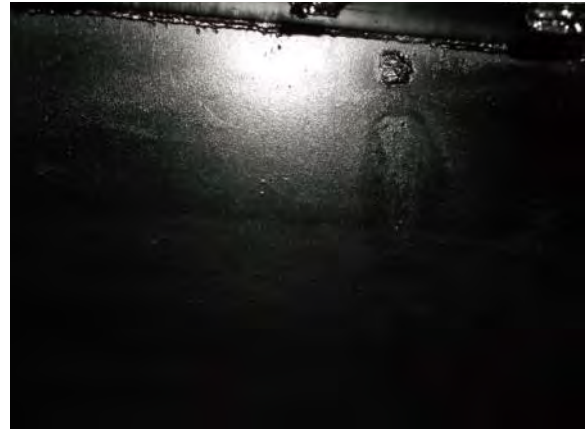
Figure 11.88 "Side of outer skin B-80.5F with oil coated and no corrosion on port side section FR 128"

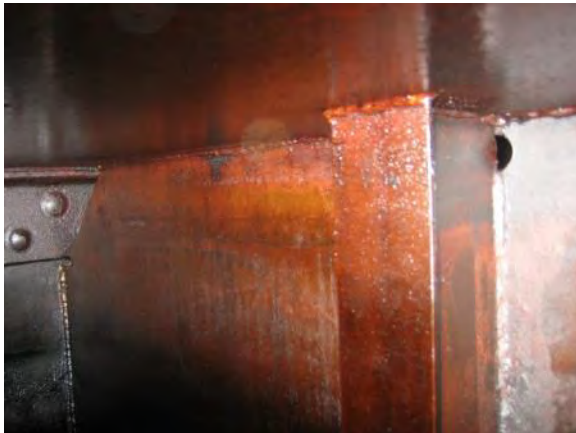
Figure 11.86 "Front corner of outer ballast B-79F with oil coated and no corrosion on starboard side section FR 128"

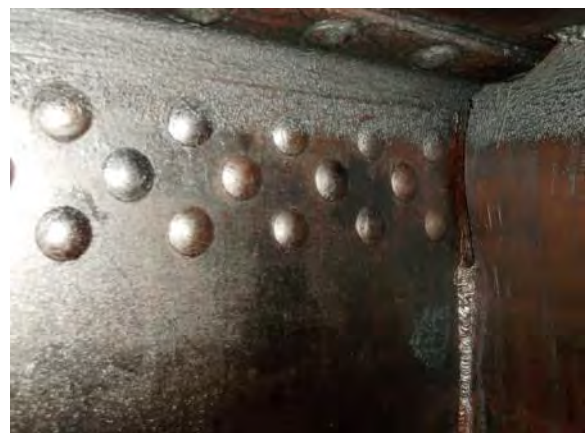
Figure 11.89 "Back corner of outer ballast B-80F with oil coated and no corrosion on port side section FR 128"

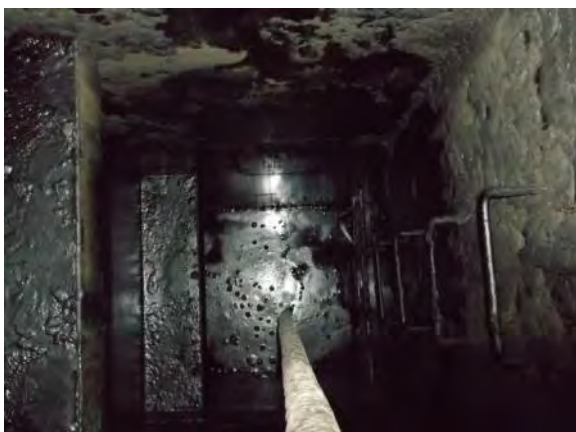
Figure 11.87 "Sides of outer skin B-79.5F with oil coated and partly full of oil/water on starboard side section FR 128"

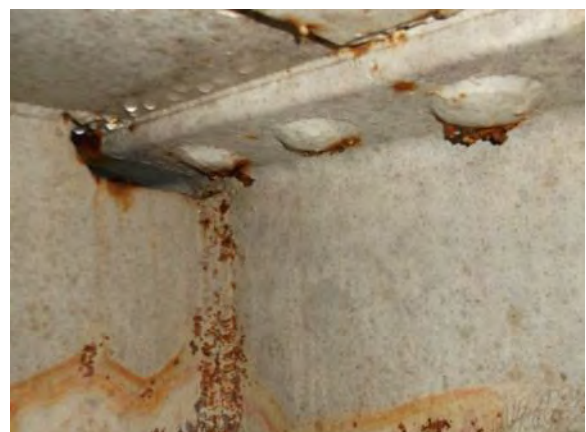
Figure 11.90 "Front corner of inner void B-82V with light surface corrosion on port side section FR 133"

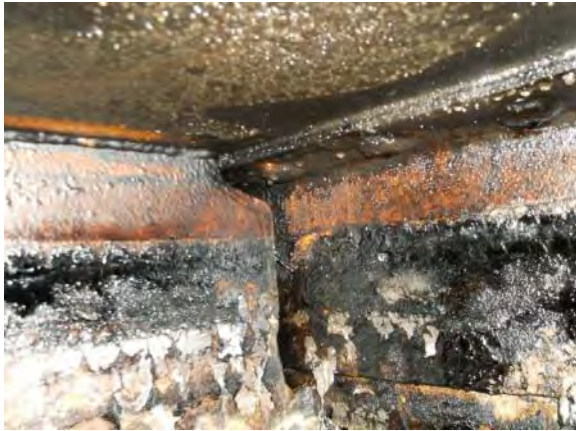
Figure 11.91 "Front corner of inner ballast B-86V with peeling paint and light corrosion on port side section FR 133"

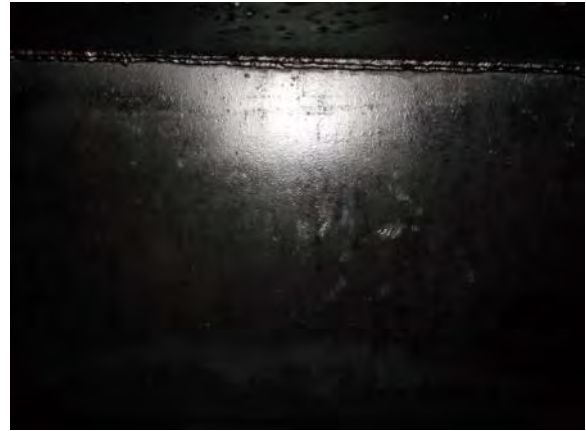
Figure 11.94 "Side of outer skin B-88.5F with oil coated and no corrosion on port side section FR 133"

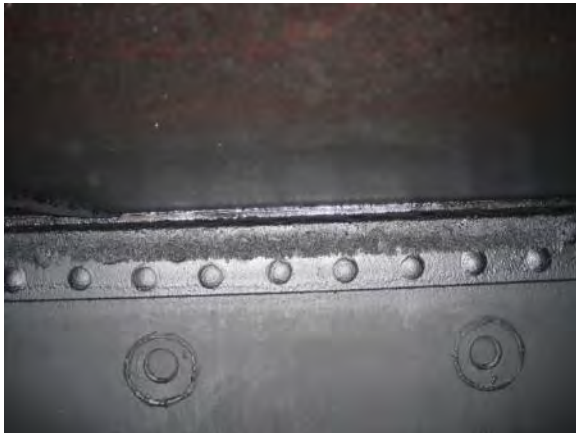
Figure 11.92 "Side of outer ballast B-87F with oil coated and no corrosion on starboard side section FR 133"

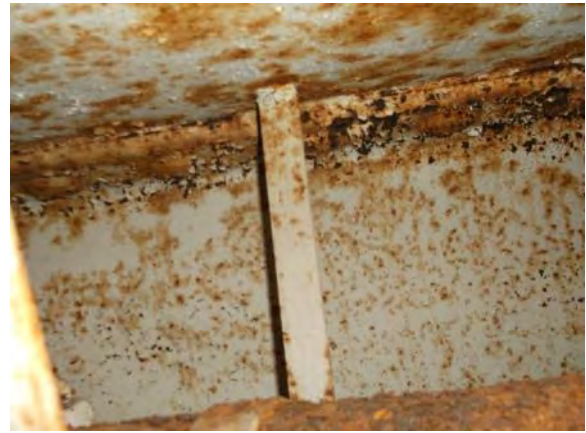
Figure 11.95 "Side of inner void B-90V with peeling paint and light corrosion on port side section FR 137"

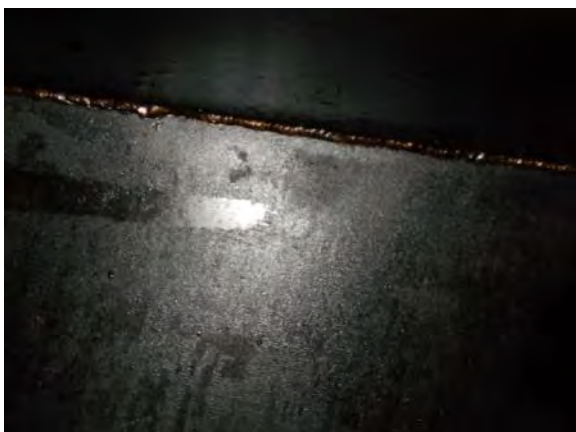
Figure 11.93 "Side of outer skin B-87.5F with oil coated and no corrosion on starboard side section FR 133"

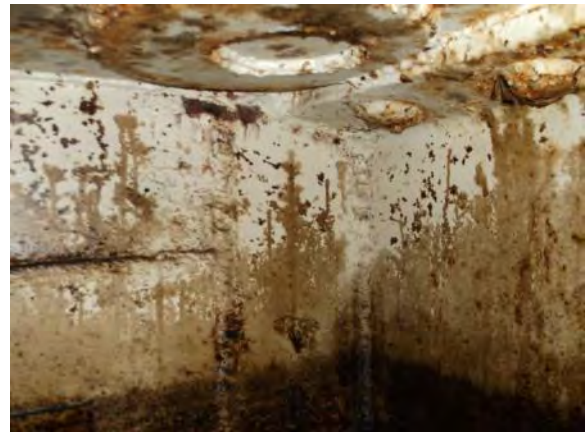
Figure 11.96 "Back corner of inner ballast B-92V with light corrosion on port side section FR 137"

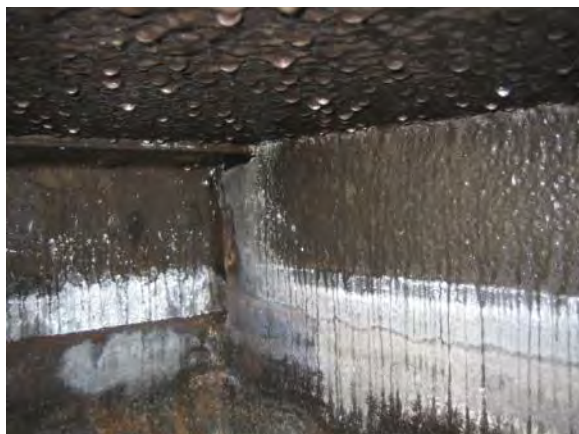
Figure 11.97 "Front corner of inner ballast B-93V with oil coated and no corrosion on starboard side section FR 137"

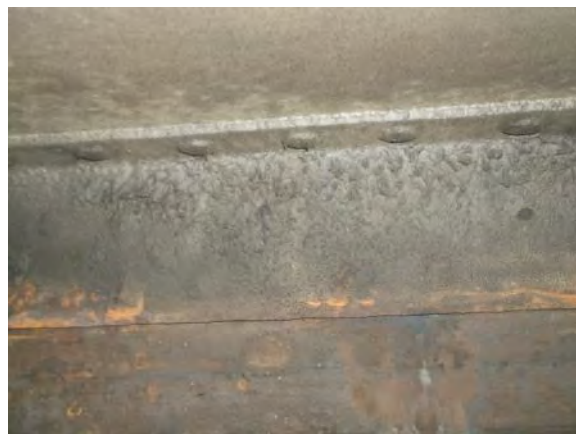
Figure 11.100 "Side of inner ballast B-94V with oil coated and no corrosion on port side section FR 137"

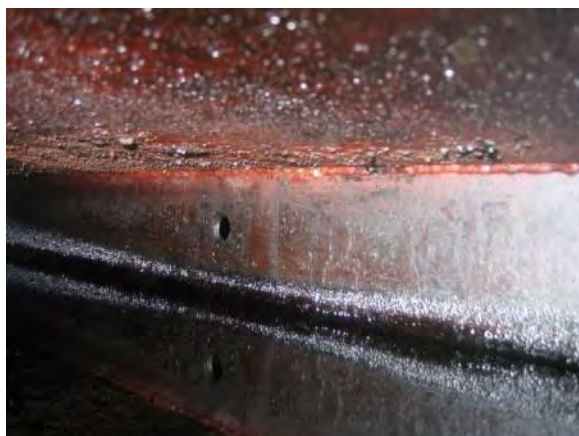
Figure 11.98 "Side of outer ballast B-93.5F with oil coated and no corrosion on starboard side section FR 137"

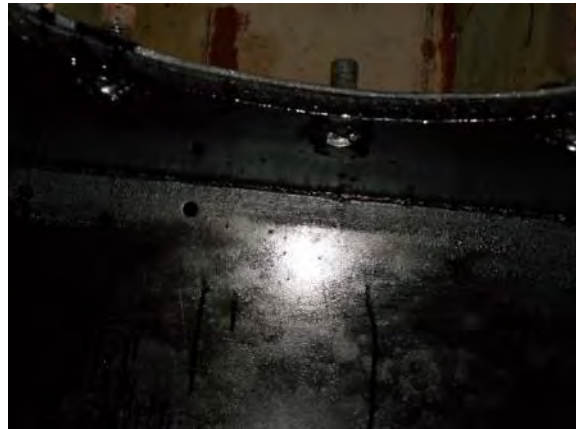
Figure 11.101 "Side of outer skin B-95F with oil coated and no corrosion on starboard side section FR 137"

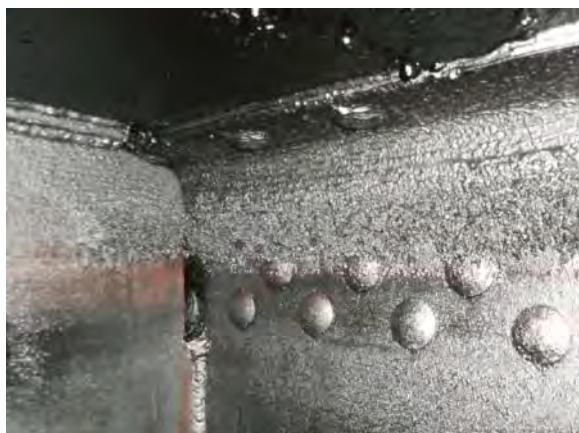
Figure 11.99 "Back corner of outer ballast B-94.5F with oil coated and no corrosion on port side section FR 137"

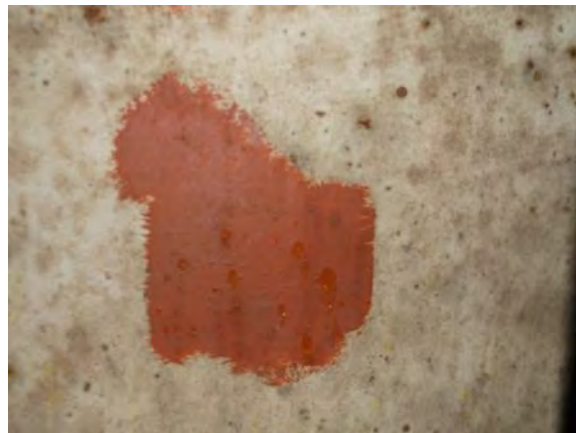
Figure 11.102 "Front corner of inner void B-96.5V with light surface corrosion on port side section FR 149"

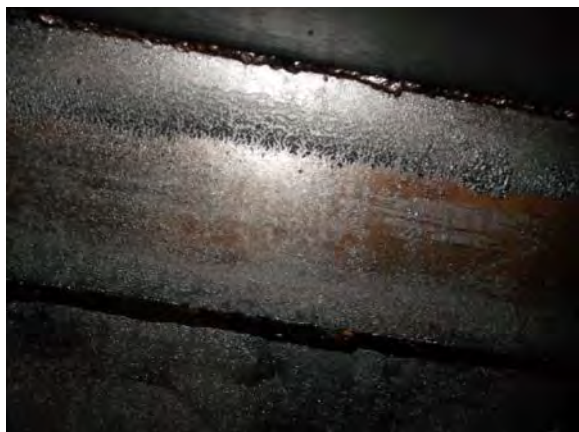
Figure 11.103 "Side of outer skin B-96F with oil coated and no corrosion on starboard side section FR 137"

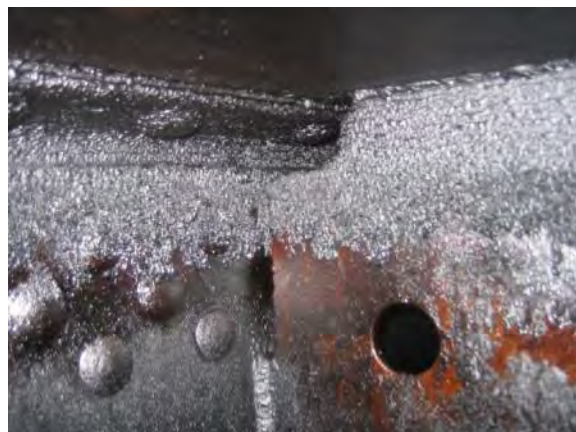
Figure 11.106 "Back corner of outer ballast B-99F with oil coated and no corrosion on starboard side section FR 149"

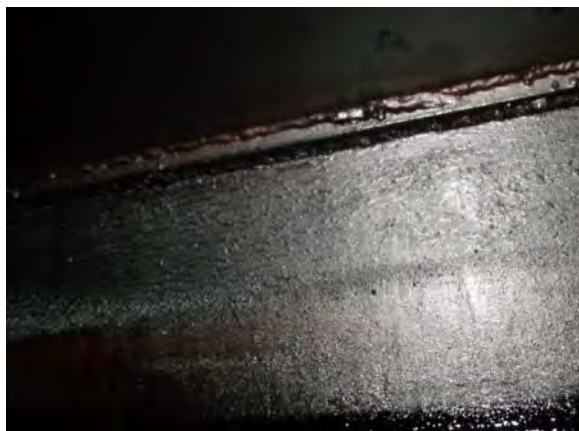
Figure 11.104 "Side of inner ballast B-98.5F with oil coated and no corrosion on port side section FR 149"

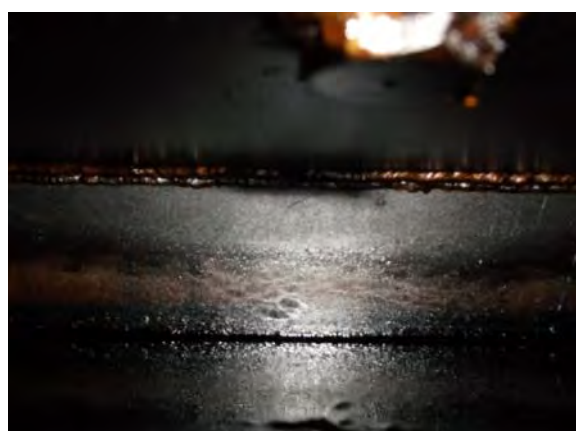
Figure 11.107 "Side of outer skin B-99.5F with oil coated and no corrosion on starboard side section FR 149"

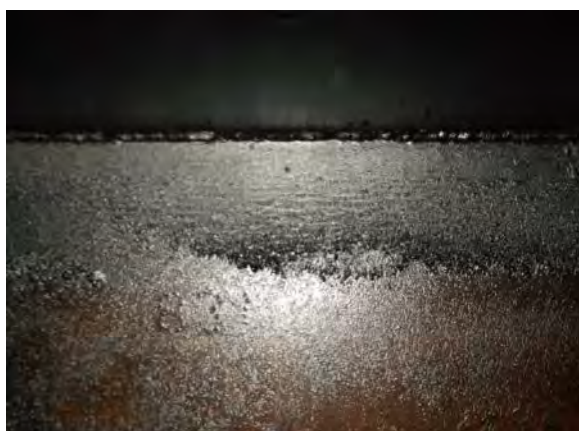
Figure 11.105 "Side of outer ballast B-98.75F with oil coated and no corrosion on port side section FR 149"

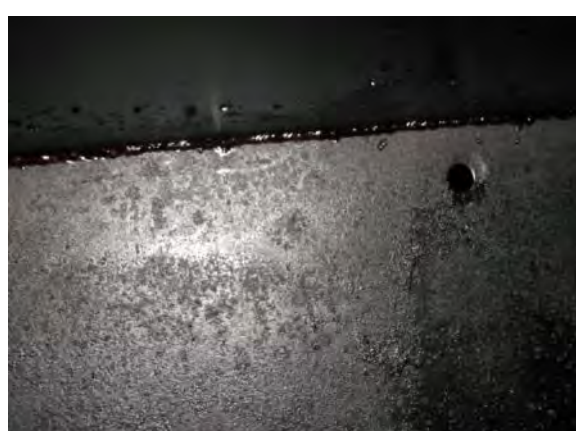
Figure 11.108 "Side of outer skin B-100F with oil coated and no corrosion on starboard side section FR 149"

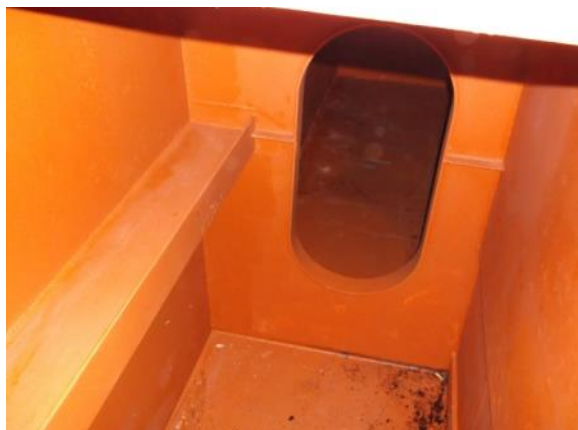
Figure 11.109 "Floor and walls of upper outer skin B-404.5V with no corrosion on port side section FR 83"

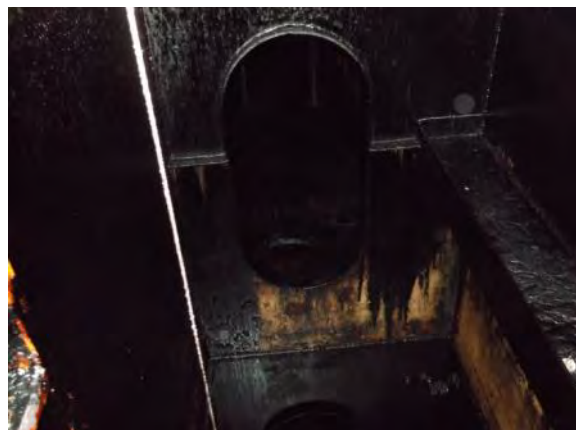
Figure 11.112 "Floor and walls of upper outer skin B-418.5V with oil coated, no corrosion on port side section FR 96"

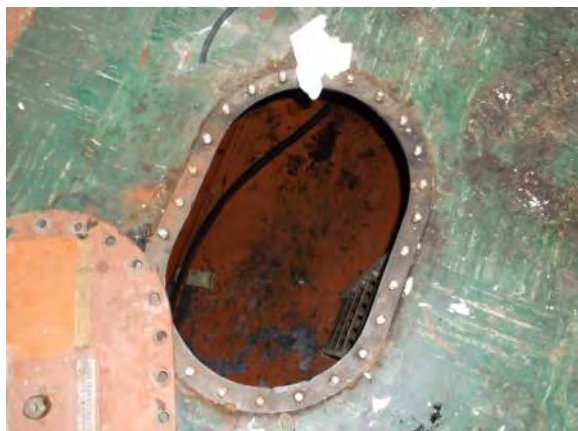
Figure 11.110 "Floor of upper outer skin B-409.5V with light surface corrosion on starboard side section FR 92"

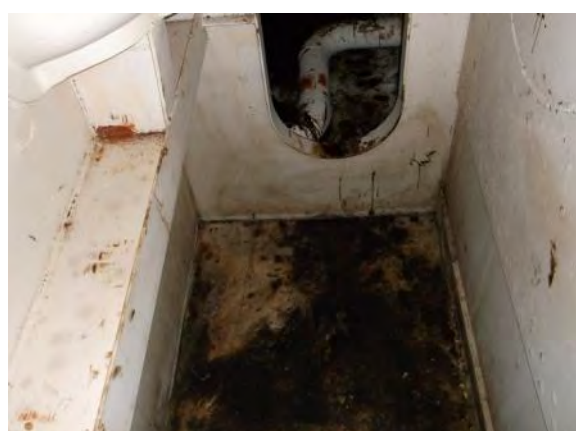
Figure 11.113 "Floor and walls of upper outer skin B-419.5V with no corrosion on starboard side section FR 103"

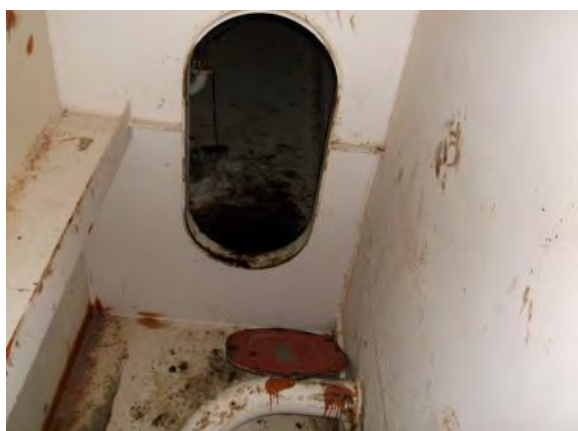
Figure 11.111 "Floor and walls of upper outer skin B-413.5V with no corrosion on starboard side section FR 96"

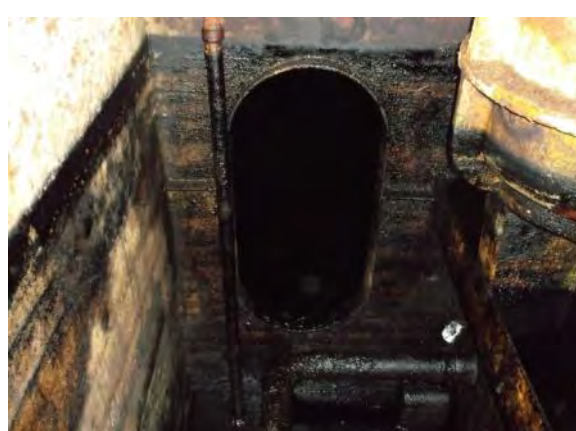
Figure 11.114 "Walls of upper outer skin B-420.5V with oil coated, light surface corrosion on port side section FR 103"

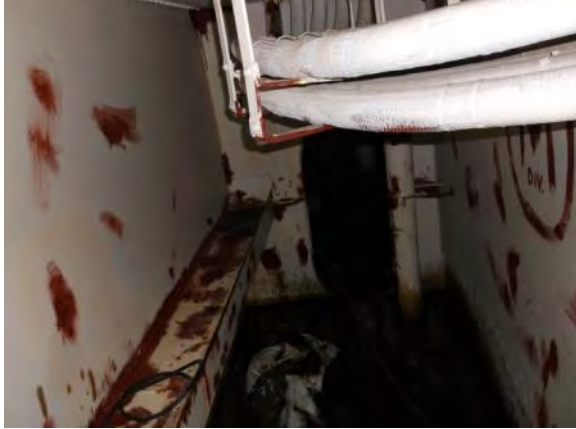
Figure 11.115 "Floor and walls of upper outer skin B-425.5V with no corrosion on starboard side section FR 113"

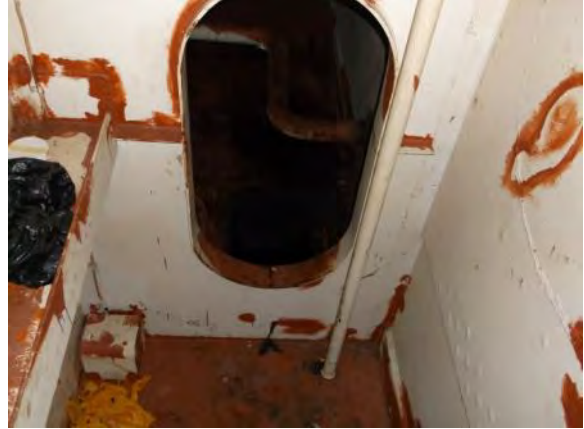
Figure 11.118 "Floor and walls of upper outer skin B-436.5V with no corrosion on port side section FR 133"

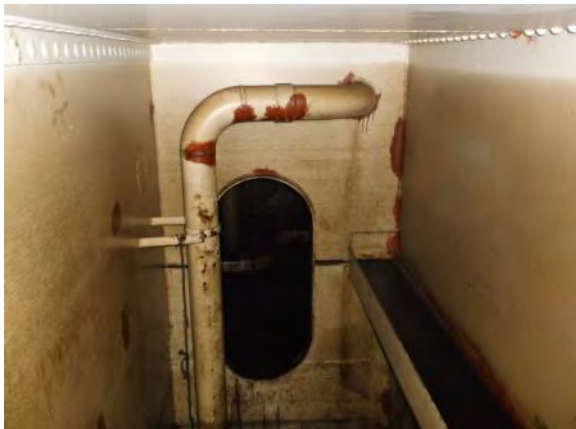
Figure 11.116 "Walls and ceiling of upper outer skin B-428.5V with no corrosion on port side section FR 113"

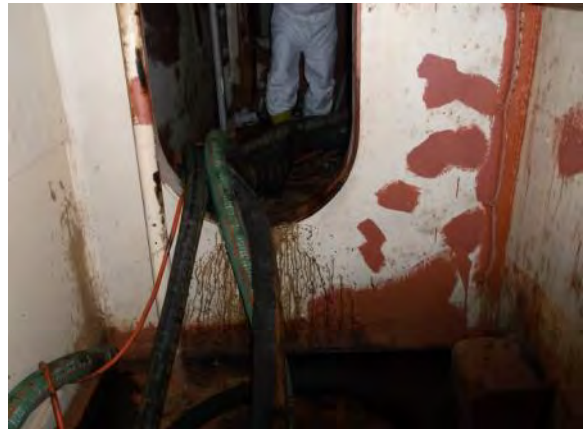
Figure 11.119 "Floor and walls of upper outer skin B-437.5V with no corrosion on starboard side section FR 123"

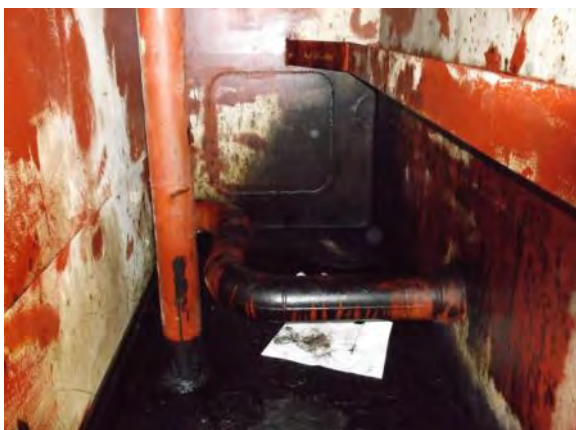
Figure 11.117 "Floor and walls of upper outer skin B-430.5V with oily floor, no corrosion on port side section FR 123"

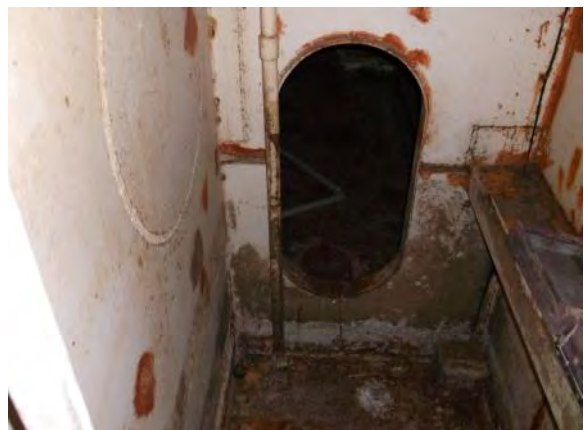
Figure 11.120 "Floor and walls of upper outer skin B-439.5V with surface corrosion on starboard side section FR 133"

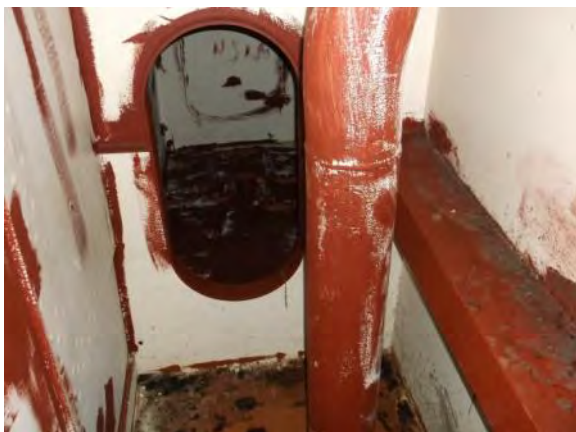
Figure 11.121 "Floor and walls of upper outer skin B-442.5V with no corrosion on port side section FR 145"

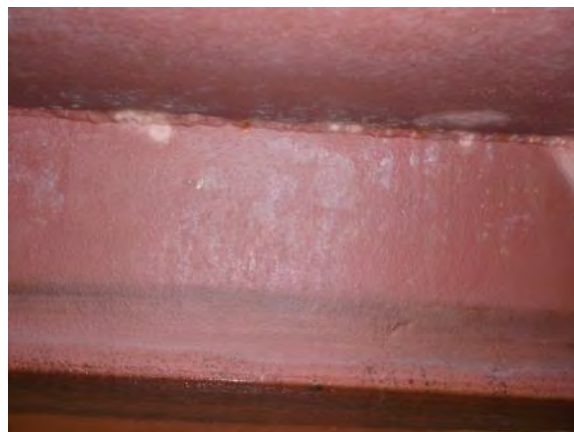
Figure 11.124 "Side wall of AFT AMR Hull Skin B-970F with no corrosion on center section FR 145"

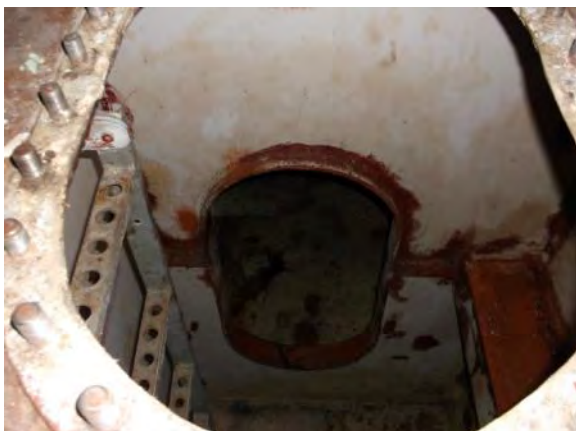
Figure 11.122 "Floor and walls of upper outer skin B-443.5V with no corrosion on starboard side section FR 145"

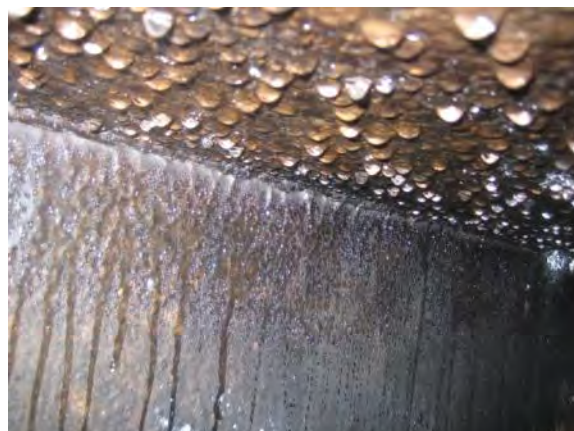
Figure 11.125 "Side wall of inner ballast C-9V with no corrosion on starboard side section FR 153"

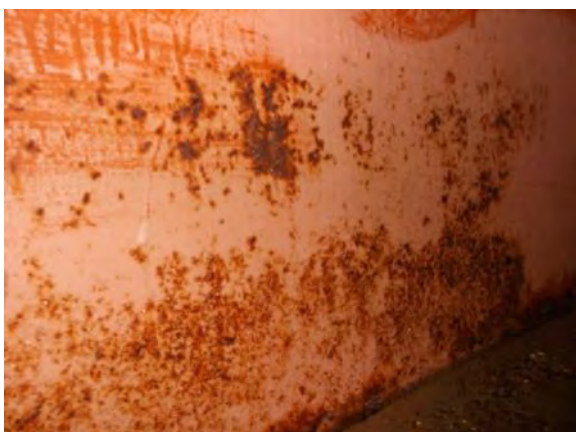
Figure 11.123 "Side wall of AFT Eng Rm Floor B-821V with light surface corrosion on center section FR 133"

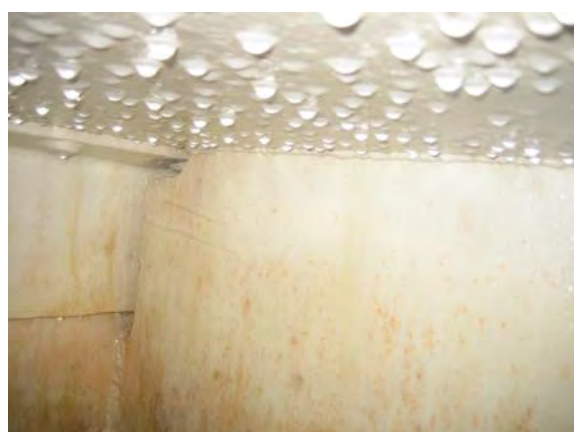
Figure 11.126 "Back corner of inner ballast C-11V with no corrosion on starboard side section FR 153"

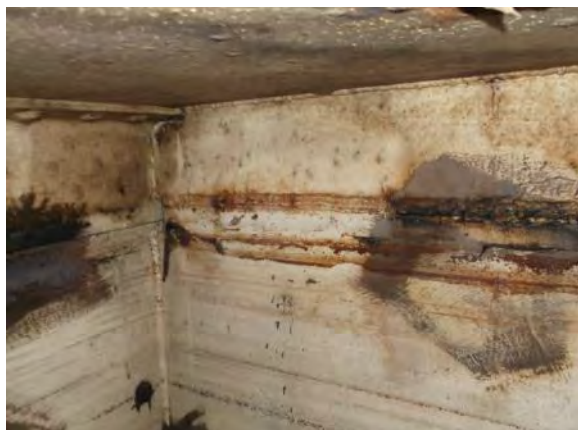
Figure 11.127 "Front corner of inner ballast C-12V with light surface corrosion on port side section FR 153"

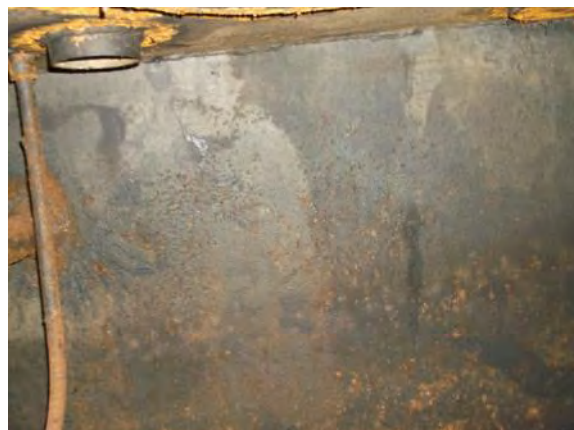
Figure 11.130 "Side wall of inner ballast C-9V with light surface corrosion on starboard side section FR 160"

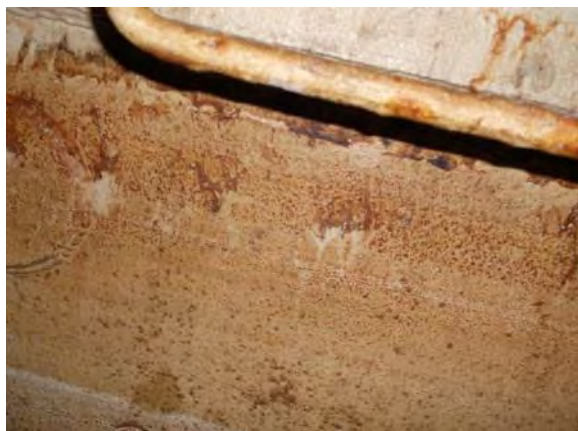
Figure 11.128 "Side wall of outer ballast C-14.5F with light surface corrosion on port side section FR 153"

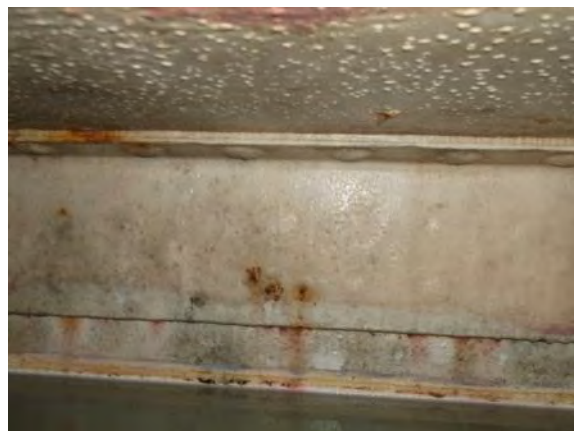
Figure 11.131 "Side wall of inner ballast C-19J with light surface corrosion on starboard side section FR 160"

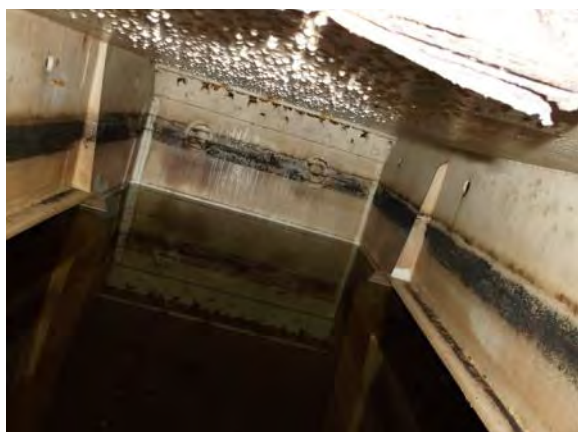
Figure 11.129 "Side walls and floor of outer ballast C-14F partly full of water, no corrosion on port side section FR 153"

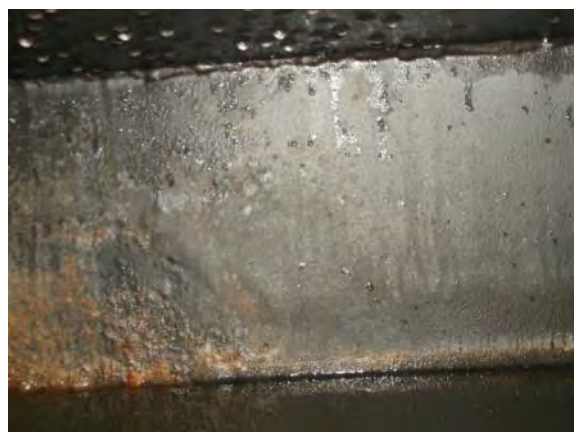
Figure 11.132 "Side wall of inner ballast C-20J with light surface corrosion on port side section FR 160"

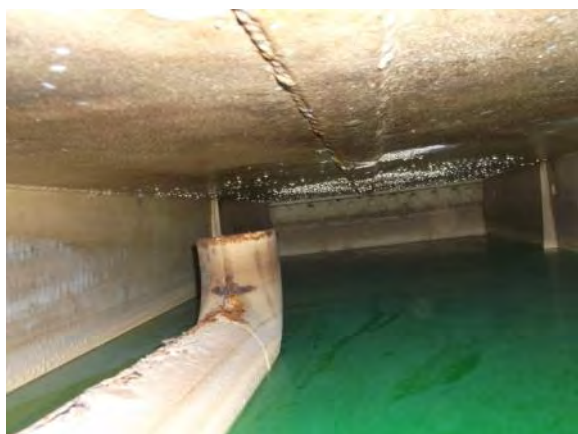
Figure 11.133 "Side walls and floor of outer ballast C-22J partly full of water, no corrosion on port side section FR 160"

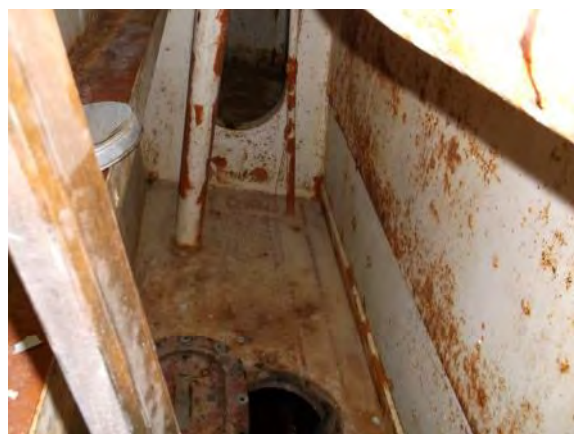
Figure 11.136 "Floor and walls of upper outer skin B-408.5V with light surface corrosion on port side section FR 160"

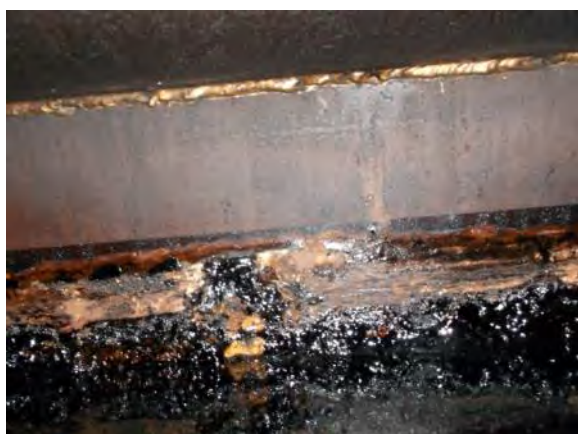
Figure 11.134 "Side wall of outer skin C-23F with oil coated, light surface corrosion on starboard side section FR 160"
