Structural Assessment of the USS Yorktown CV-10

Prepared for:

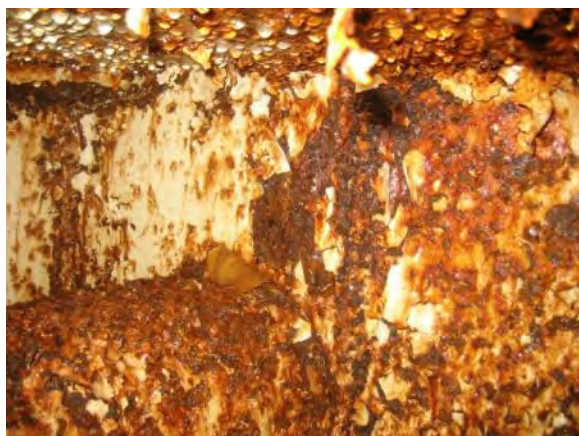
Figure 11.224 "Back corner of inner void C-7V with severe pitting and flaking on starboard side section FR 153"

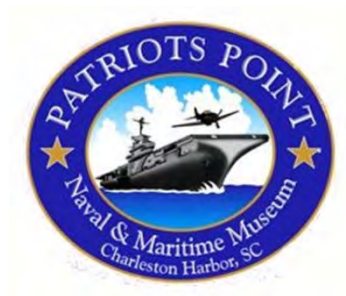
PATRIOTS POINT DEVELOPMENT AUTHORITY

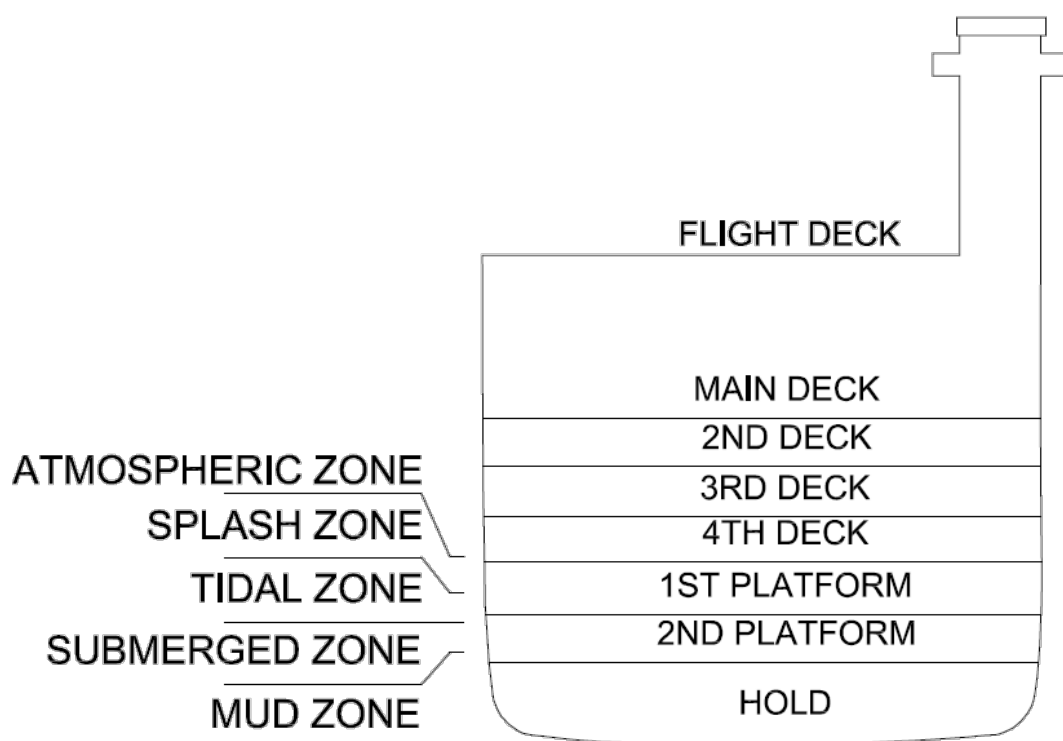
Figure 2.1 USS Yorktown Exposure Zones

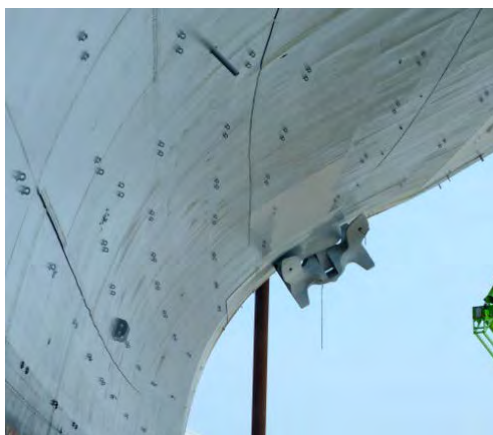
Figure 2.2 Atmospheric Zone at bow, starboard side

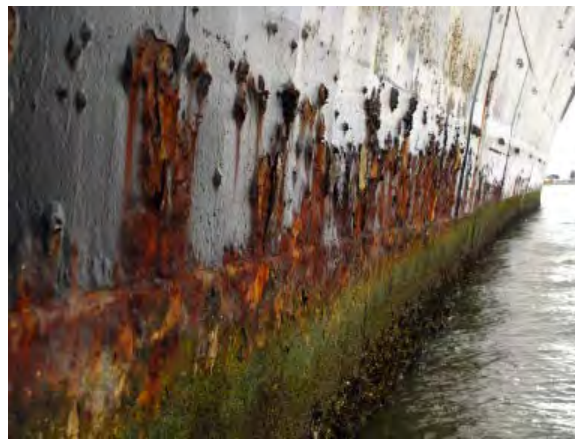
Figure 2.4 Typical condition of splash zone, port side.

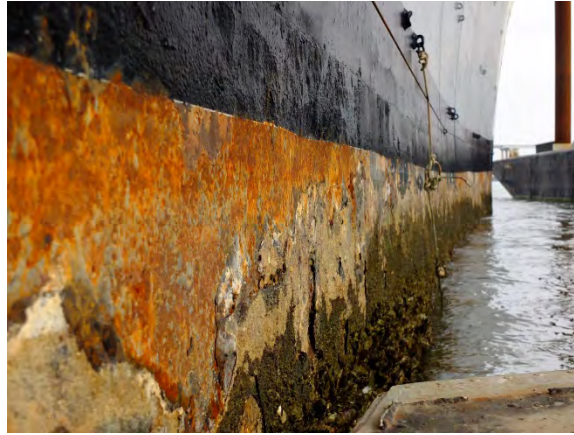
Figure 2.5 Typical condition of splash zone, starboard side.

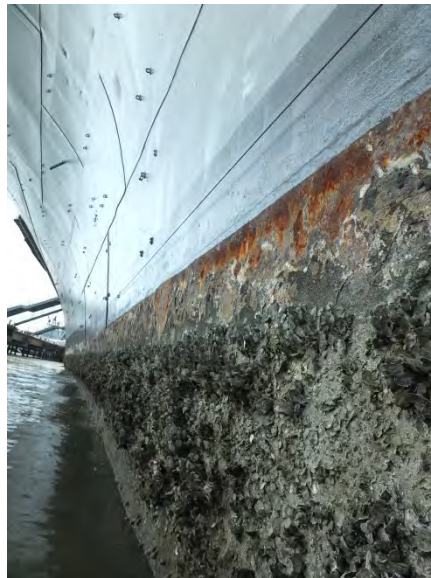
Figure 2.6 Tidal zone with typical marine growth.

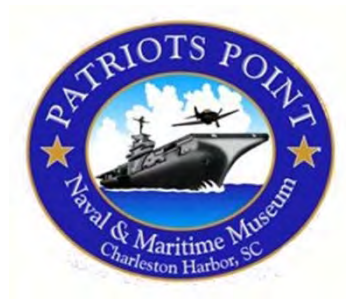
PATRIOTS POINT DEVELOPMENT AUTHORITY

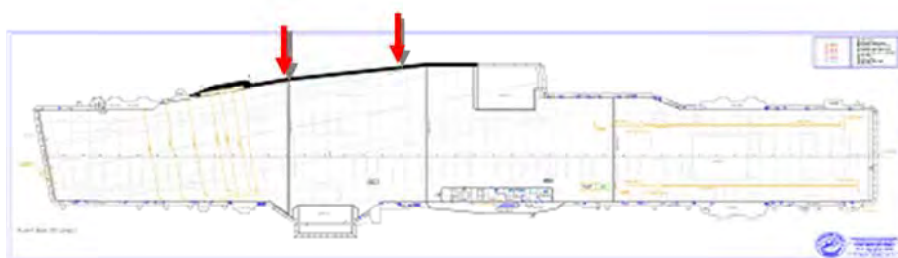
Figure 2.1 Location of catwalk along port edge of flight deck

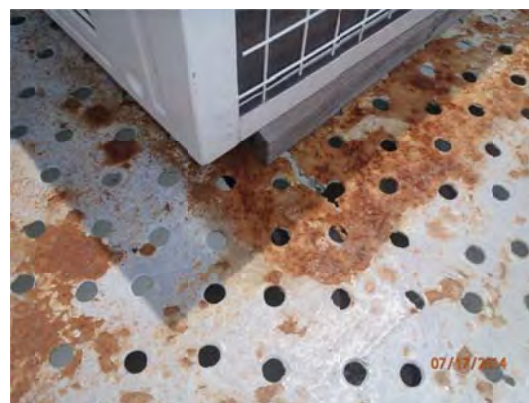
Figure 2.6 Corrosion of steel catwalk deck

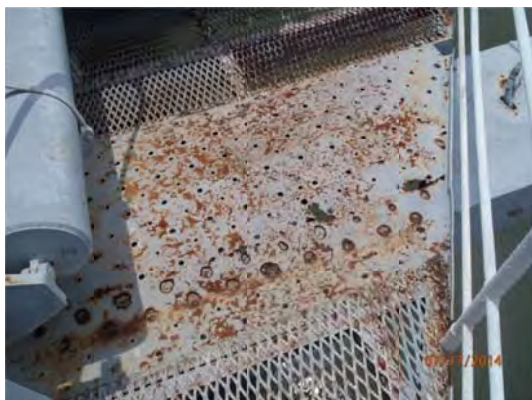
Figure 2.4 Perforated steel plate decking on catwalk

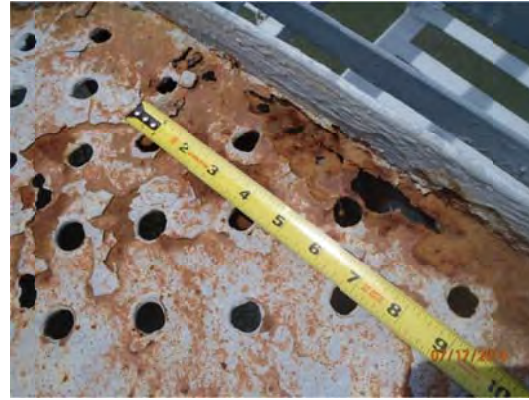
Figure 2.7 Corrosion with 100% loss of section on catwalk deck

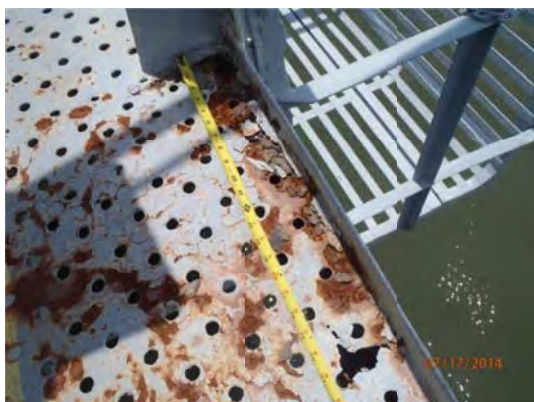
Figure 2.8 Corrosion with 100% loss of section on catwalk deck

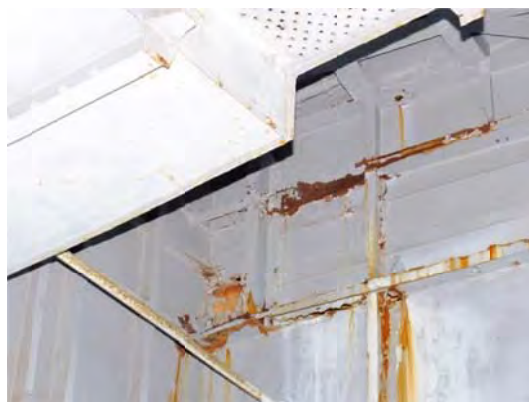
Figure 2.11 Corrosion with 100% loss of section on catwalk support framing

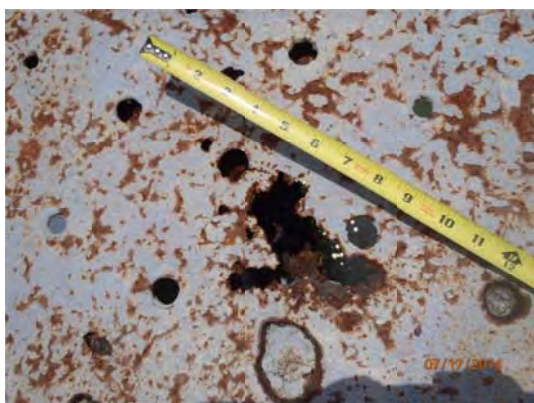
Figure 2.9 Corrosion with 100% loss of section on catwalk deck

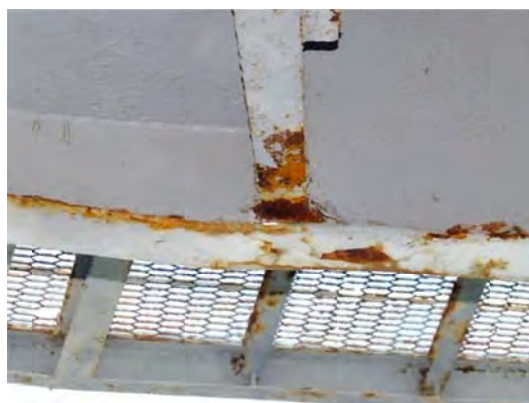
Figure 2.12 Corrosion with 100% loss of section on catwalk support framing

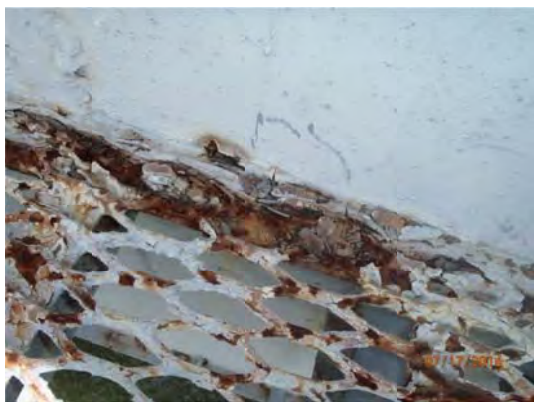
Figure 2.10 Corrosion of steel plate supporting catwalk deck

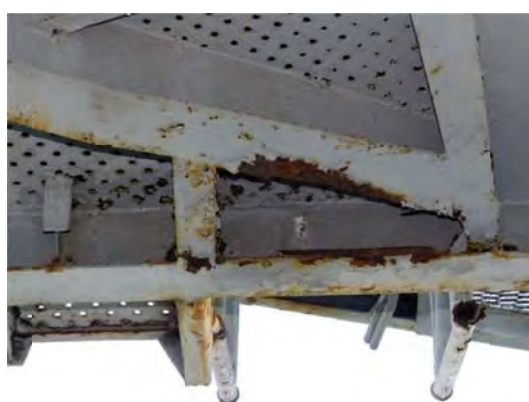
Figure 2.13 Corrosion with 100% loss of section on catwalk support framing

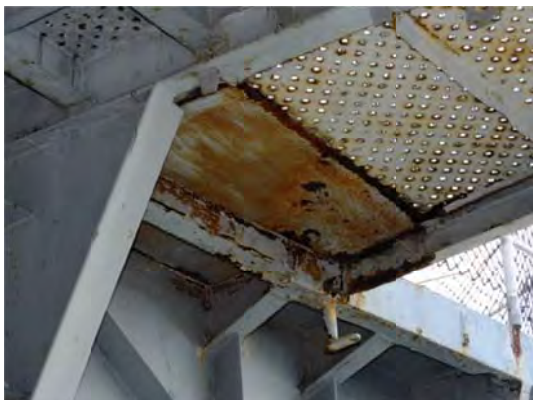
Figure 2.14 Corrosion with 100% loss of section on catwalk support framing

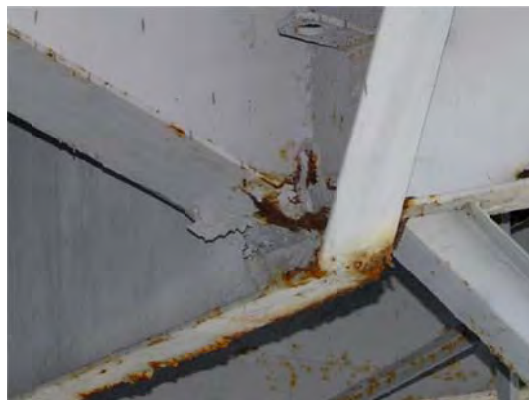
Figure 2.16 Corrosion with 100% loss of section on catwalk support framing

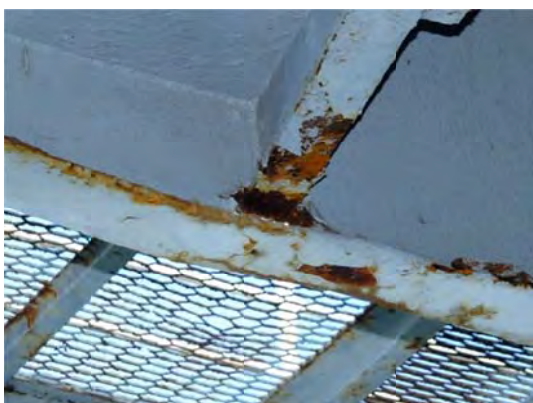
Figure 2.15 Corrosion with 100% loss of section on catwalk support framing

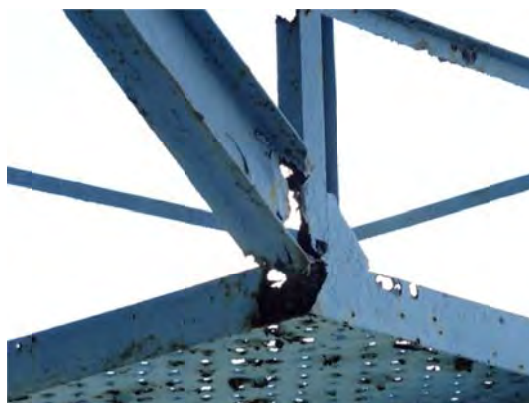
Figure 2.17 Corrosion with 100% loss of section on catwalk support framing

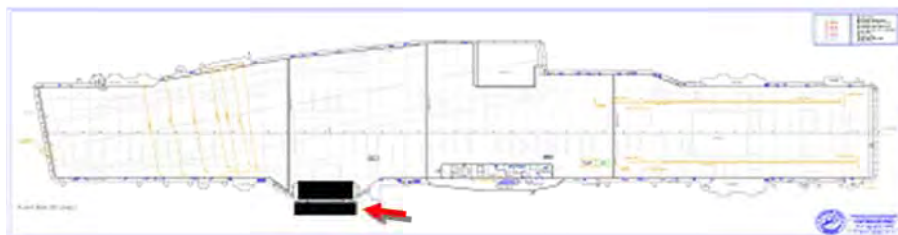
Figure 3.1 Location of starboard elevator / entrance platform

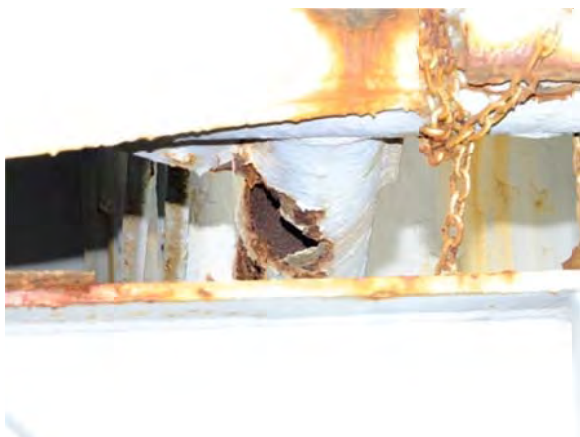
Figure 3.2 Corrosion with 100% loss of section on entrance platform support framing

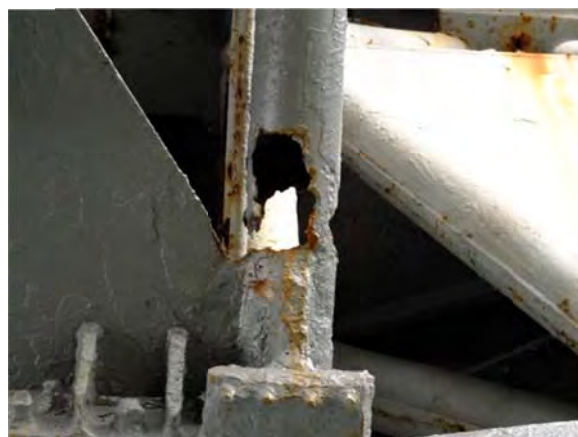
Figure 3.3 Corrosion with 100% loss of section on entrance platform support framing

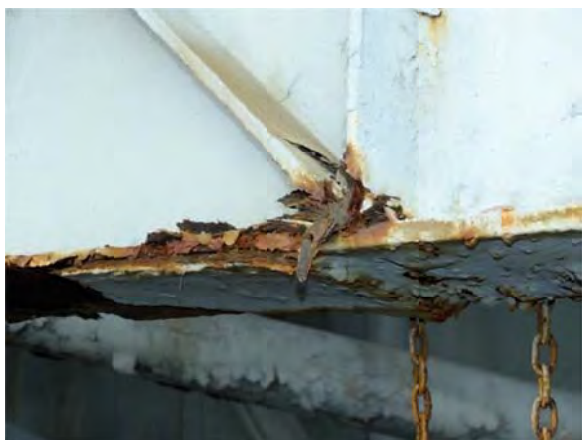
Figure 3.4 Corrosion on entrance platform support framing

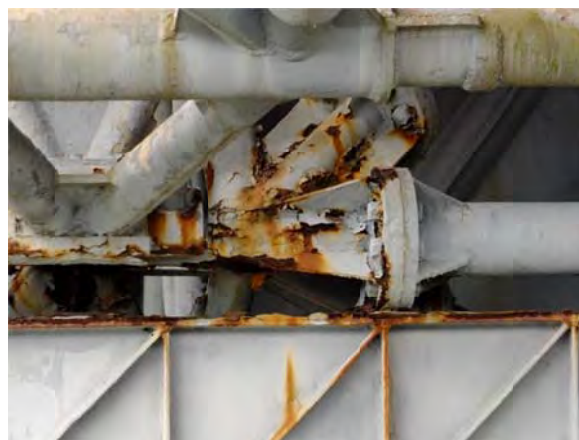
Figure 3.7 Corrosion on entrance platform support framing

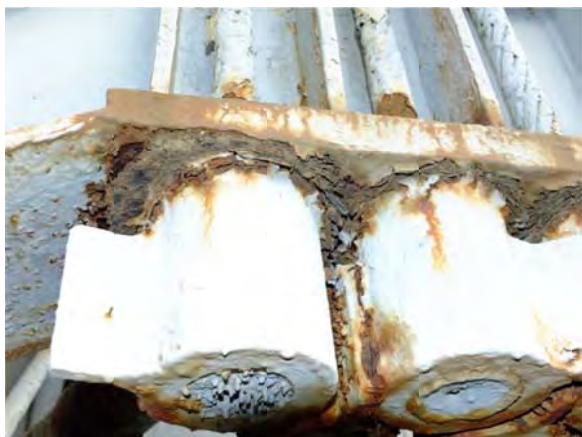
Figure 3.5 Corrosion on entrance platform support framing

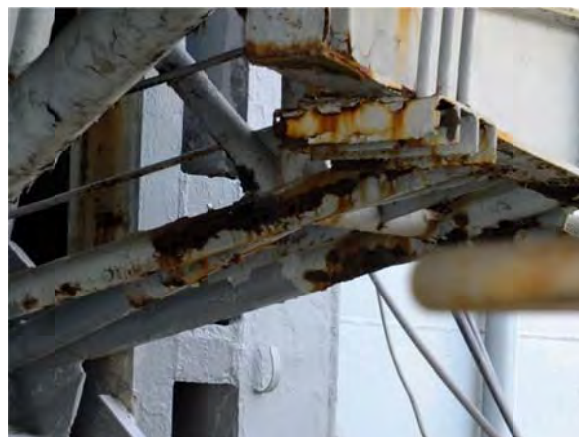
Figure 3.8 Corrosion on entrance platform support framing

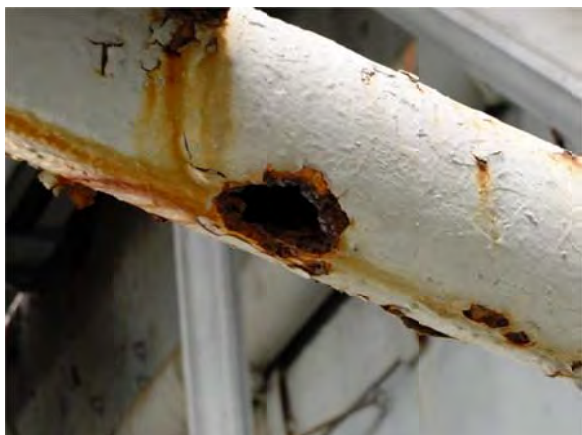
Figure 3.6 Corrosion with 100% loss of section on entrance platform support framing

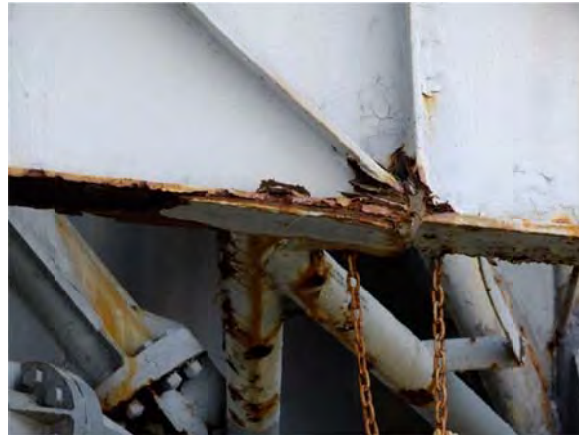
Figure 3.9 Corrosion on entrance platform support framing

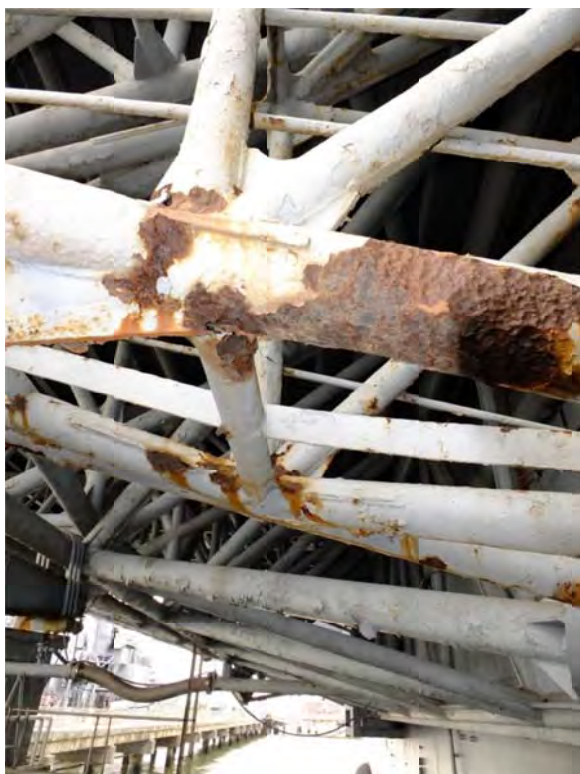
Figure 3.10 Corrosion with 100% loss of section on entrance platform support framing

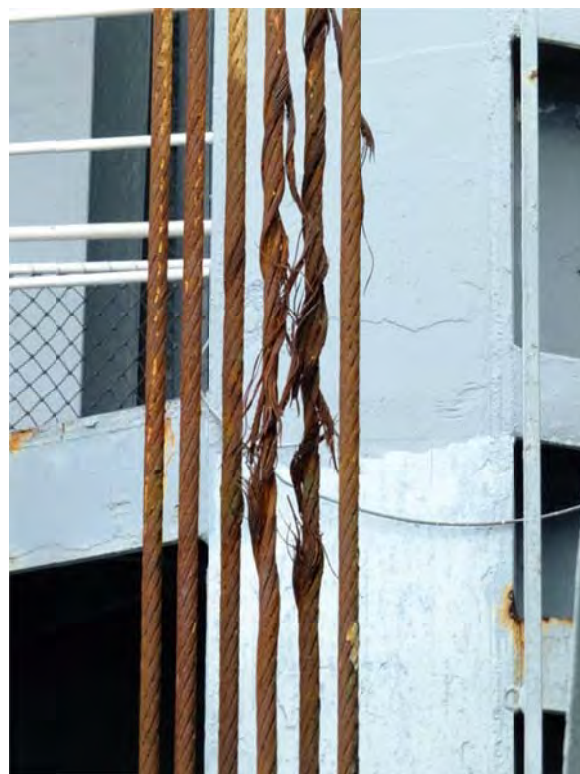
Figure 3.12 Failure of cables supporting entrance platform

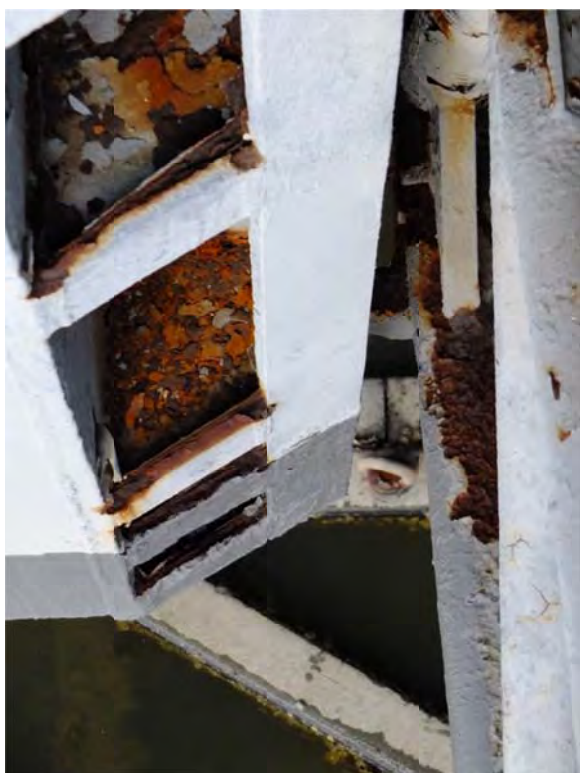
Figure 3.11 Corrosion on entrance platform support framing

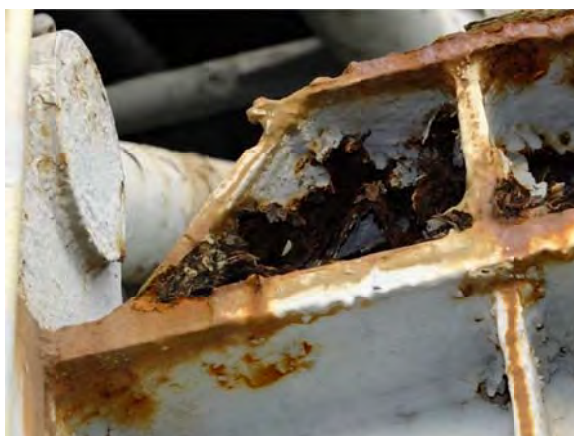
Figure 3.13 Severe corrosion of lower attachment points for support members

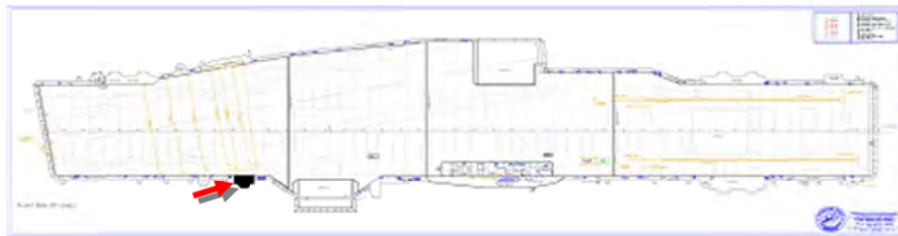
Figure 4.1 Location of crane and sponson

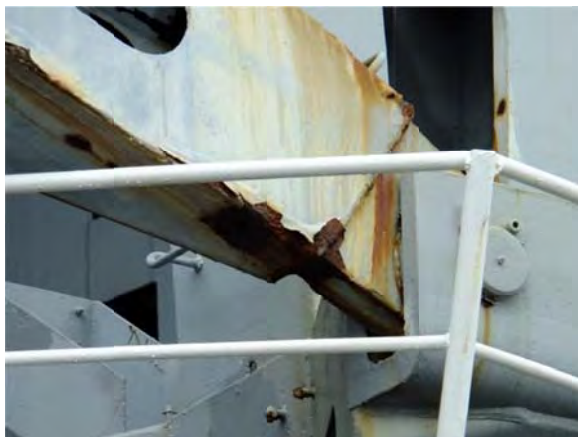
Figure 4.2 Corrosion of crane arm structure

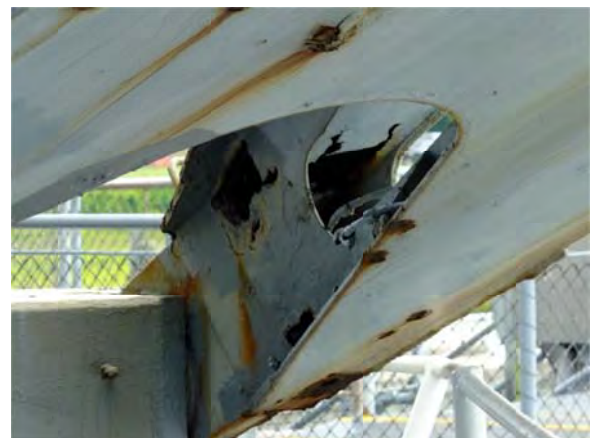
Figure 4.3 Corrosion of crane arm structure

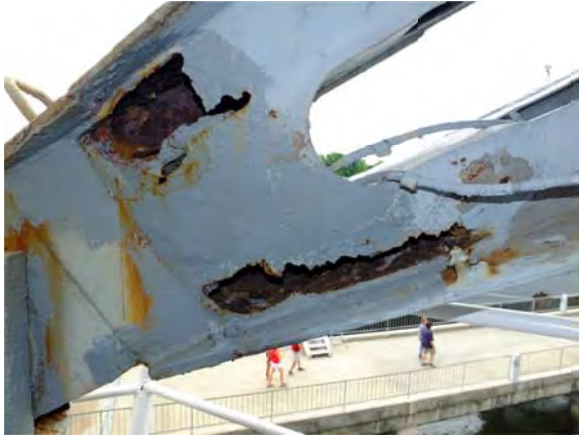
Figure 4.4 Corrosion of crane arm structure

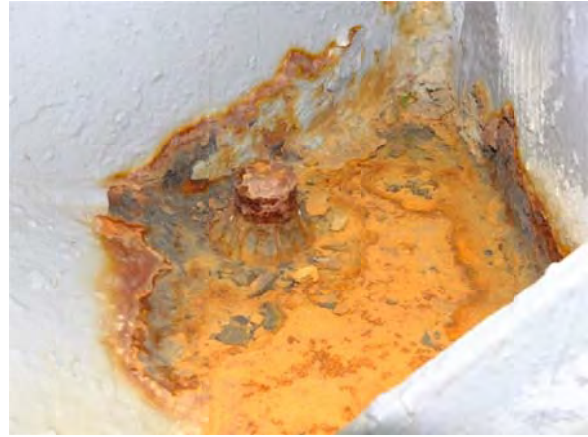
Figure 4.7 Corrosion at base of crane mount

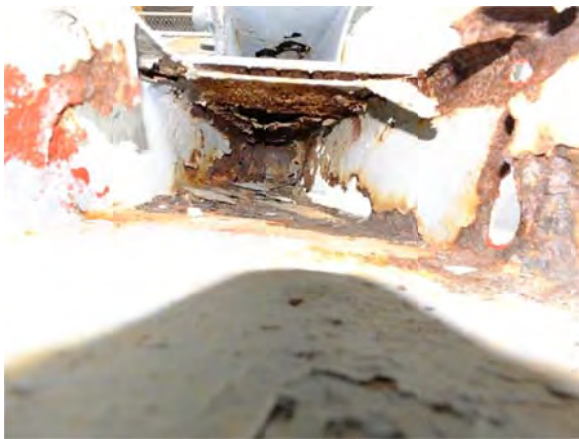
Figure 4.5 Corrosion of crane arm structure

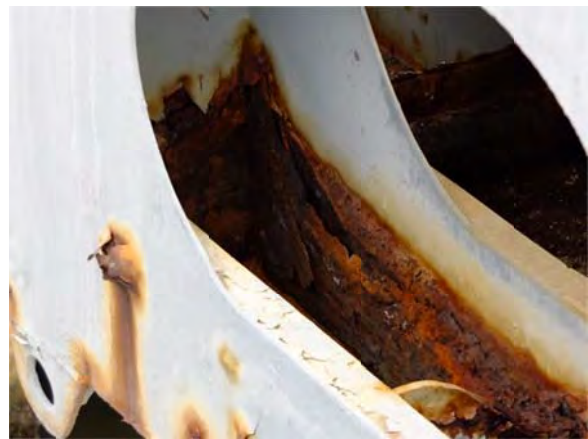
Figure 4.8 Corrosion of crane arm structure

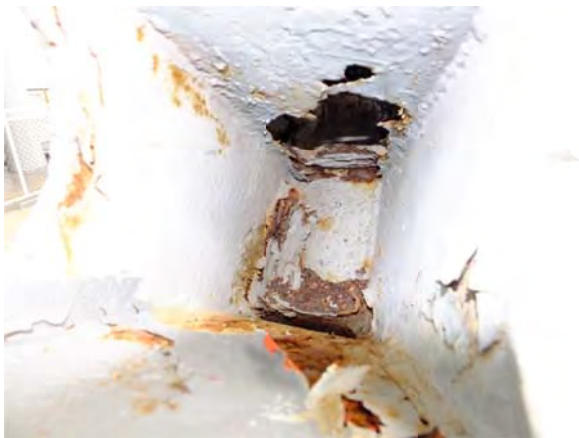
Figure 4.6 Corrosion of crane arm structure

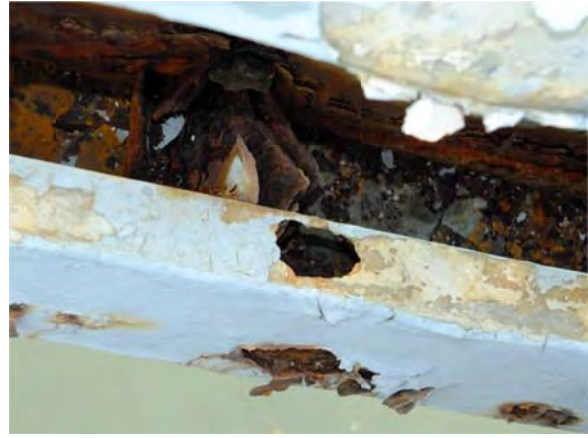
Figure 4.9 Corrosion of crane arm structure

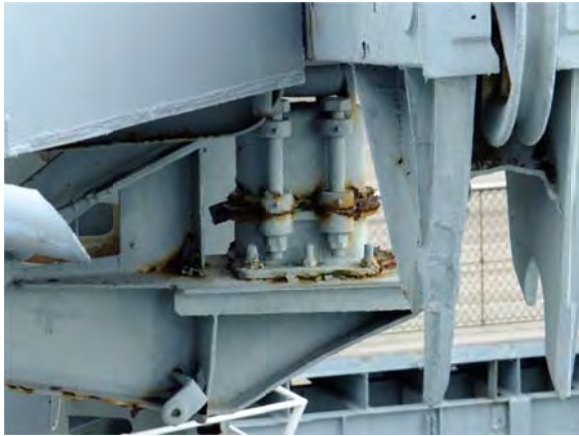
Figure 4.10 Corrosion at base of crane mount

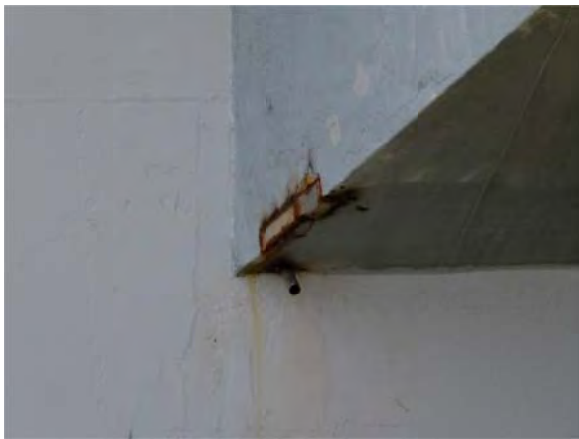
Figure 4.11 Previous repair to exterior of sponson

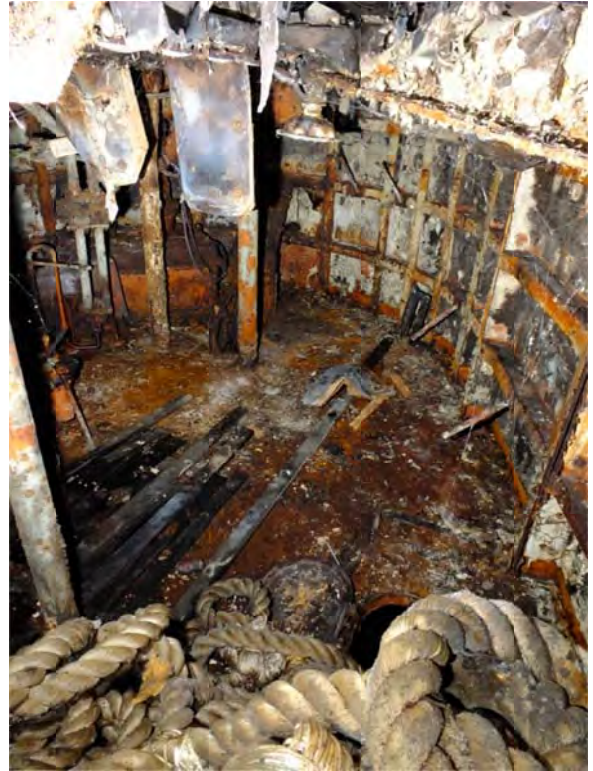
Figure 4.12 Interior view of sponson showing peeling paint and corrosion

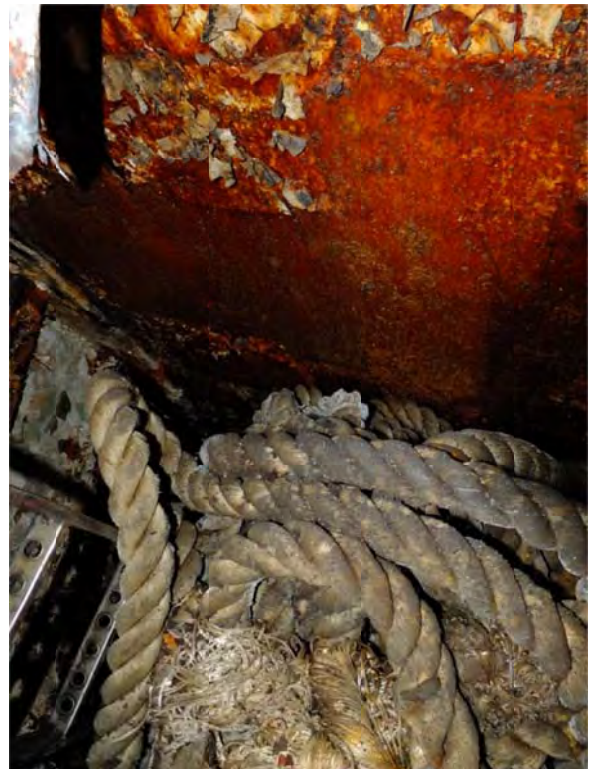
Figure 4.13 Interior view of sponson showing peeling paint and corrosion

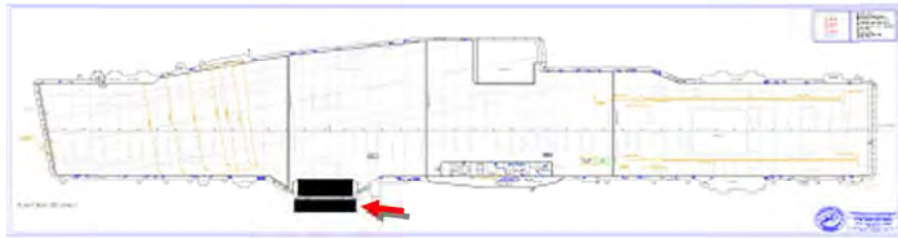
Figure 5.1 Location of main entrance platform/door

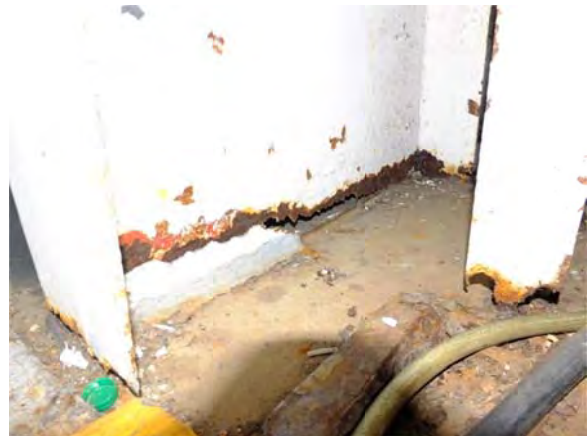
Figure 5.3 Severe corrosion and 100% loss of section on lower portions of framing

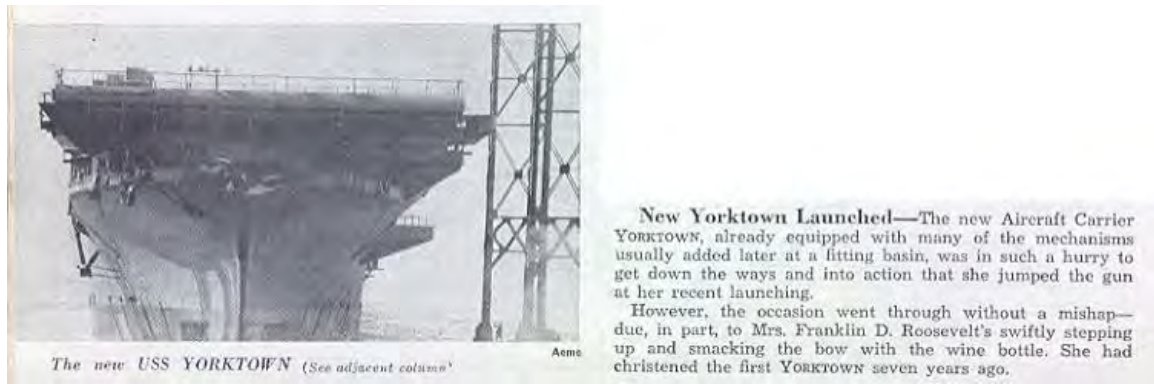
Figure 1.3 Newspaper account of launch of U.S.S. YORKTOWN (CV-10).

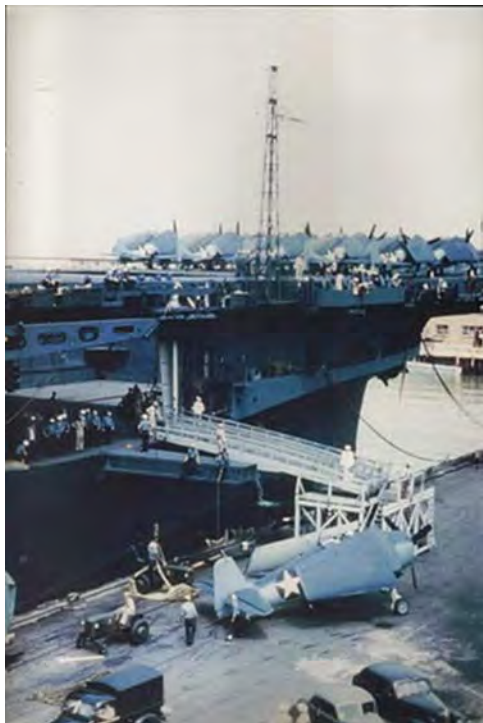
Figure 1.4 Loading planes aboard, at NOB Norfolk, prior to departure for South Pacific.

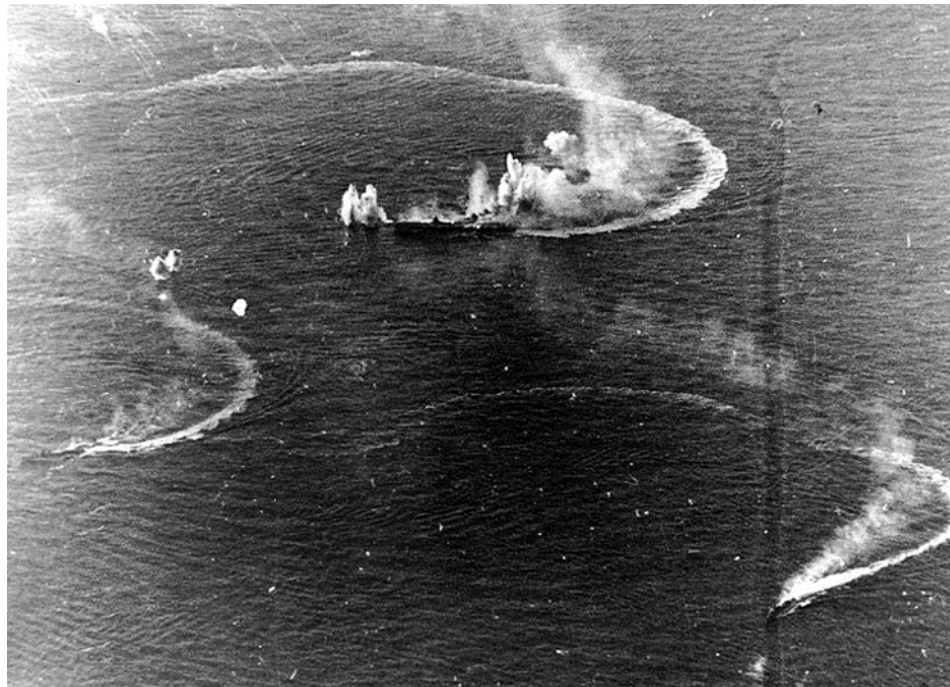
Figure 1.12 Japanese carrier ZUIKAKU maneuvering while under attack by dive bombers from YORKTOWN, June 1944.

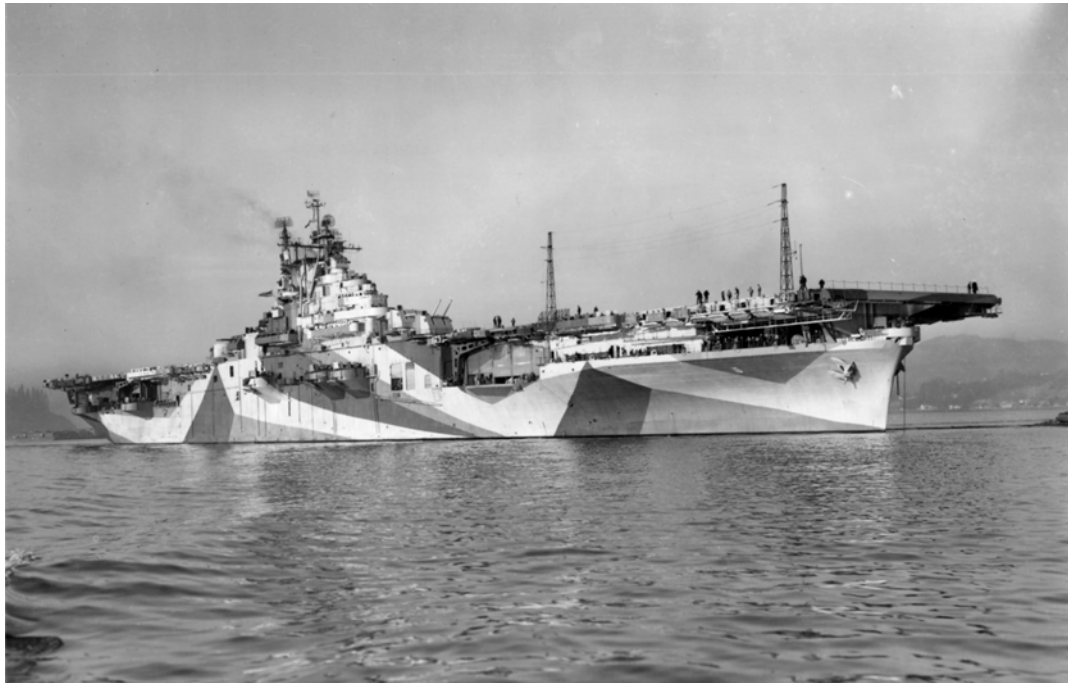
Figure 1.13 YORKTOWN departing Puget Sound Naval Shipyard with new dazzle camouflage Measure 33/10A profile.

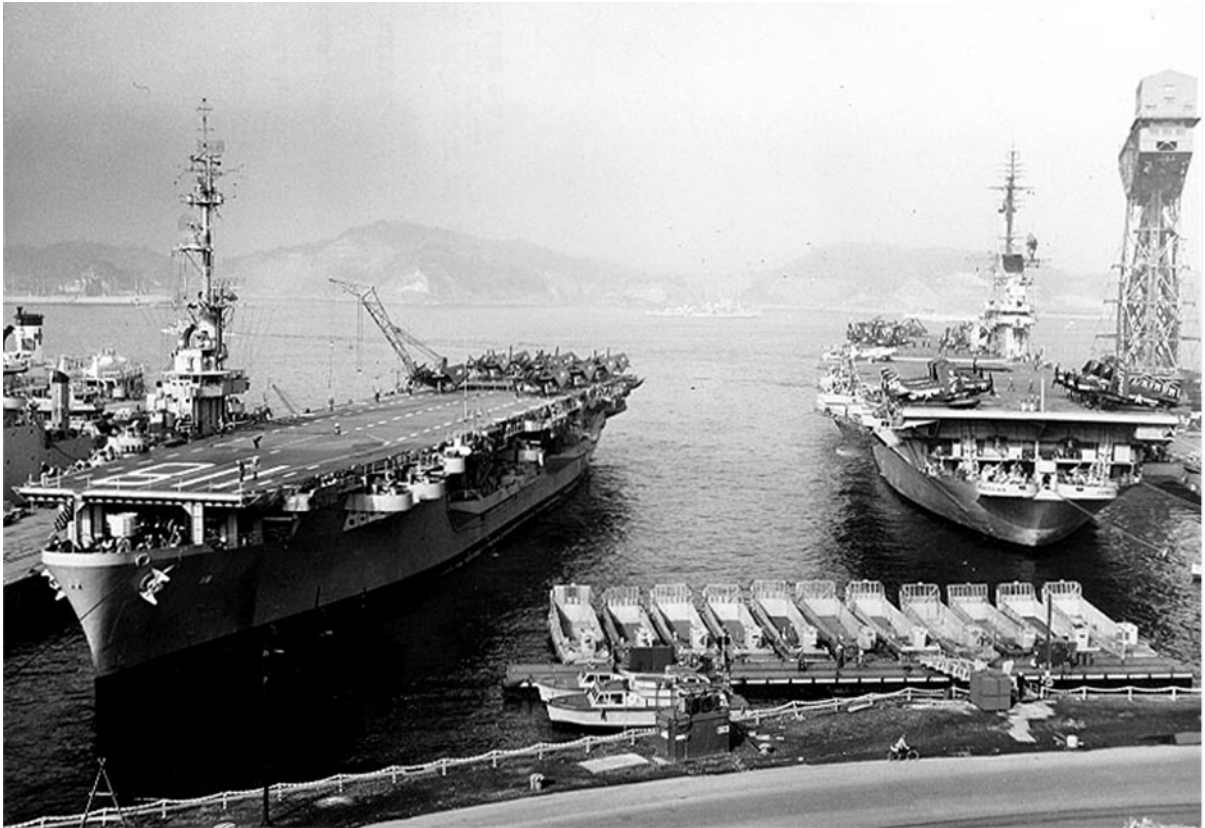
Figure 1.19 U.S.S. SICILY at left and U.S.S. YORKTOWN at Yokosuka, Japan, 1954.

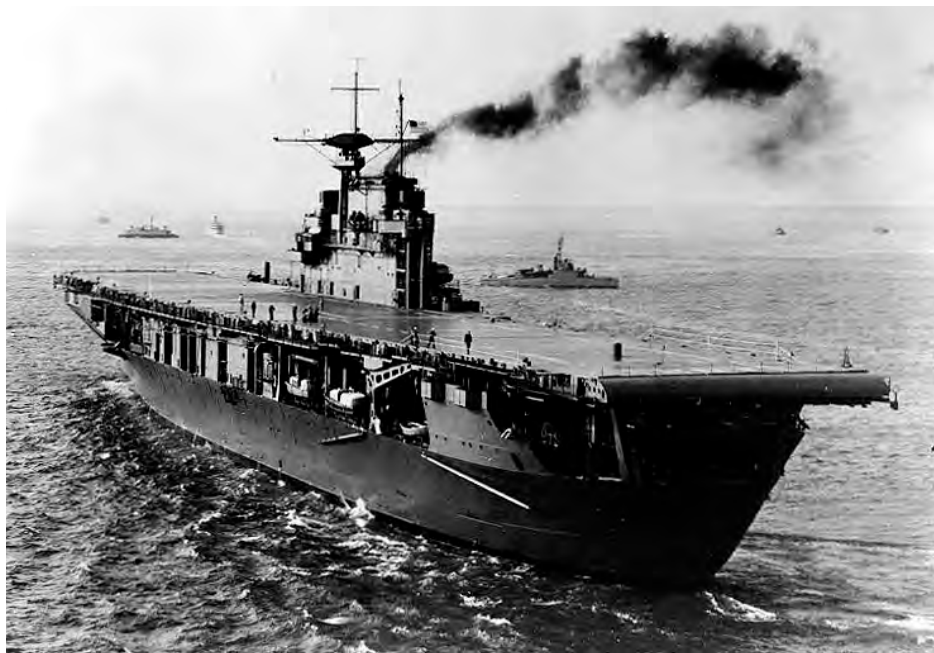
Figure 1.1 U.S.S. HORNET (CV-8) in Hampton Roads shortly before commissioning in November 1941.

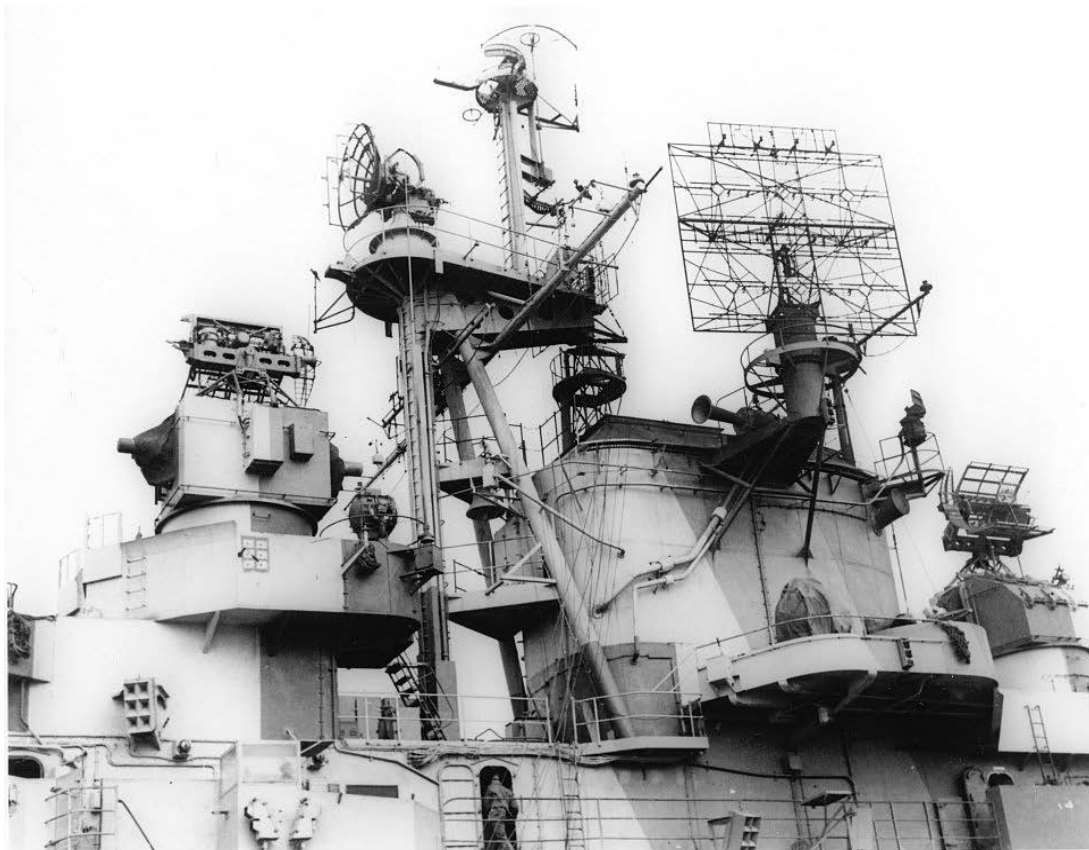
Figure 1.7 U.S.S. YORKTOWN'S topside island superstructure, showing newly installed radars and directors, 1944.

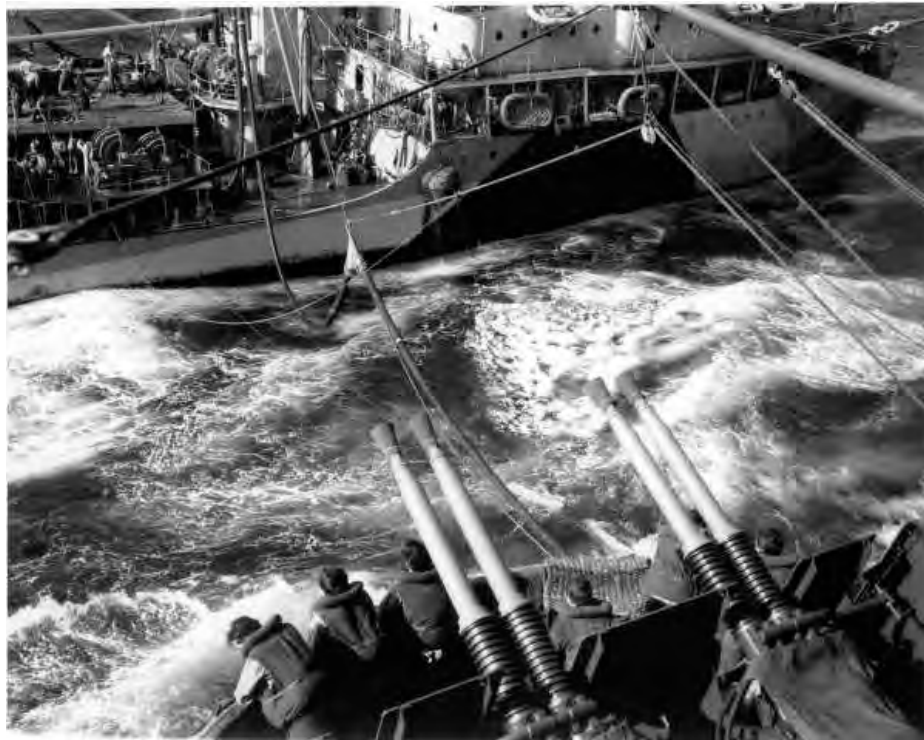
Figure 1.8 Quad 40MM Bofors anti-aircraft battery. Tanker alongside in background is U.S.S. CIMMARON (AO-22).

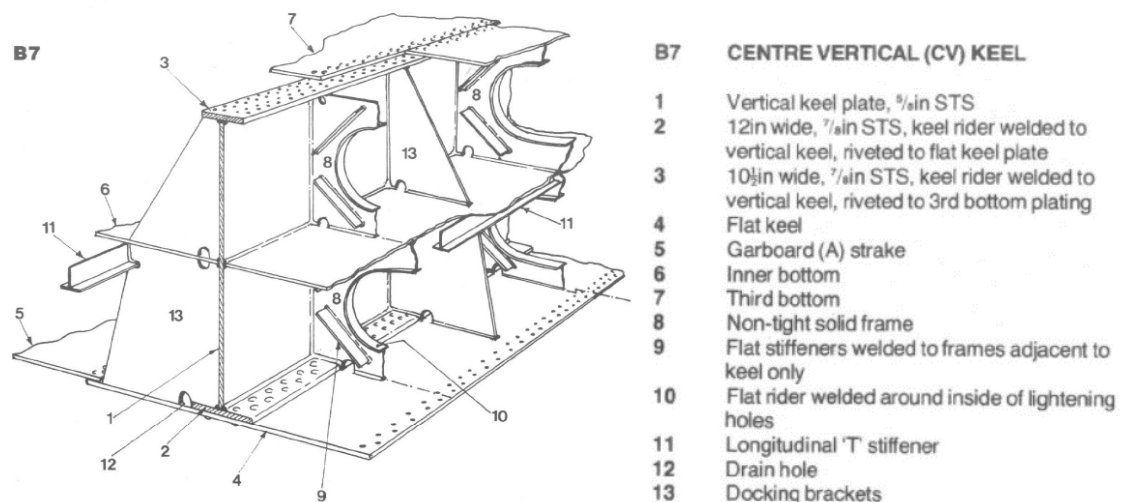
Figure 1.4 Center vertical keel details

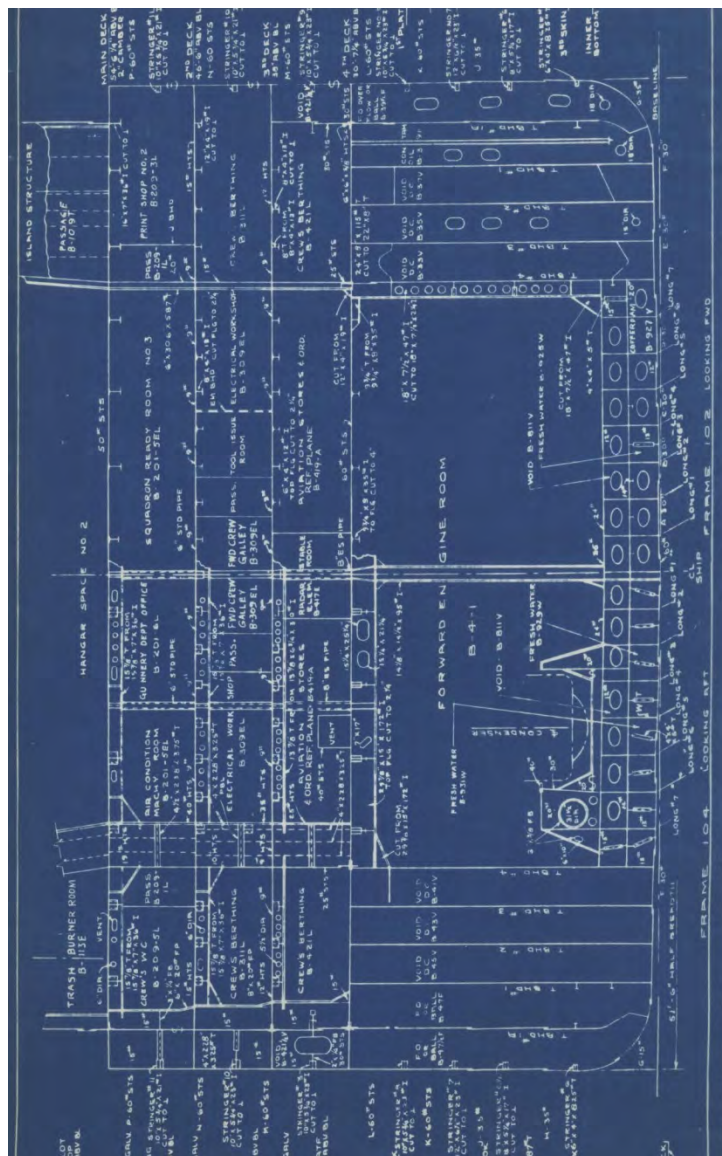
Figure 1.6 Midship Section Drawing

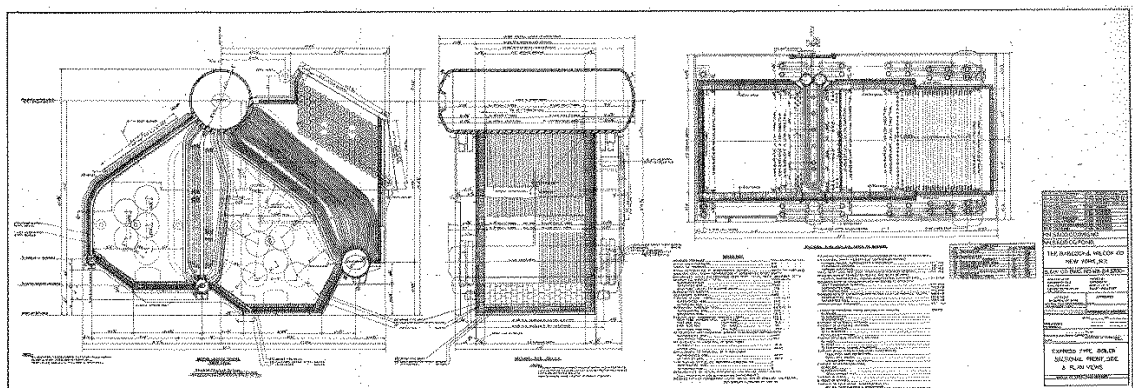
Figure 1.3 Express-type boiler, with sectional, front and plan views, as found on U.S.S. YORKTOWN (CV-10).

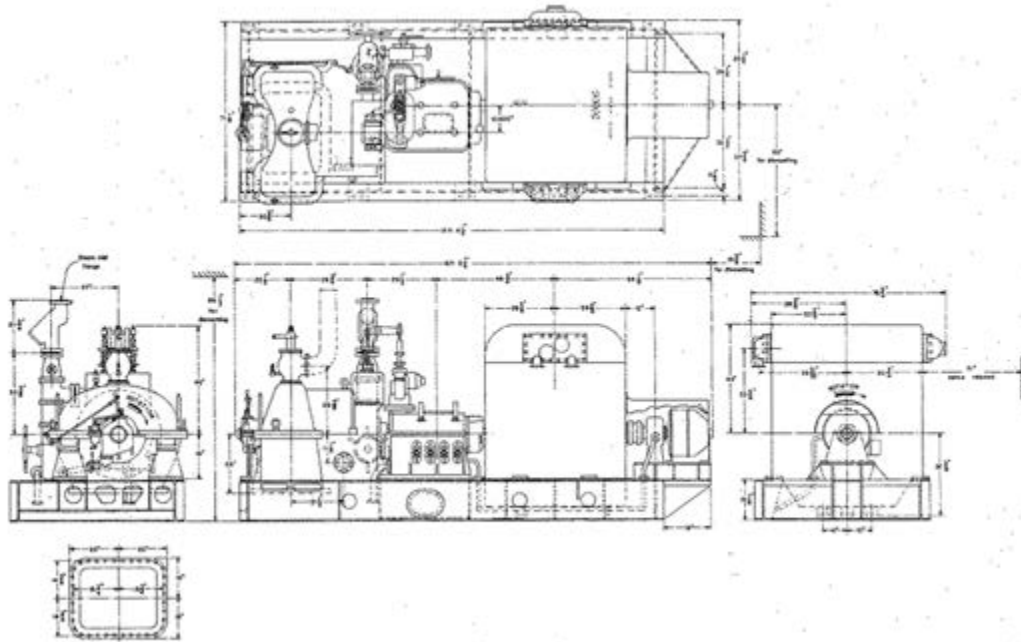
Figure 1.7 Outline Dimensions of Turbine-generator set.

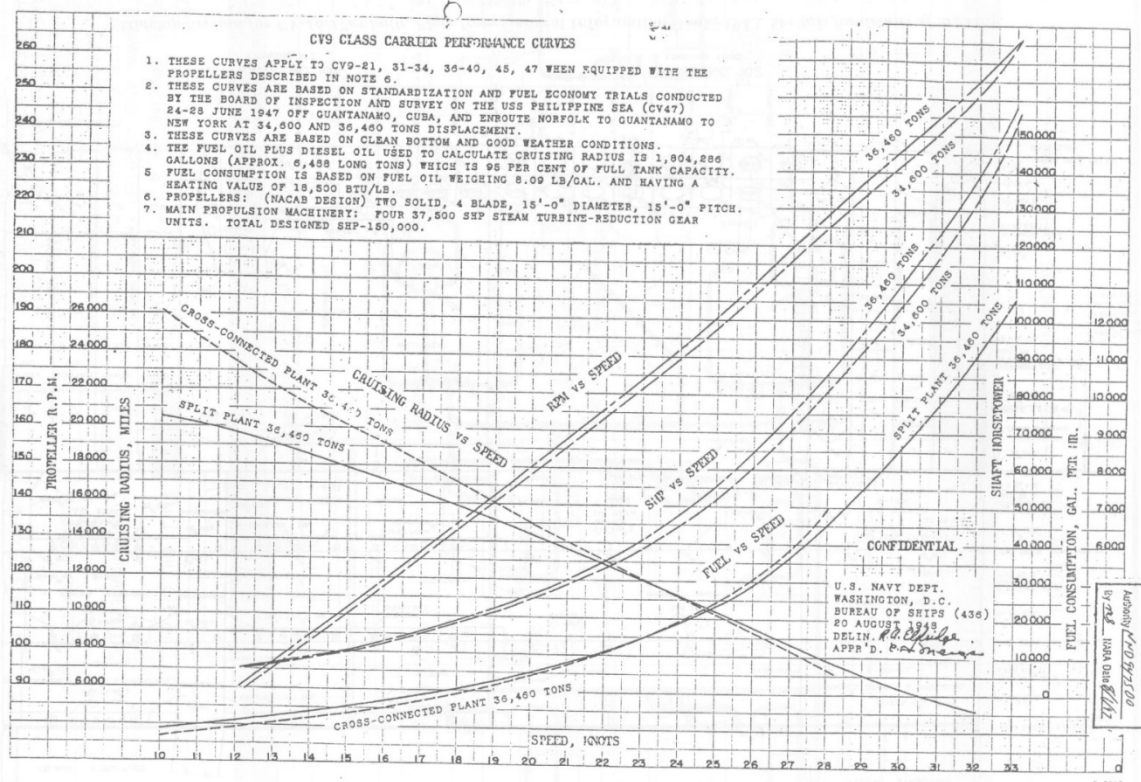
Figure 1.8 Essex class "Performance Curves" showing fuel consumption. Bureau of Ships compilation dated 20 August 1948 reflecting class performance with solid, four blade, 15-ft diameter propellers, clean bottom, and good weather conditions. Fuel assumed to be about 6,448 tons (95% of full tank capacity).
