Structural Assessment of the USS Yorktown CV-10

Prepared for:

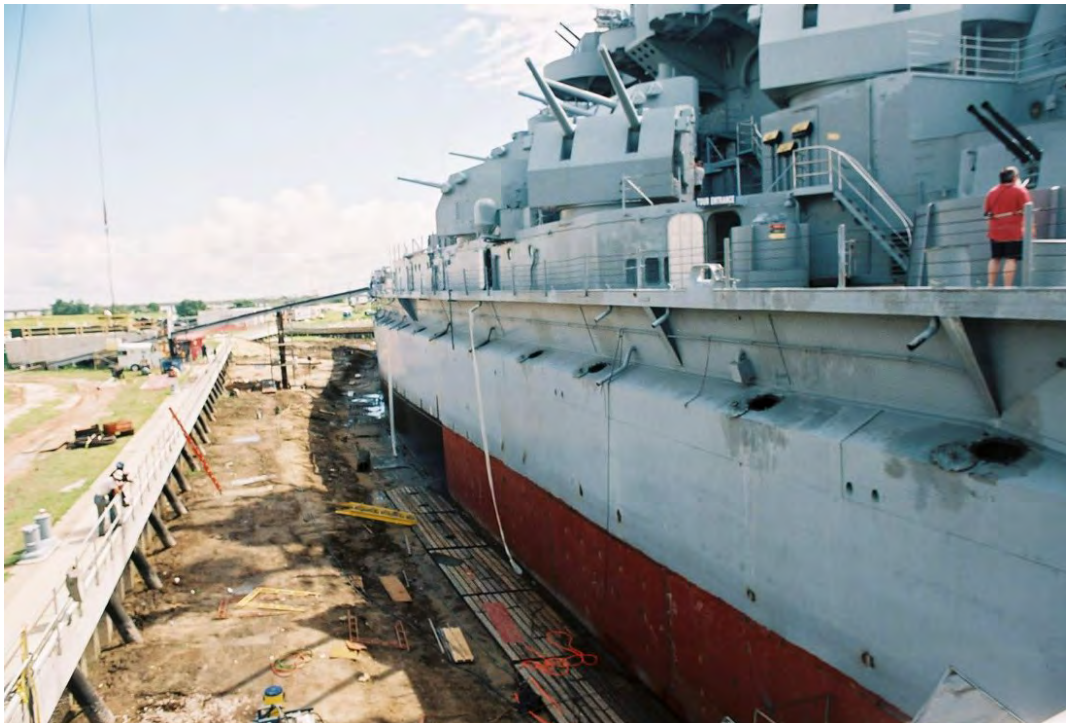
Coffer dam around battleship U.S.S. ALABAMA after holed shell plating leaked oil into Mobile Bay. Notice installation of wind/waterline shell plate doublers.

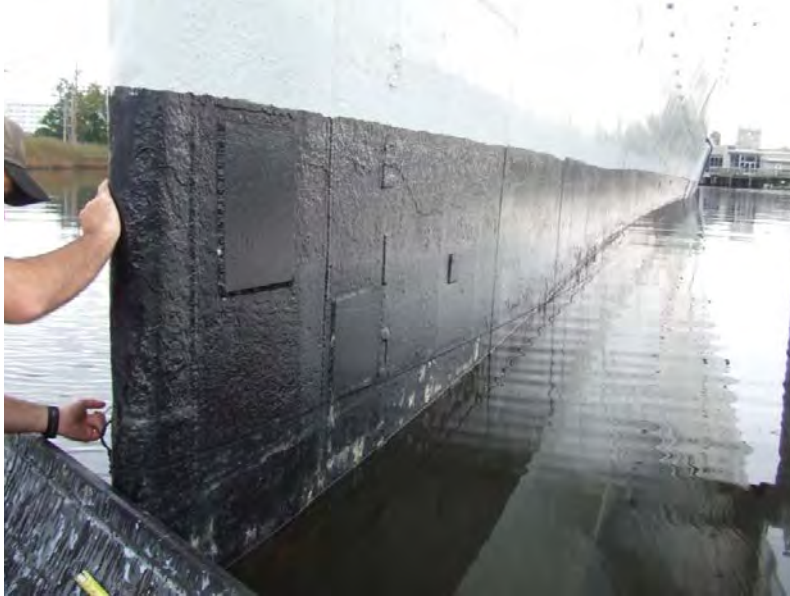
Holed shell plating repaired with small doubler patches (a Band-Aid), subsequent to inspection/survey by the undersigned, above the waterline on battleship U.S.S. NORTH CAROLINA. Much additional work is desperately needed.

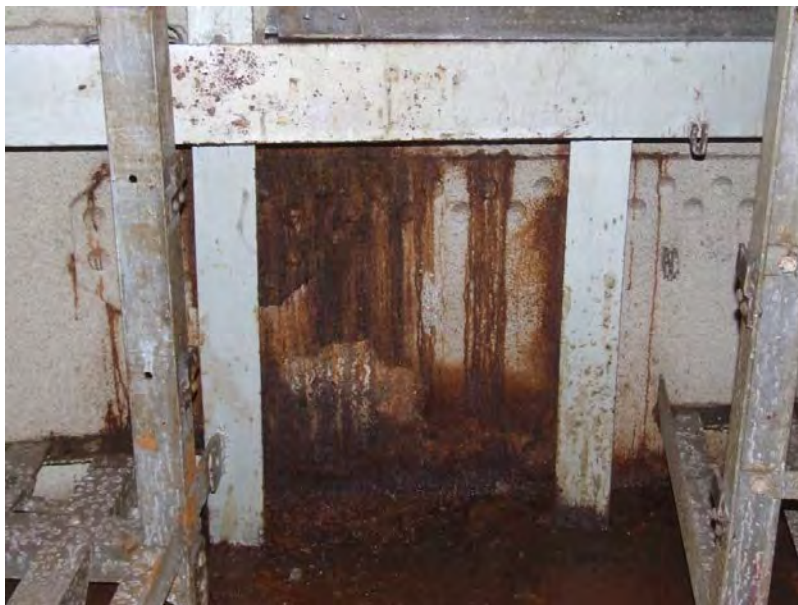
Leaking shell plating below the waterline, Frame 34, starboard side, battleship U.S.S. NORTH CAROLINA.
Her shell plating forward matches exactly the same plating fitted aboard U.S.S. MISSOURI.

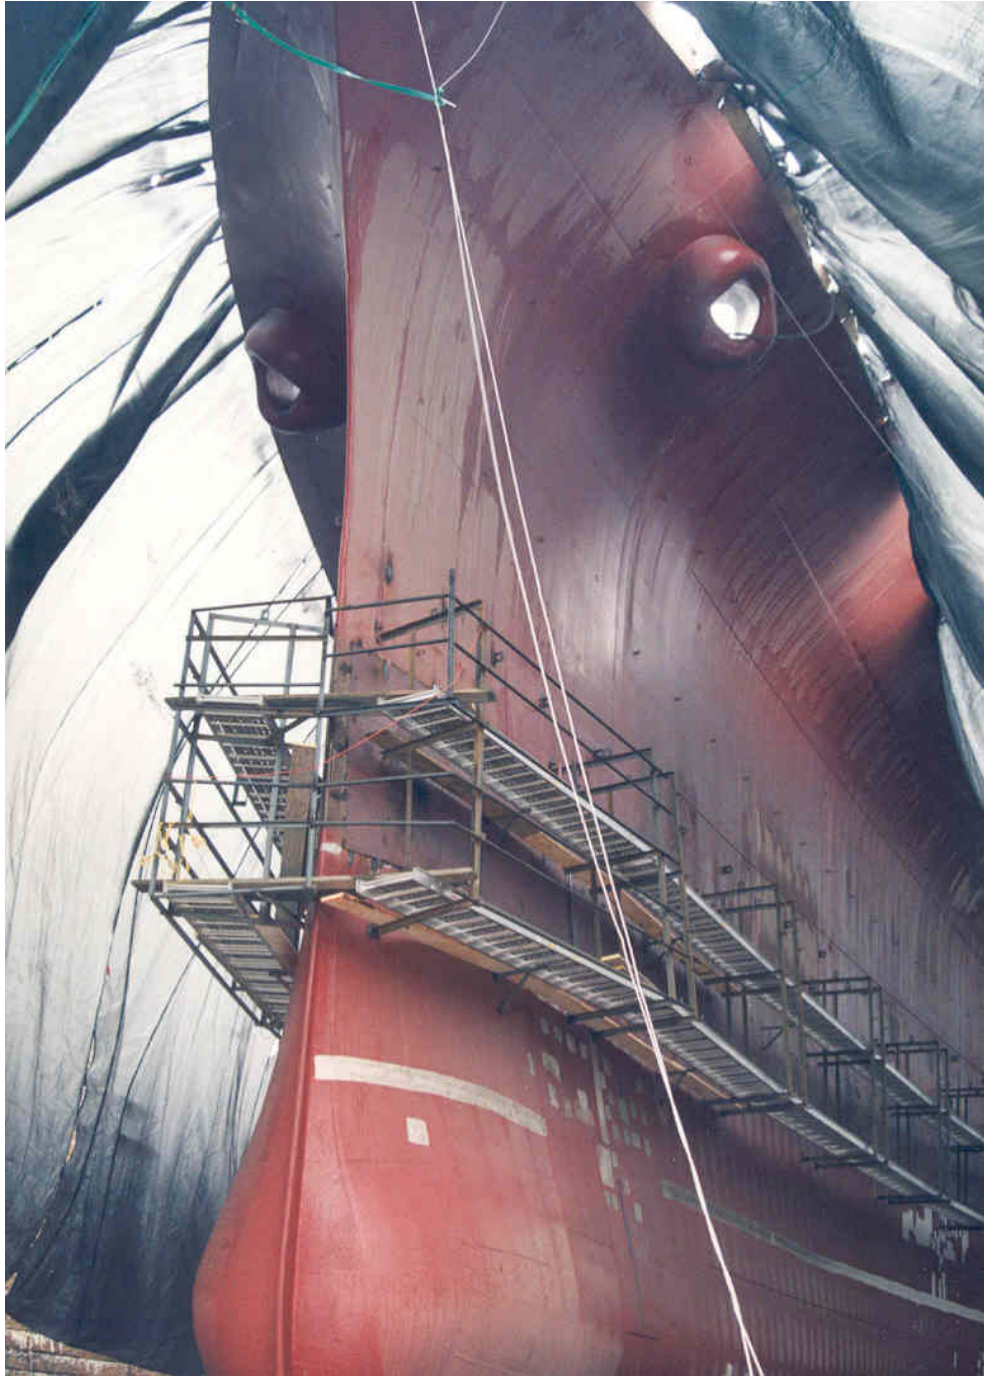
U.S.S. MASSACHUSETTS drydocked at Dry-dock #3, S. Boston in 1998/9. Notice installation of shell doubler plating at the wind/waterline. Also, note the epoxy sheathing weldments and riveting on underwater plating.

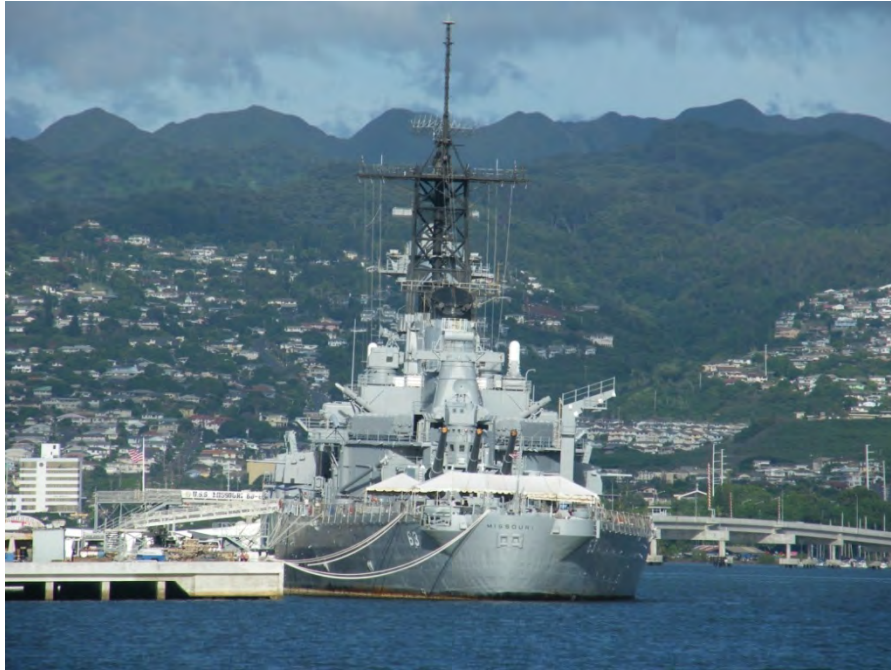
U.S.S. MISSOURI at a 1 ½ degree starboard list, December 2007. Her list caused by leaking rivet(s) in her fuel/ballast tank. This took over two months to correct with resulting drainage issues caused by poor understanding of tank ventilation systems.

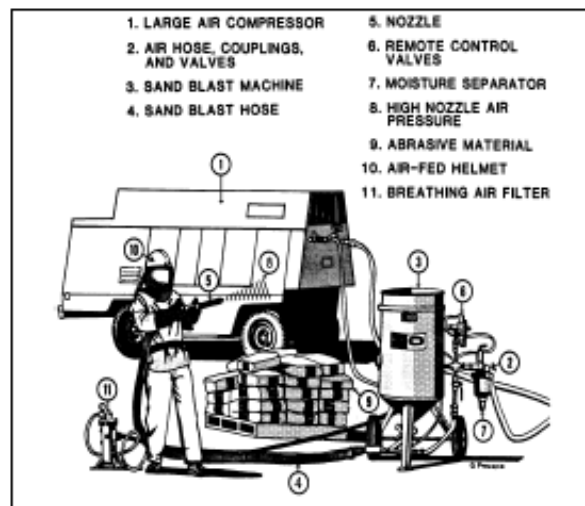
Figure 1
Schematic Drawing Illustrating Components of Conventional
Abrasive Blasting Equipment

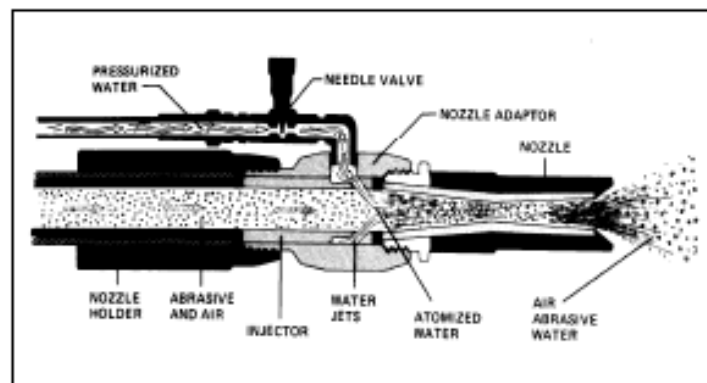
Figure 2
Schematic Drawing of Cross Section of Typical Water-Injected
Wet Abrasive Blasting Nozzle

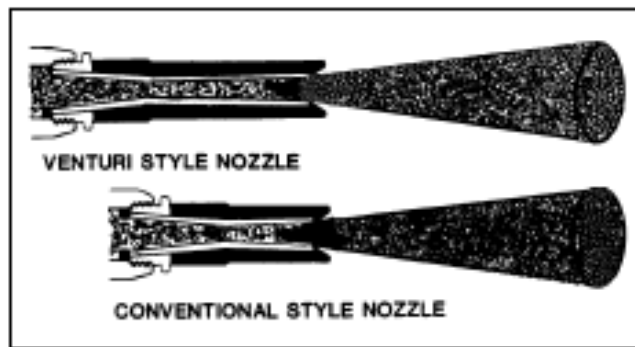
Figure 3
Cross-Sectional Drawing of Nozzles

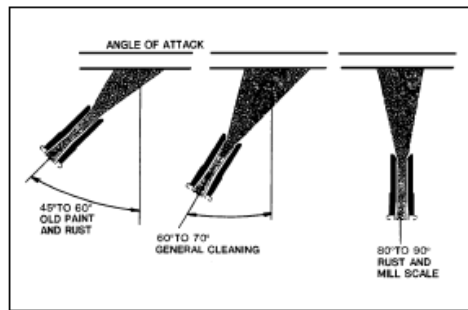
Figure 5
Schematic Illustrating Typical Cleaning Angles
for Various Surface Conditions

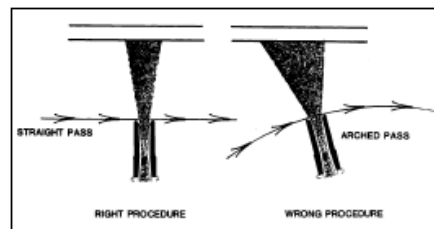
Figure 6
Illustration of Proper Stroke Pattern for Blast Cleaning

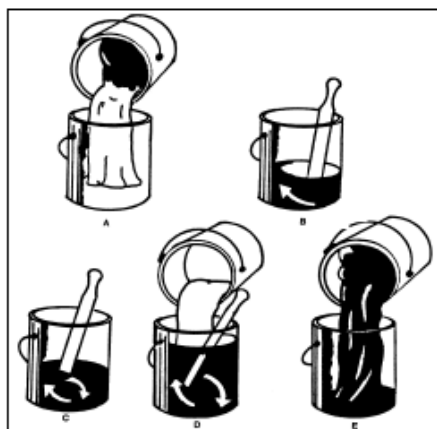
Figure 7
Illustration of Mixing and "Boxing" One-Component Paint: A -
Pouring Off Pigment-Poor Vehicle, B and C - Mixing Pigment
to Form Smooth Paste, D - Pouring in Vehicle and Mixing,
E - Boxing Paint

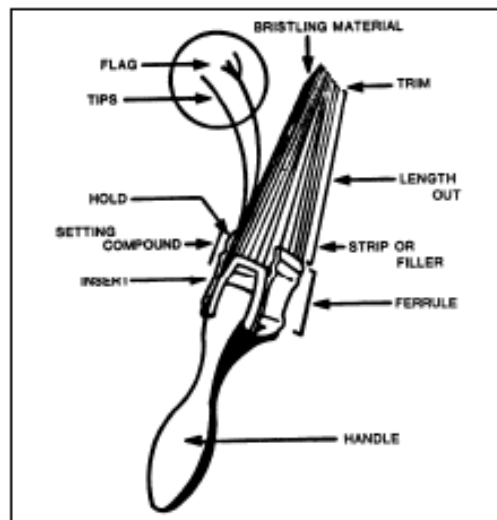
Figure 8
Illustration of Parts of Paint Brush

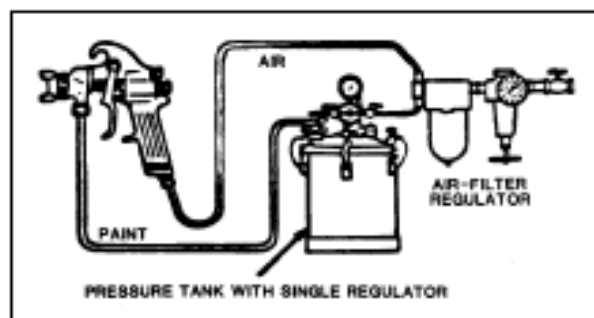
Figure 10
Schematic Drawing Illustrating Basic Parts of Conventional Air Spray Application Equipment

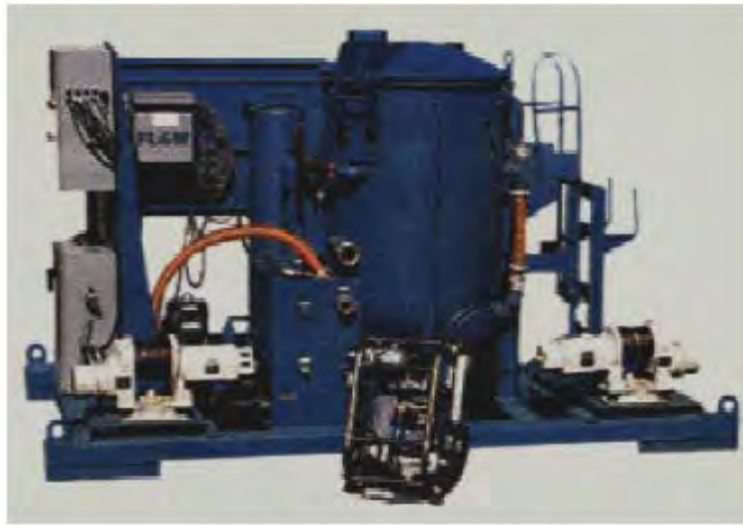
Figure 634-3-4. HYDROCAT

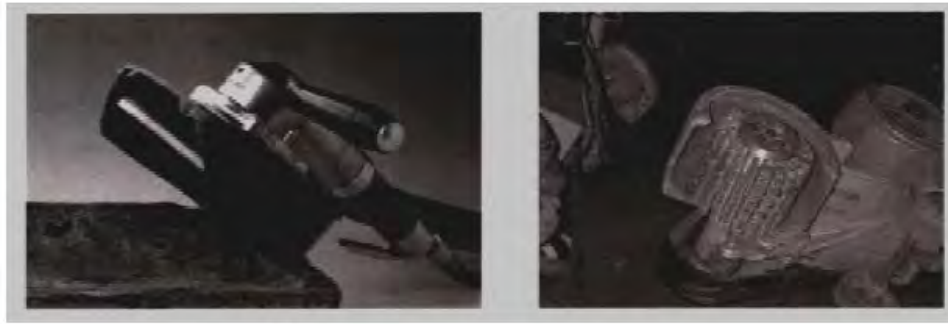
Figure 634-3-6. ROTO-PEEN AND DUST FREE POWER TOOLS

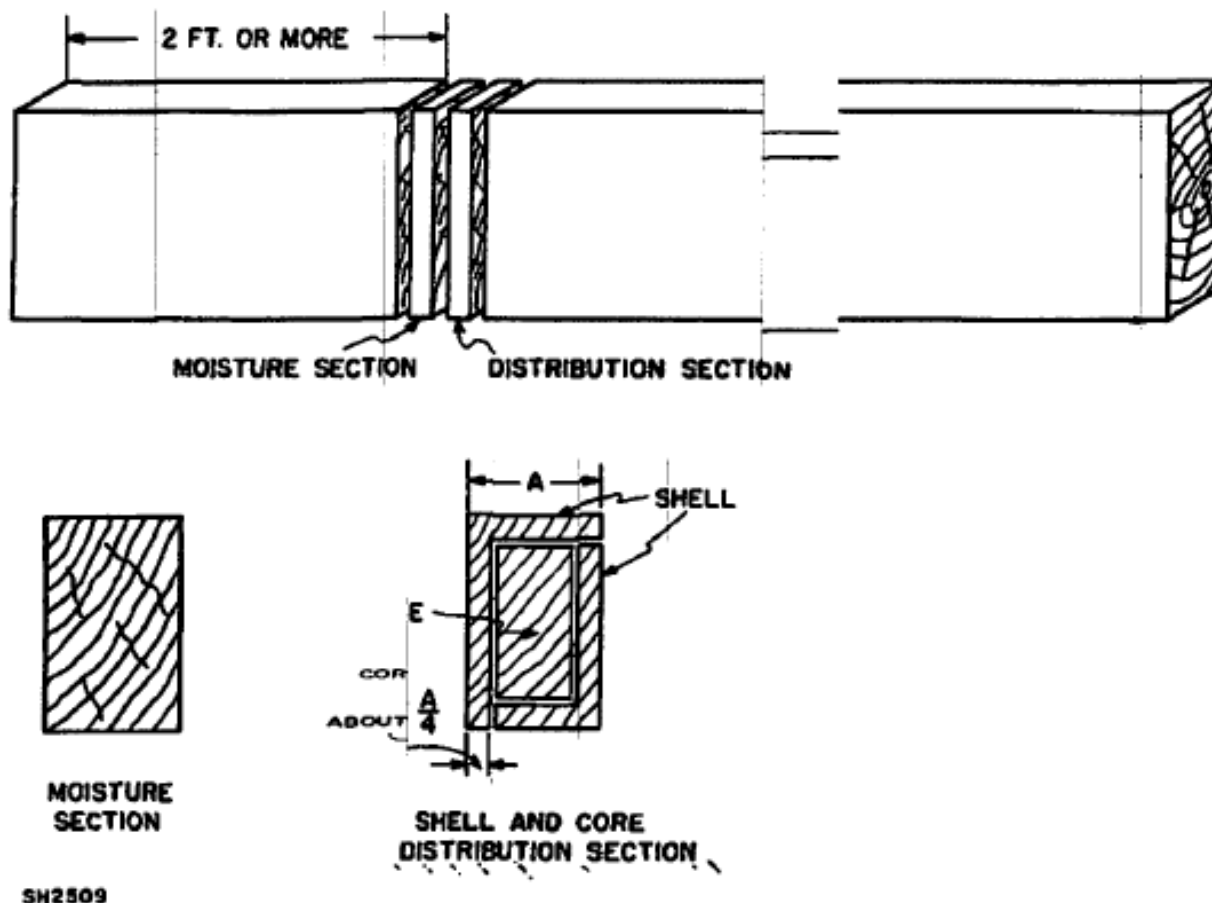
Figure 1. - Moisture and case - hardening specimens.

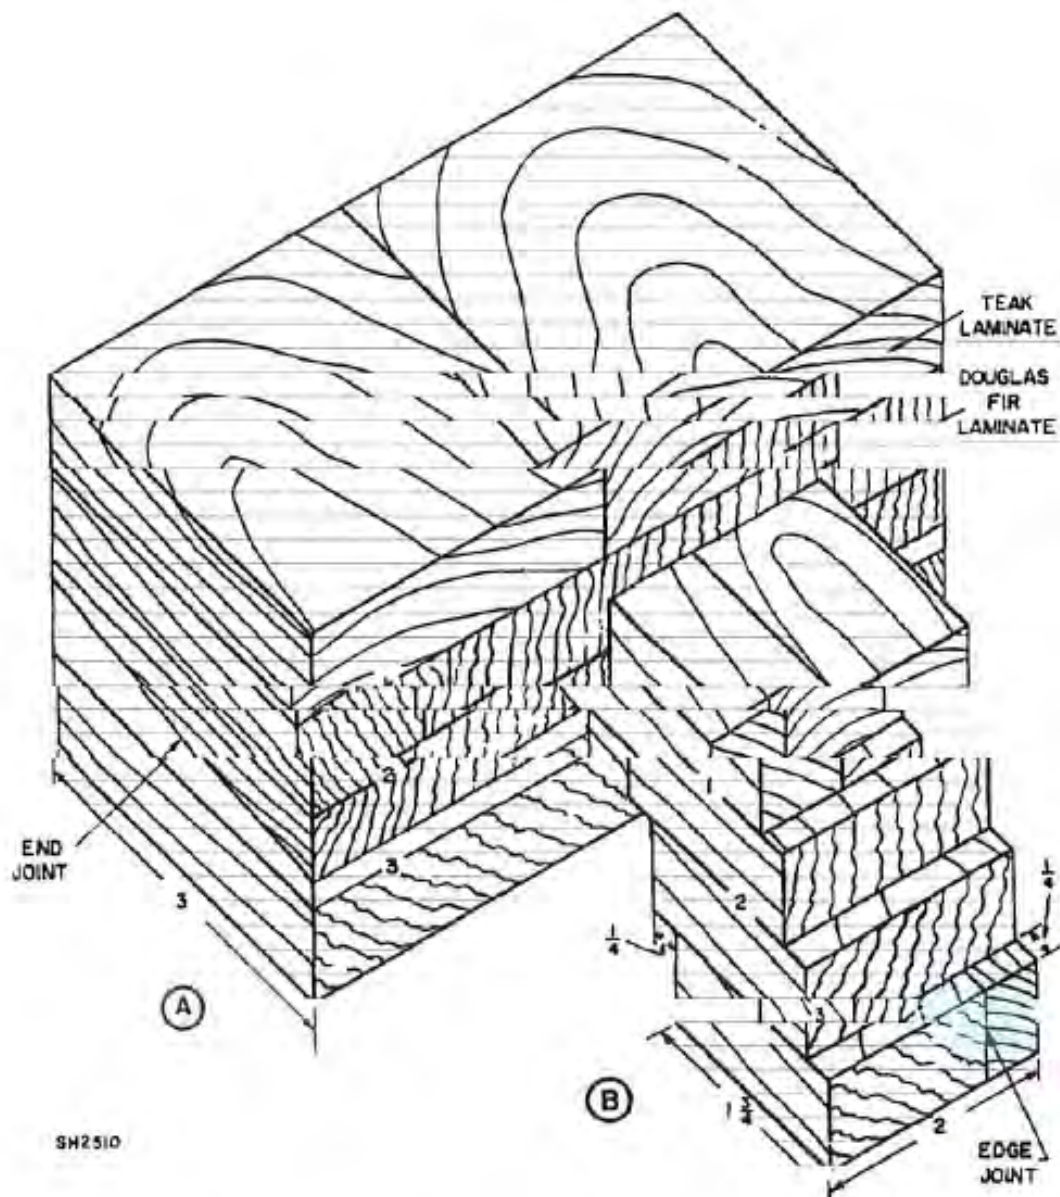
Figure 2 - Standard cyclical exposure test specimen (A), and staircase type shear test specimen (B), for testing glue joint.
