**FINAL REPORT – HYDROLOGIC AND HYDRAULIC STUDY
TOWN OF SUMMERTON, SC | SC OFFICE OF RESILIENCE**

MAY 2023

Town of Summerton Hydrologic and Hydraulic Study

Town of Summerton
Clarendon County, SC

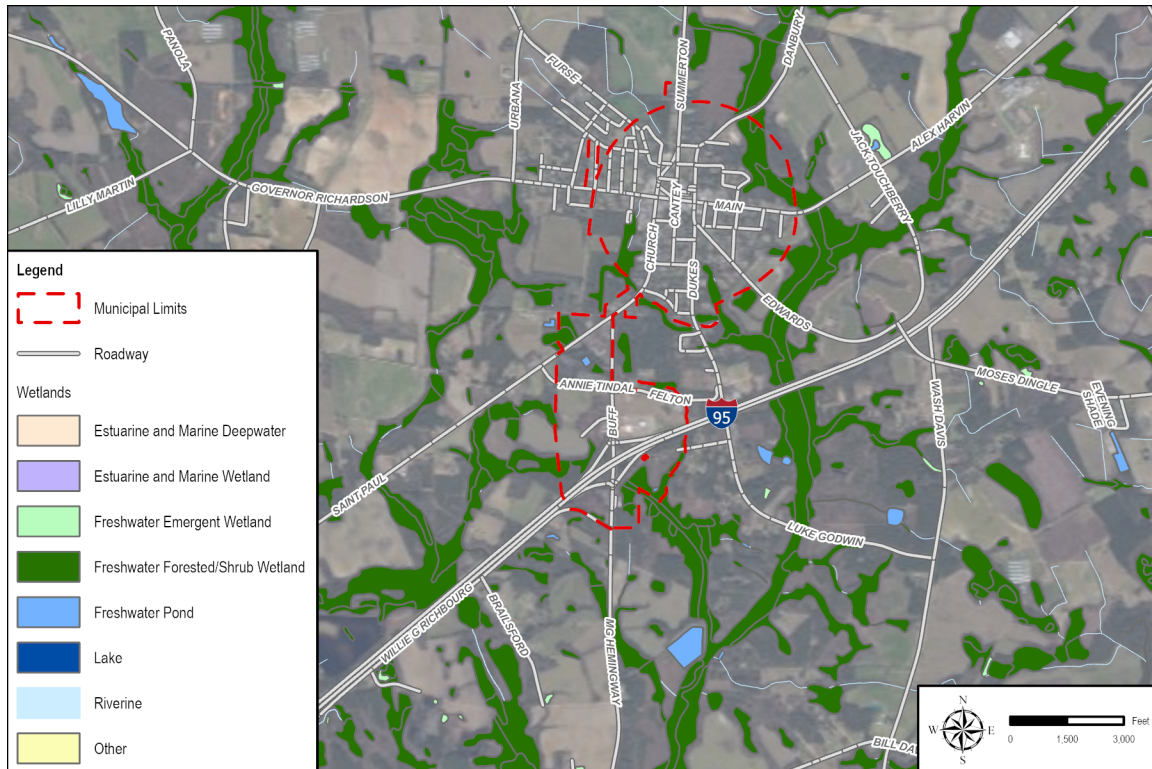
Figure 8 – Wetland classifications and mapping near the Town of Summerton as published by USFWS.

Wetland data is maintained by the United States Fish and Wildlife Service (USFWS) through the national wetlands inventory (NWI). Wetland impacts should be avoided in drainage improvement activities since wetlands are regulated by the United States Army Corps of Engineers (USACE) and any construction activities within these delineated areas may require lengthy and potentially costly permitting processes. However, it is important to note that wetland impacts cannot always be avoided. A map of wetlands near the Town of Summerton is presented in **Figure 8**.

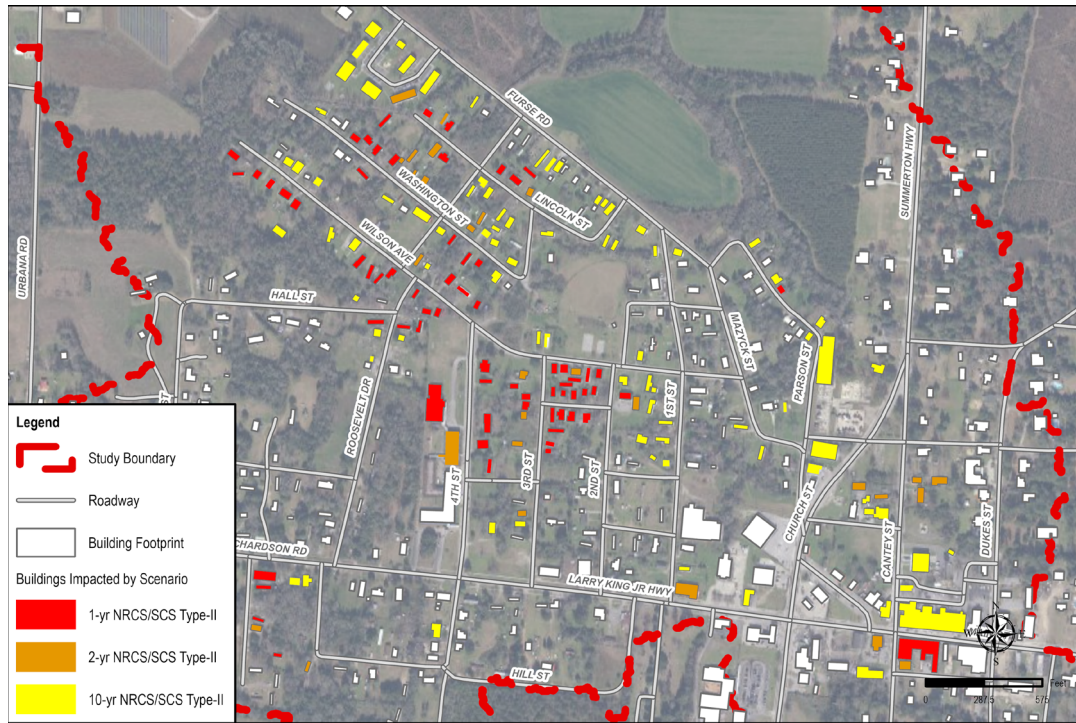
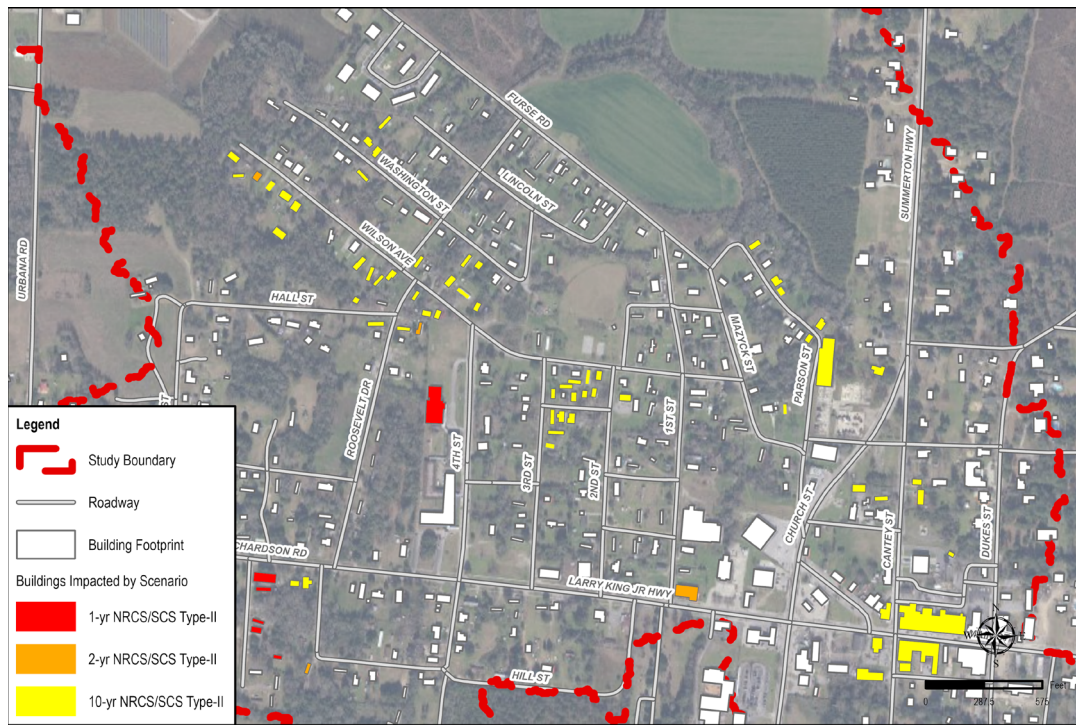
Figure 26 – Comparison of existing (a) and proposed (b) impacted buildings grouped by scenario analyzed in the benefit-cost analysis.
