Appendix B

Existing Conditions Flood Analysis

Town of Summerton | SC Office of Resilience
Hydrologic and Hydraulic Study

Existing Conditions Flood Analysis
Rainfall: 2-Year SCS Type II (3.59")

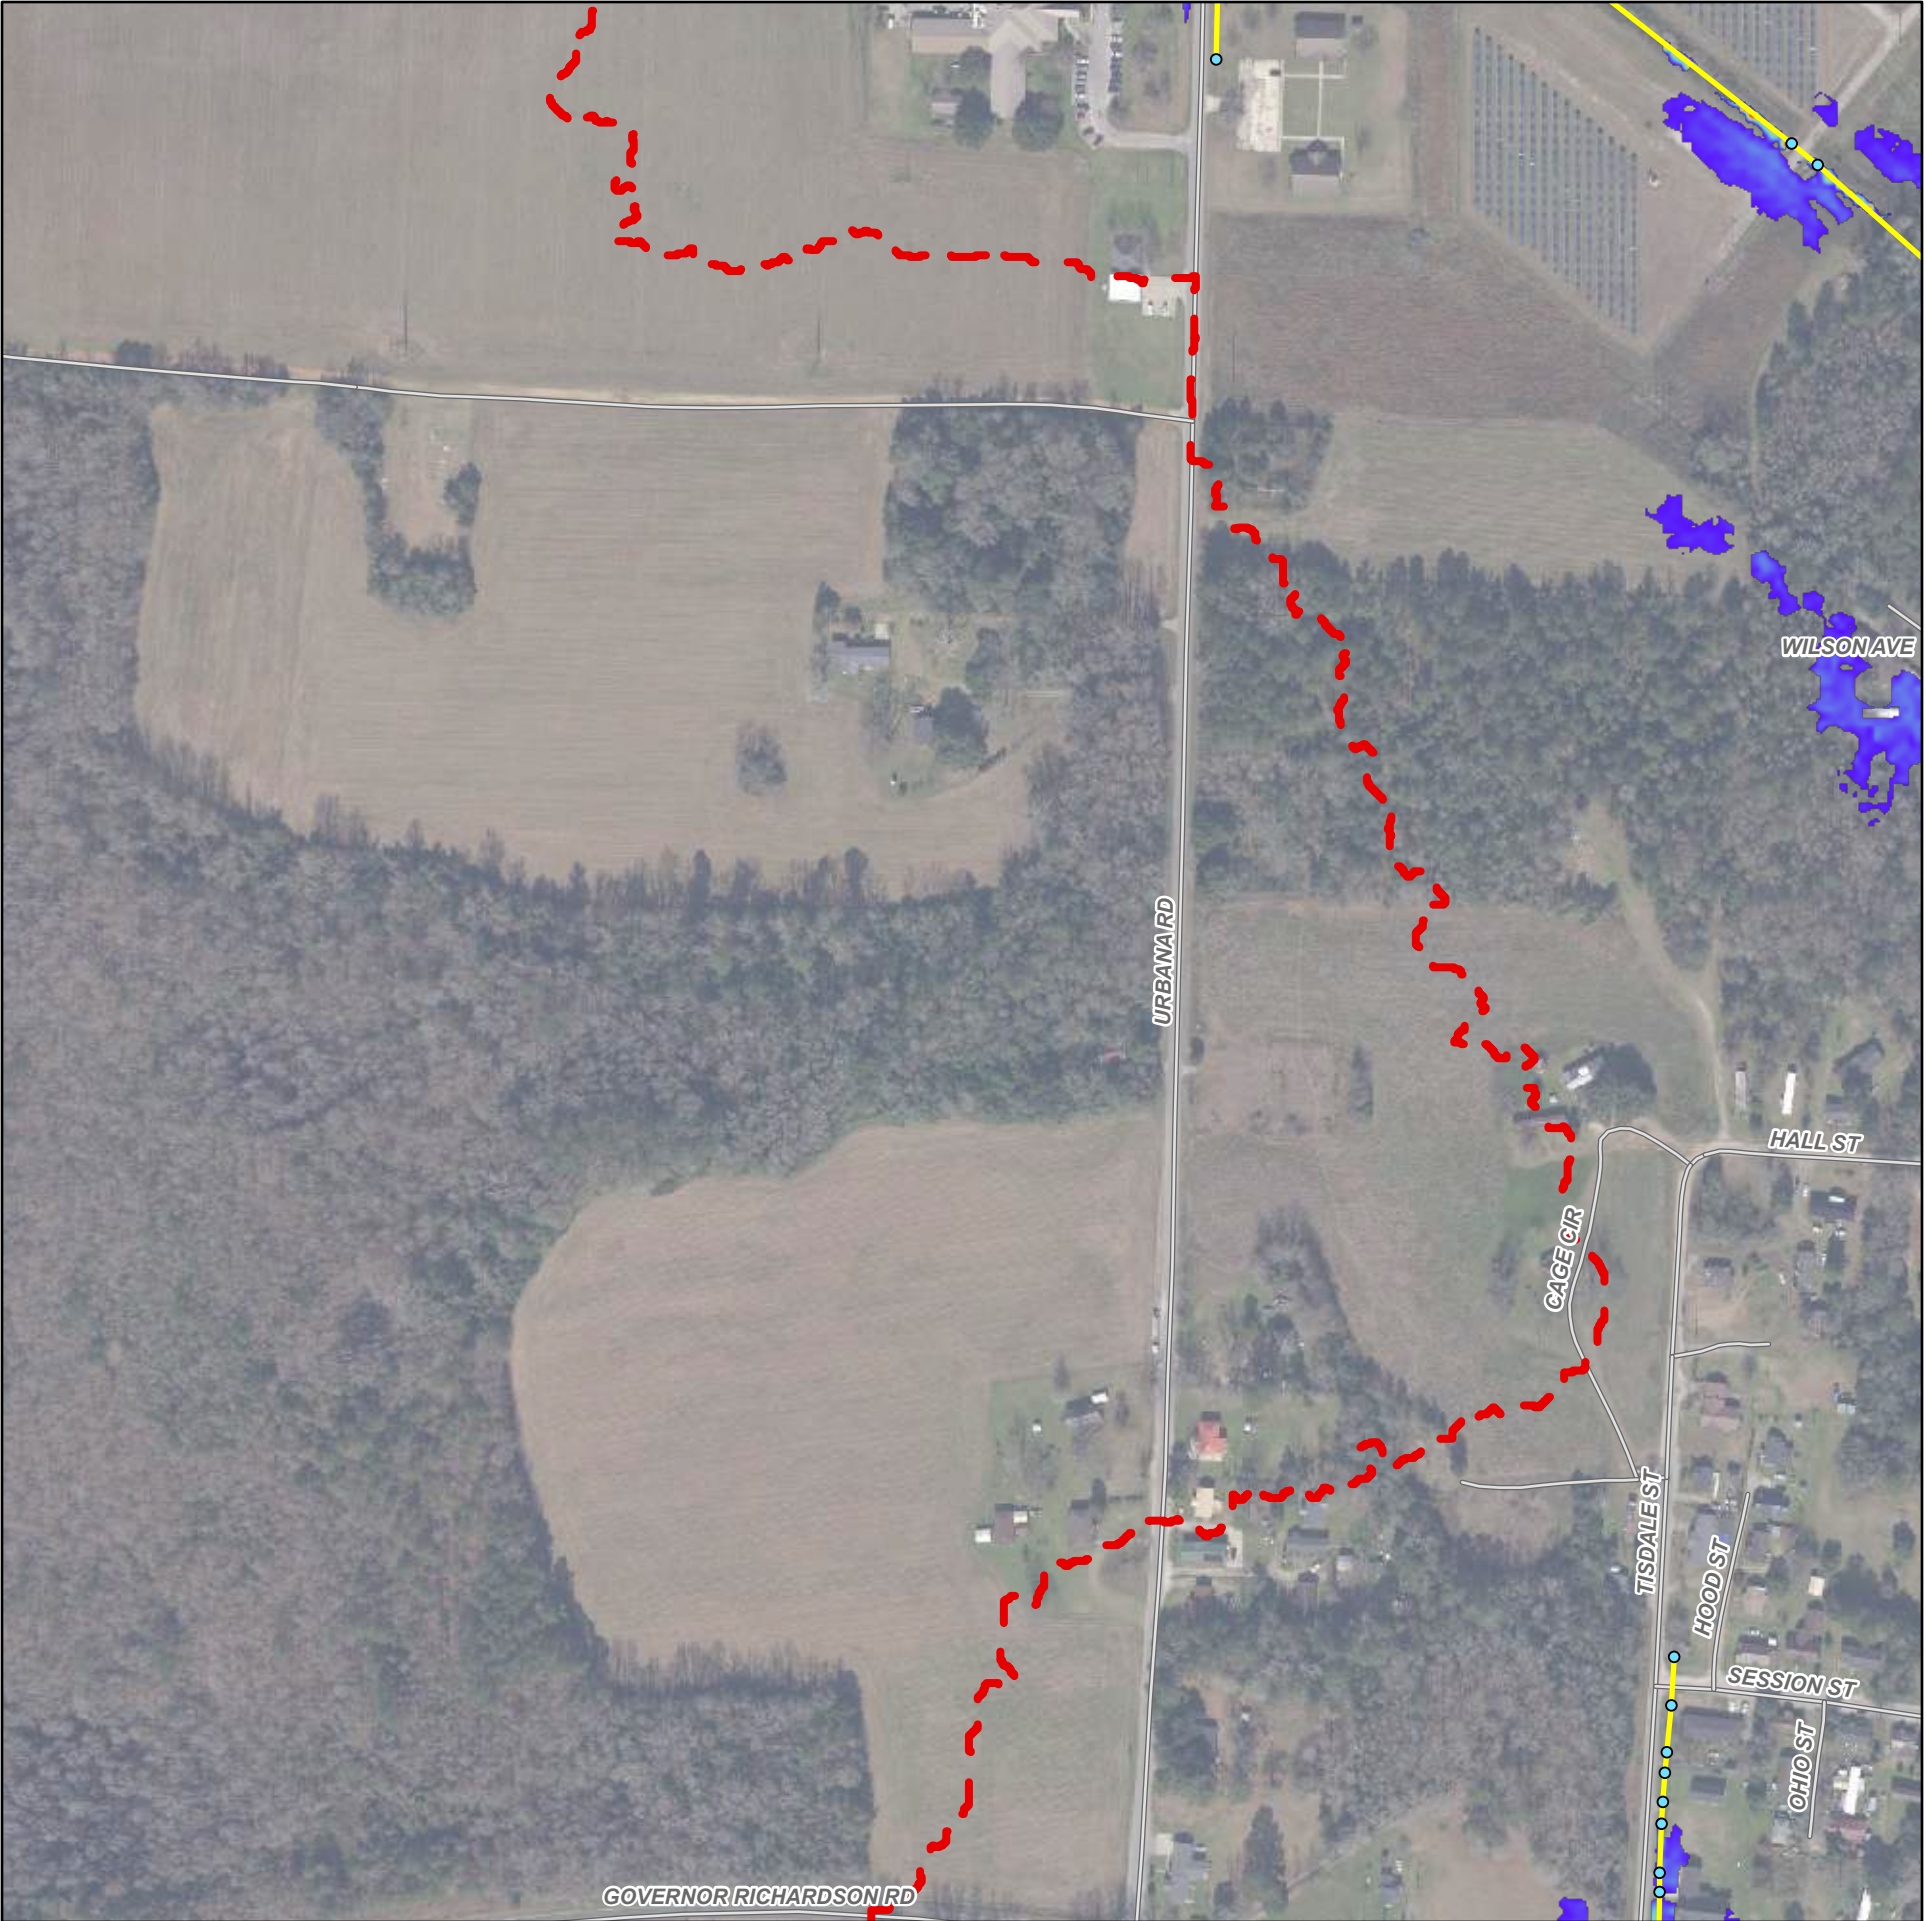
Sector A2

Existing Conditions Flood Analysis
Rainfall: 2-Year SCS Type II (3.59")

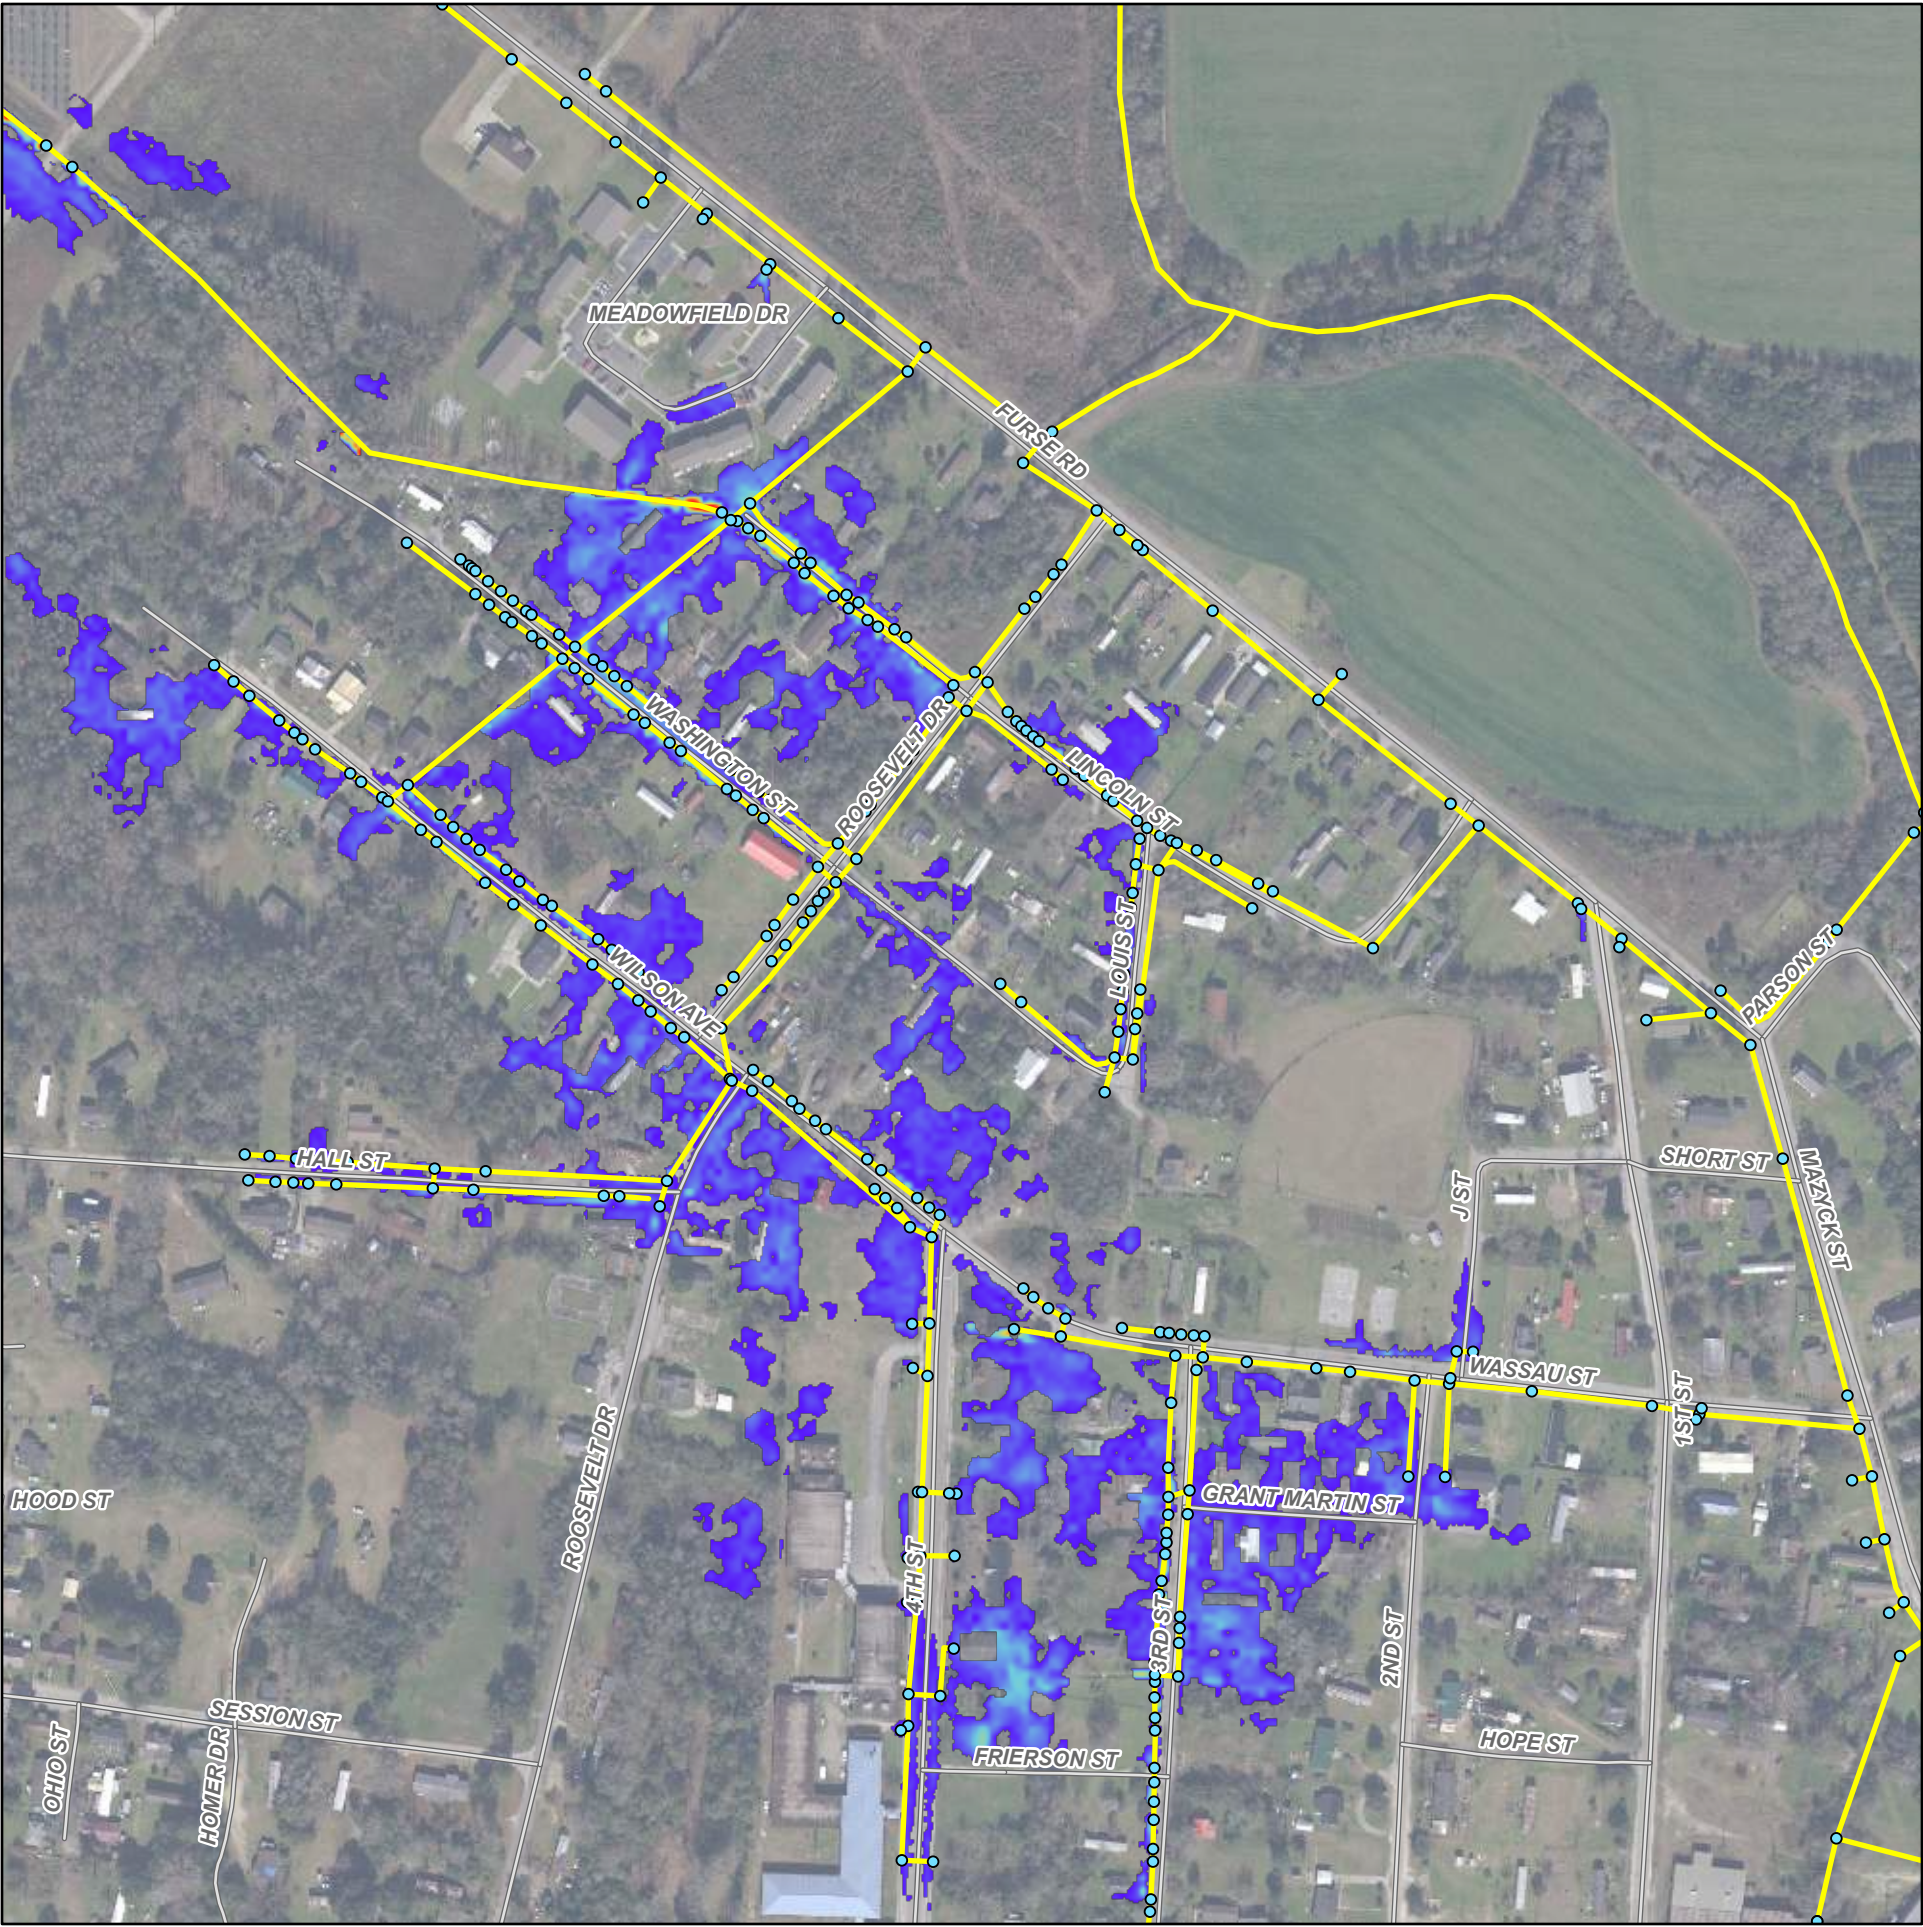
Sector B2

Existing Conditions Flood Analysis
Rainfall: 2-Year SCS Type II (3.59")

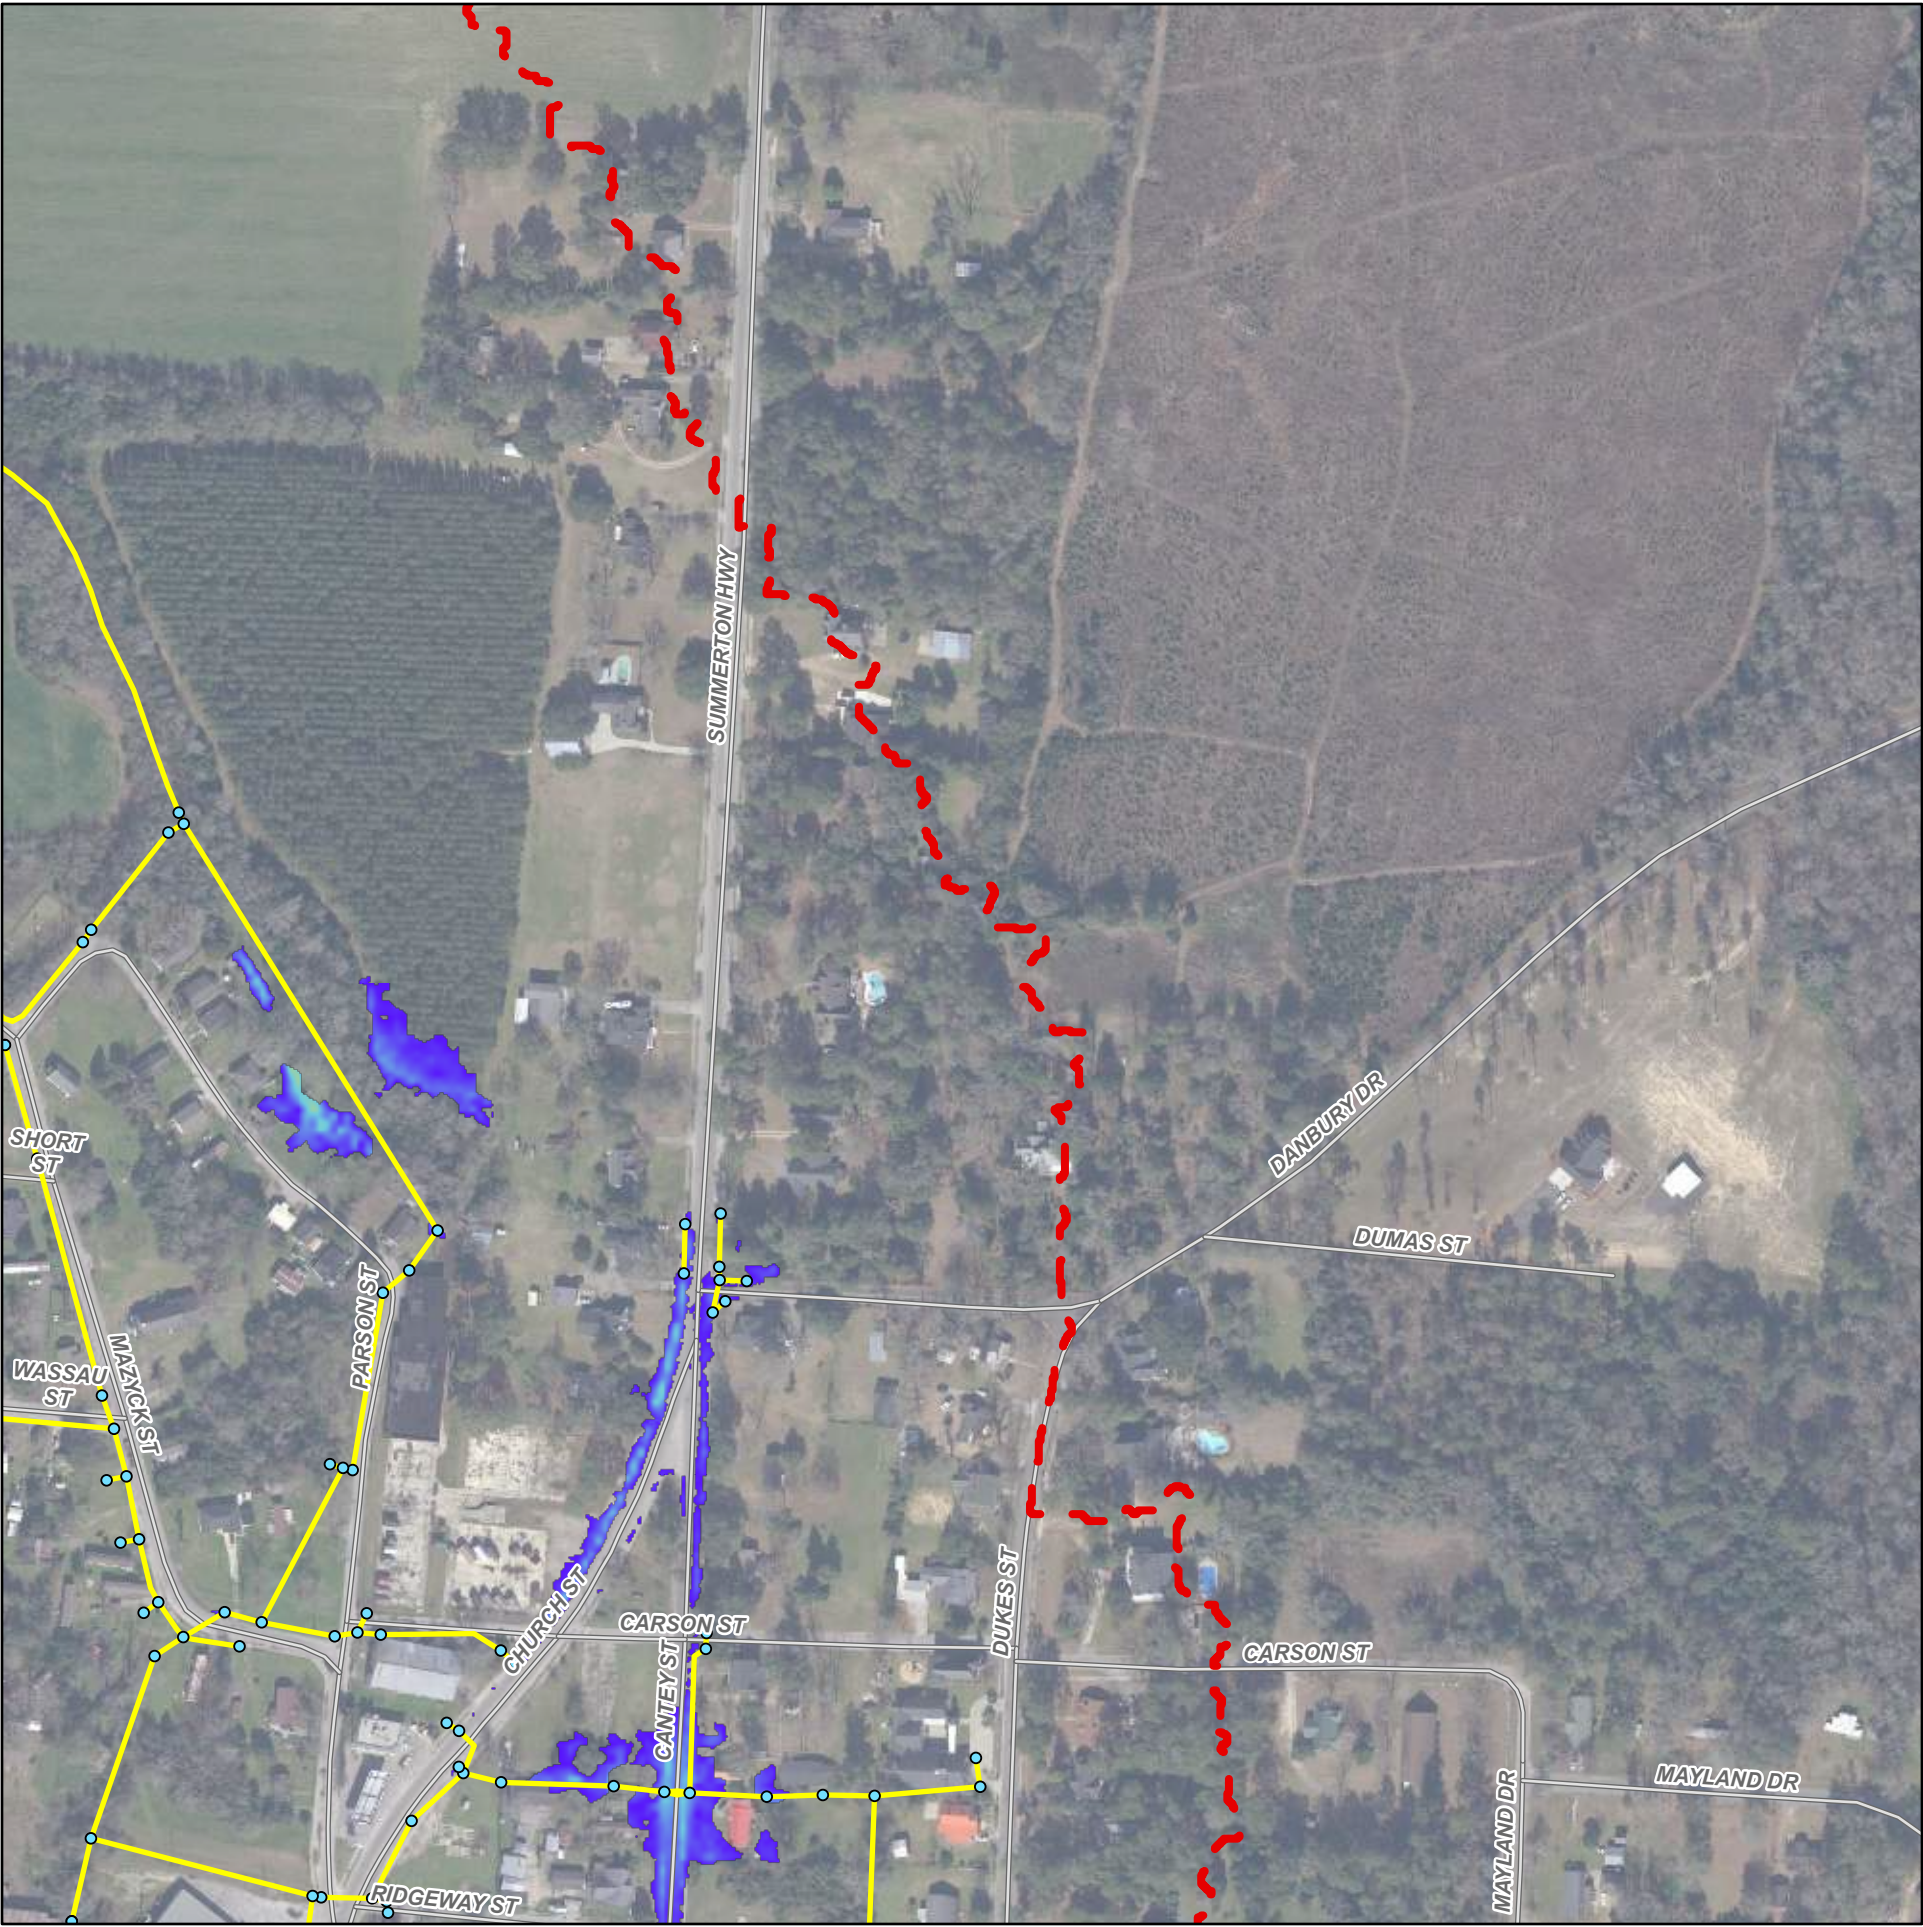
Sector B3

Existing Conditions Flood Analysis
Rainfall: 2-Year SCS Type II (3.59")

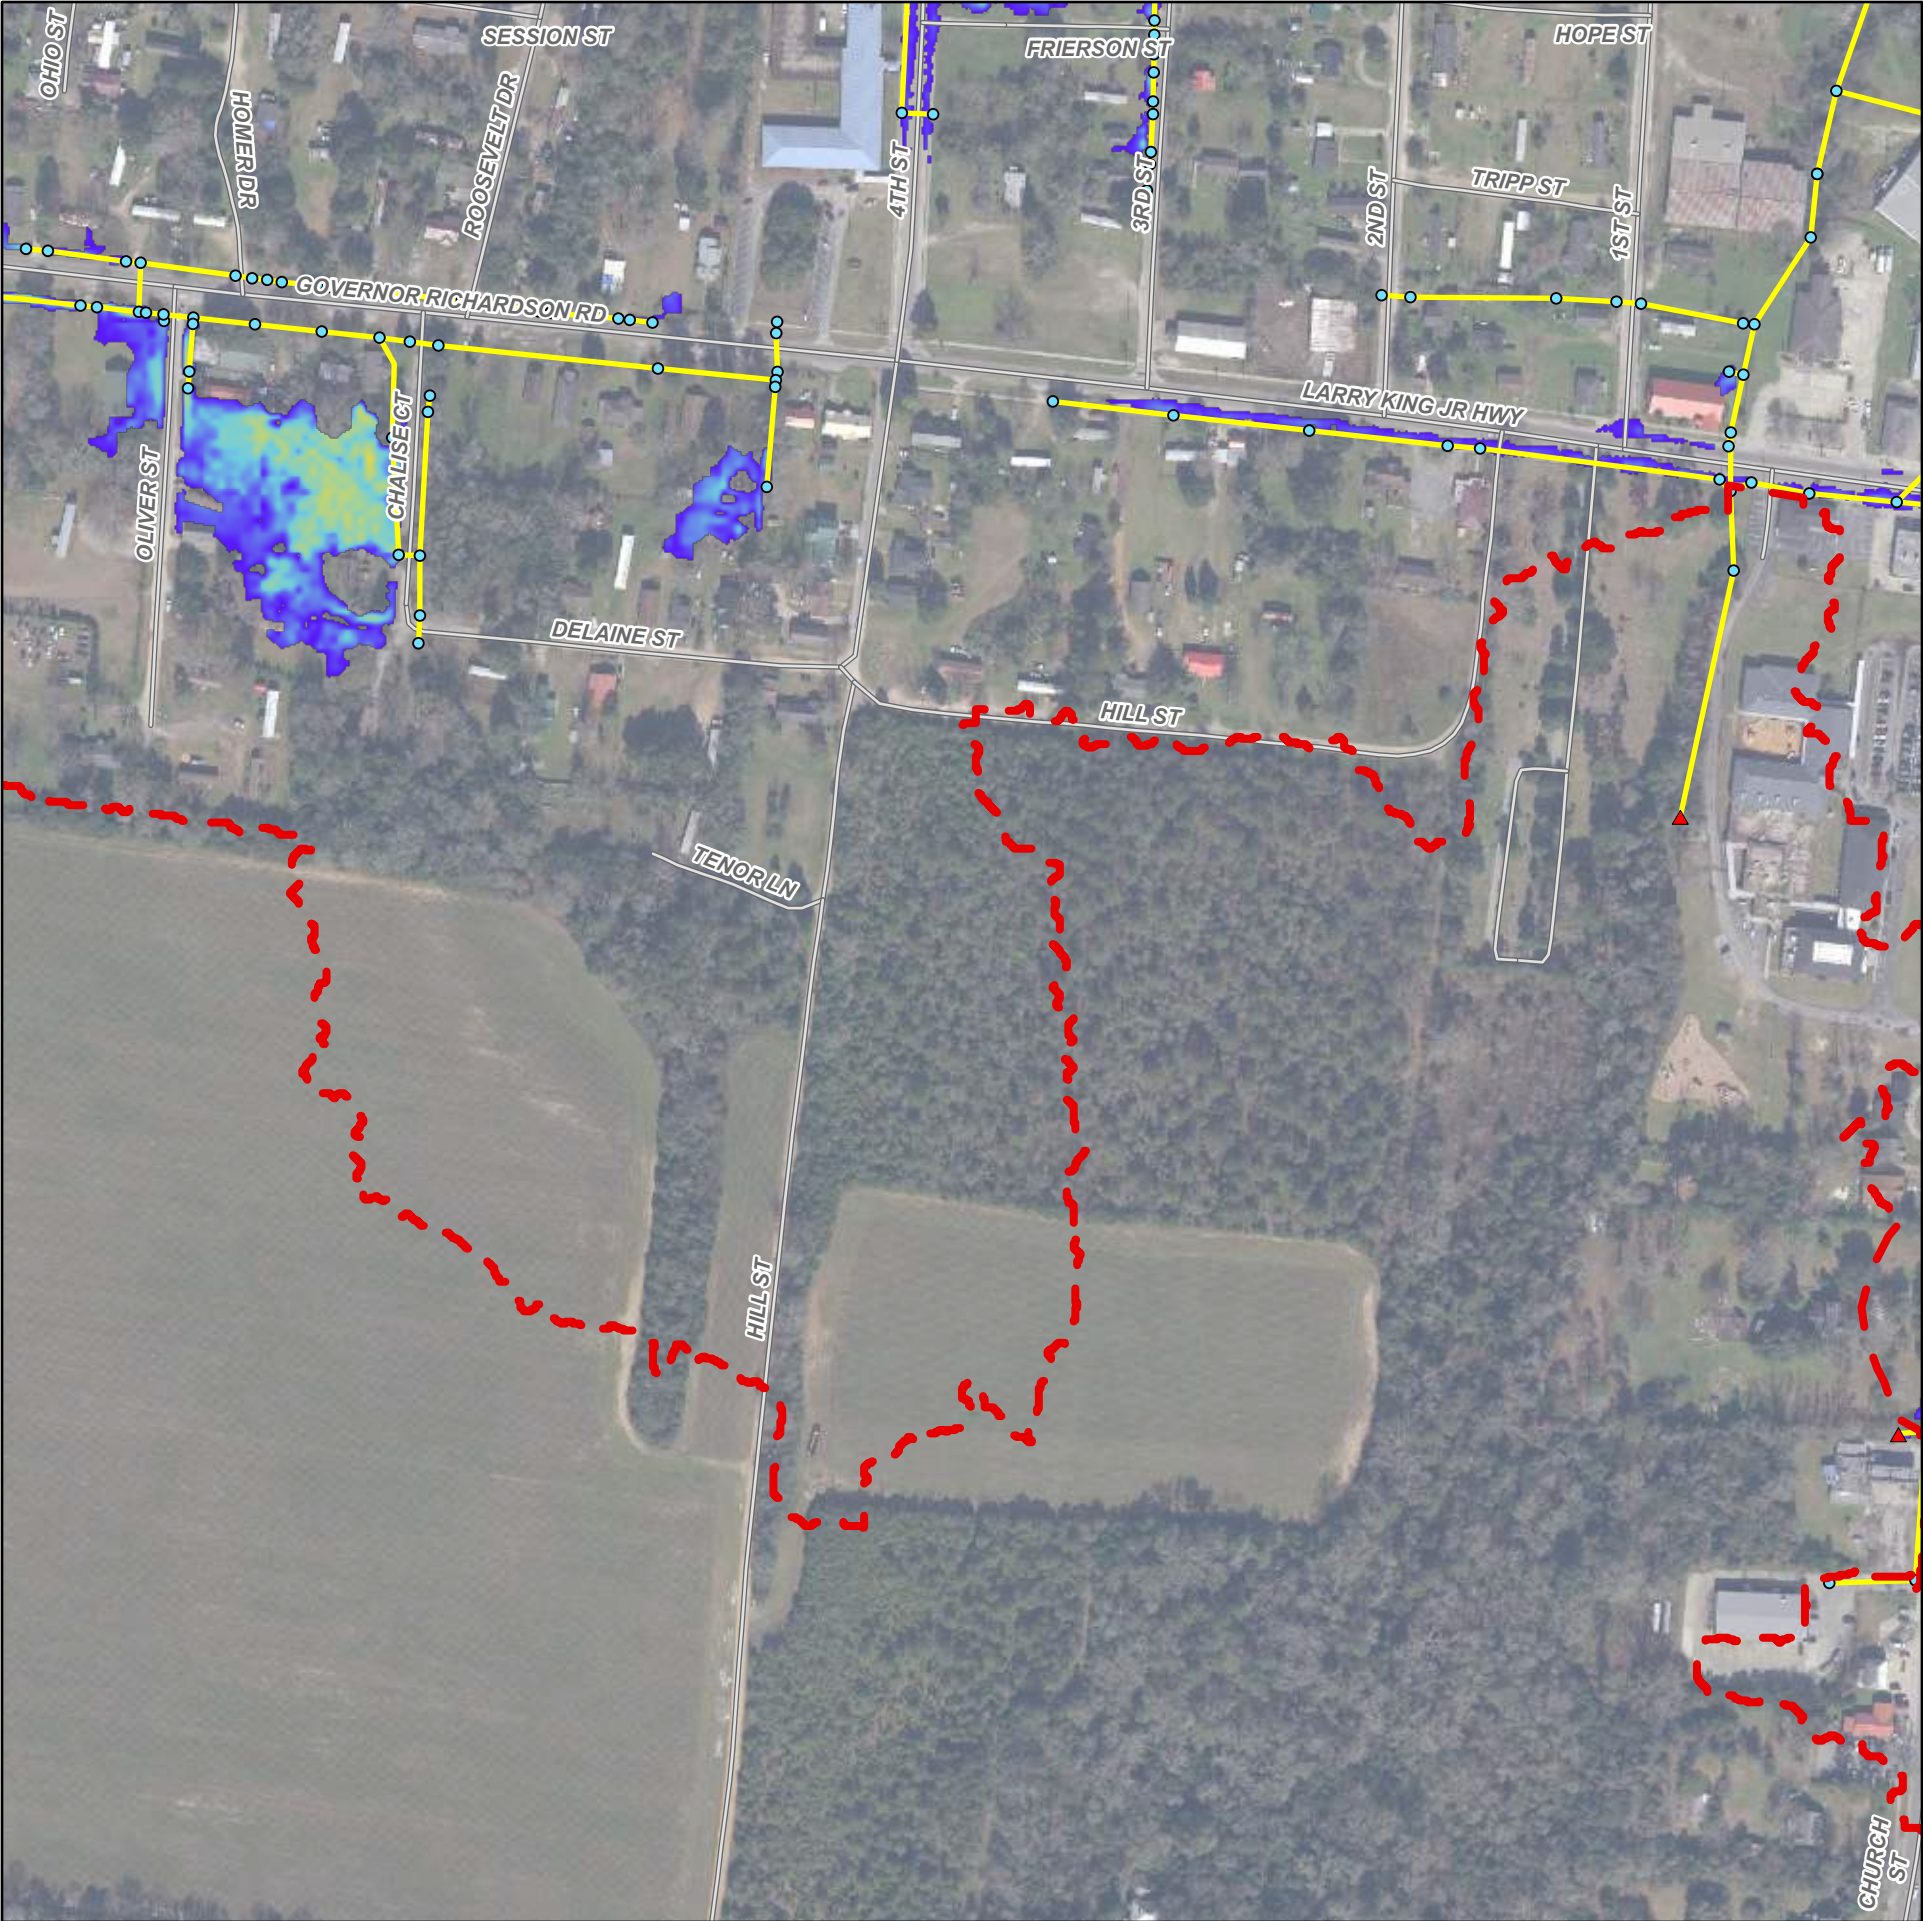
Sector C1

Existing Conditions Flood Analysis
Rainfall: 2-Year SCS Type II (3.59")

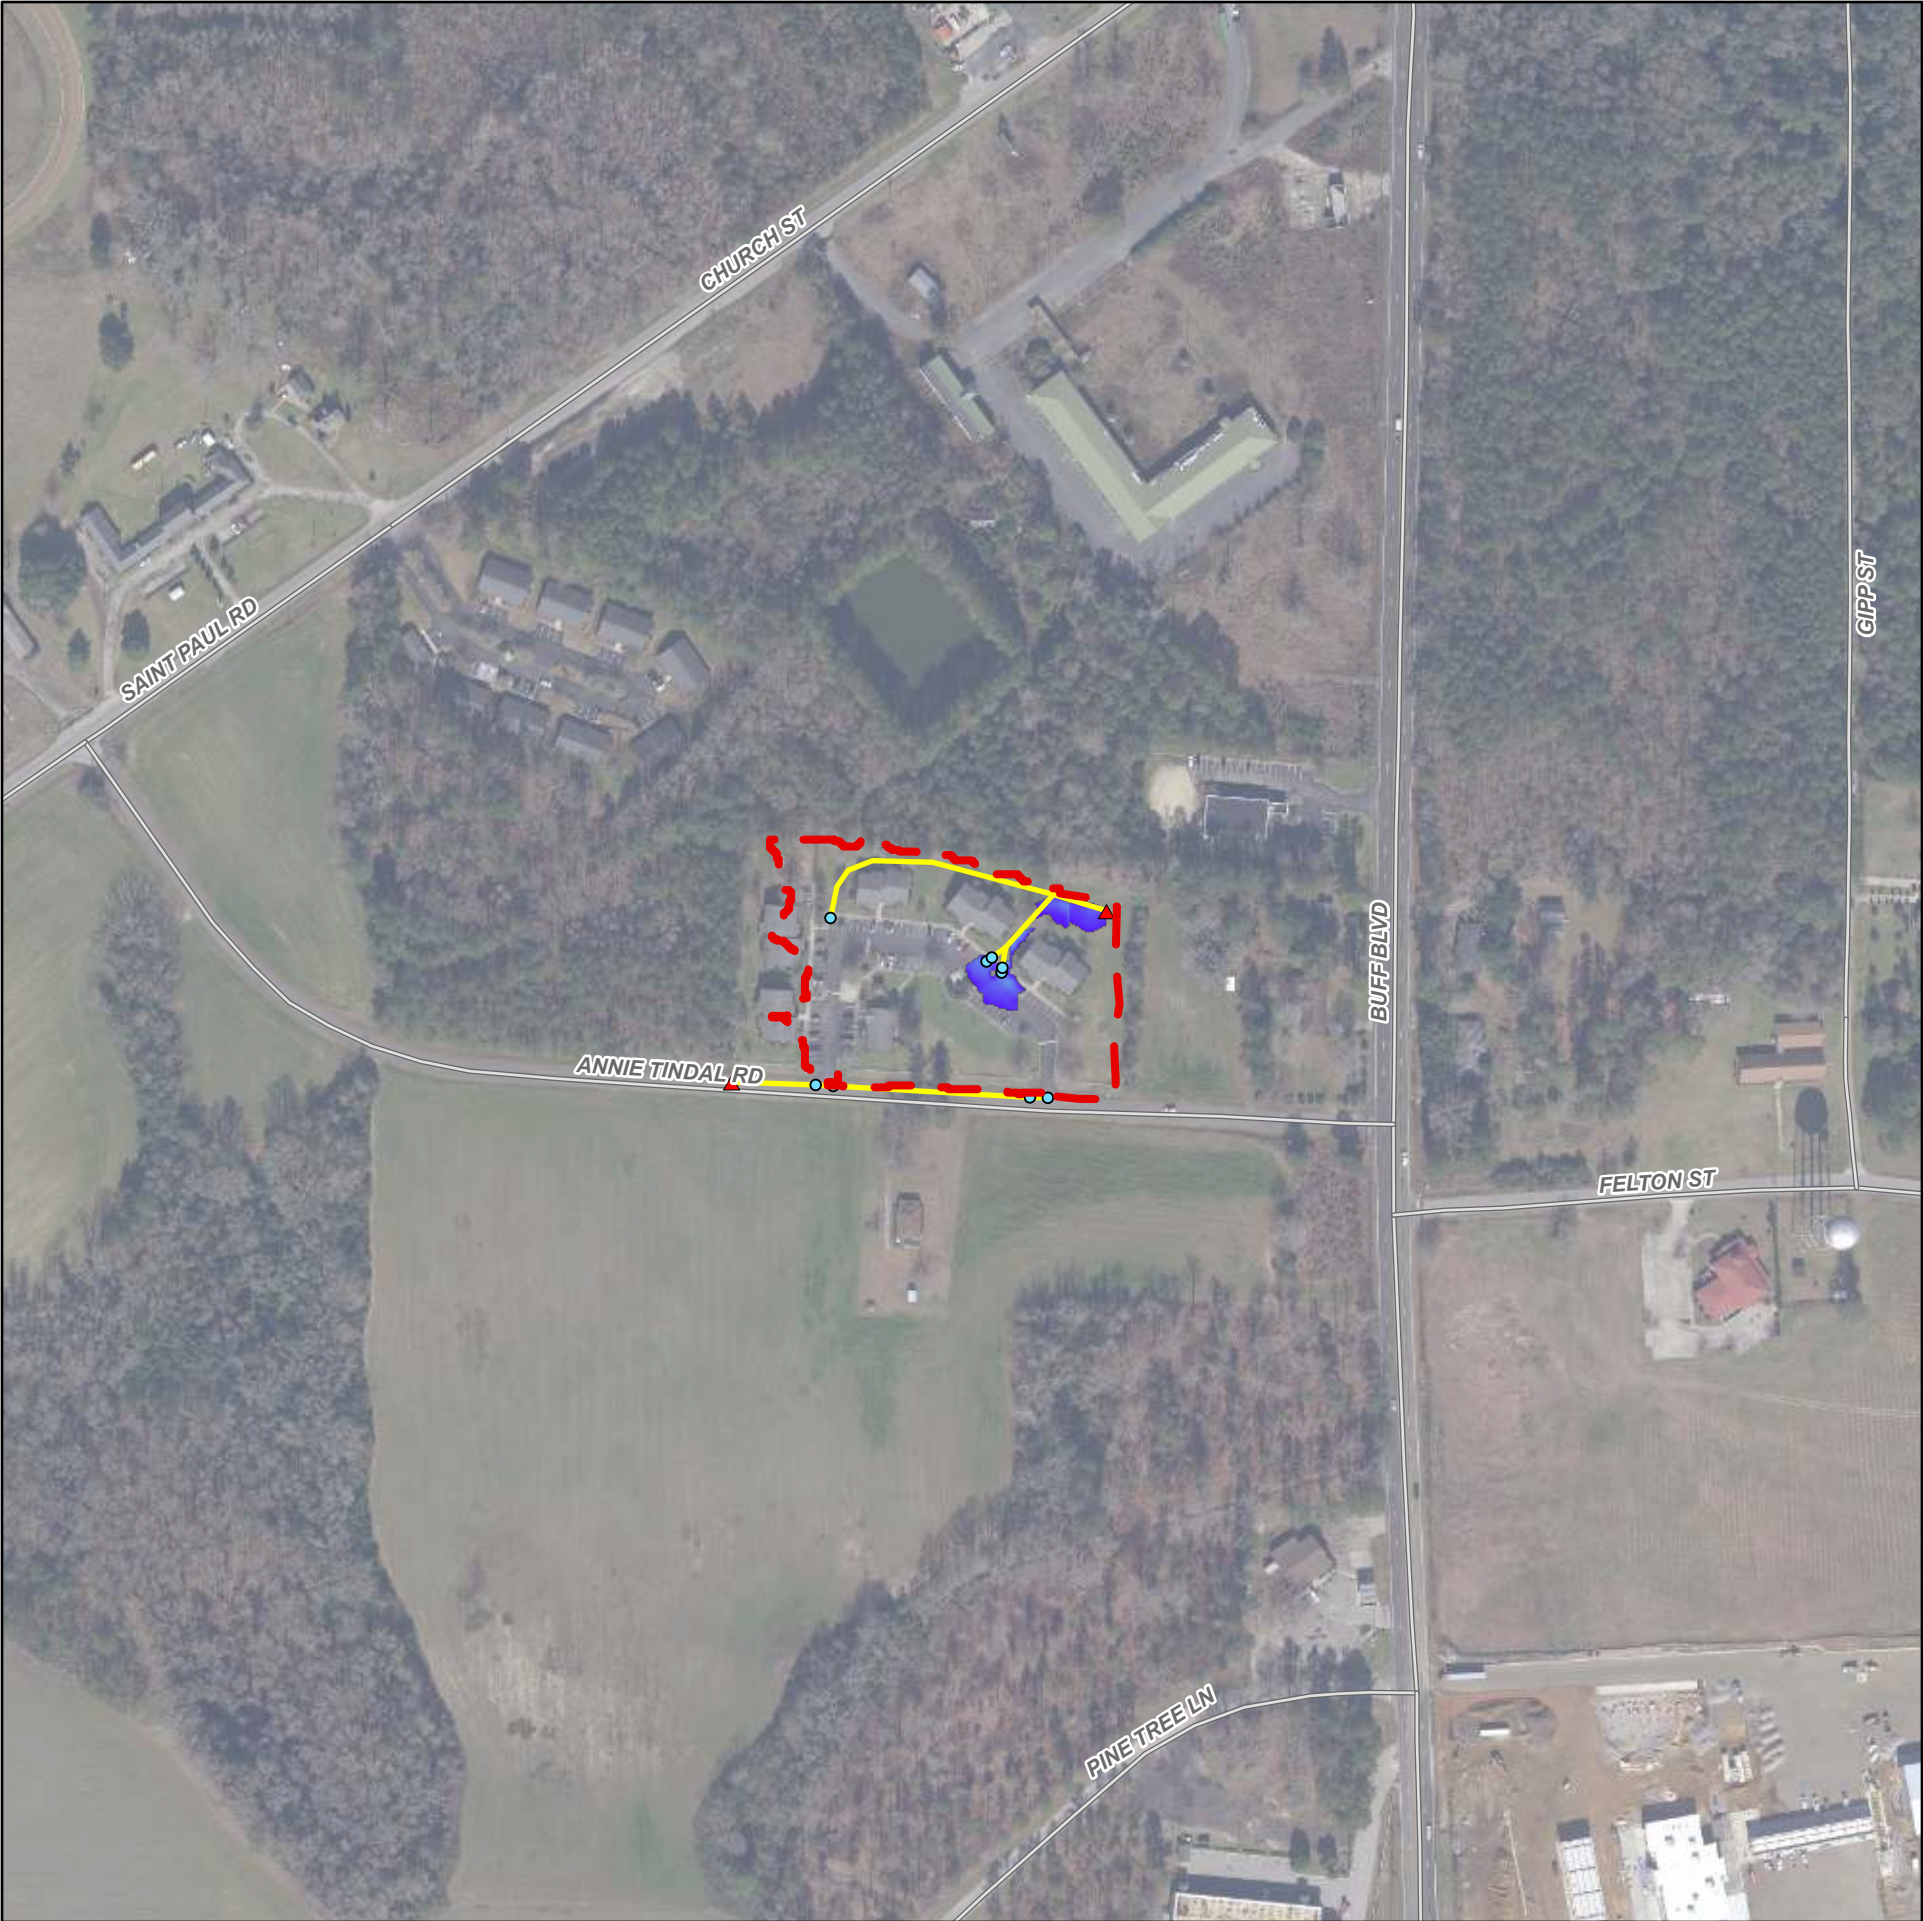
Sector C3

Existing Conditions Flood Analysis
Rainfall: 2-Year SCS Type II (3.59")

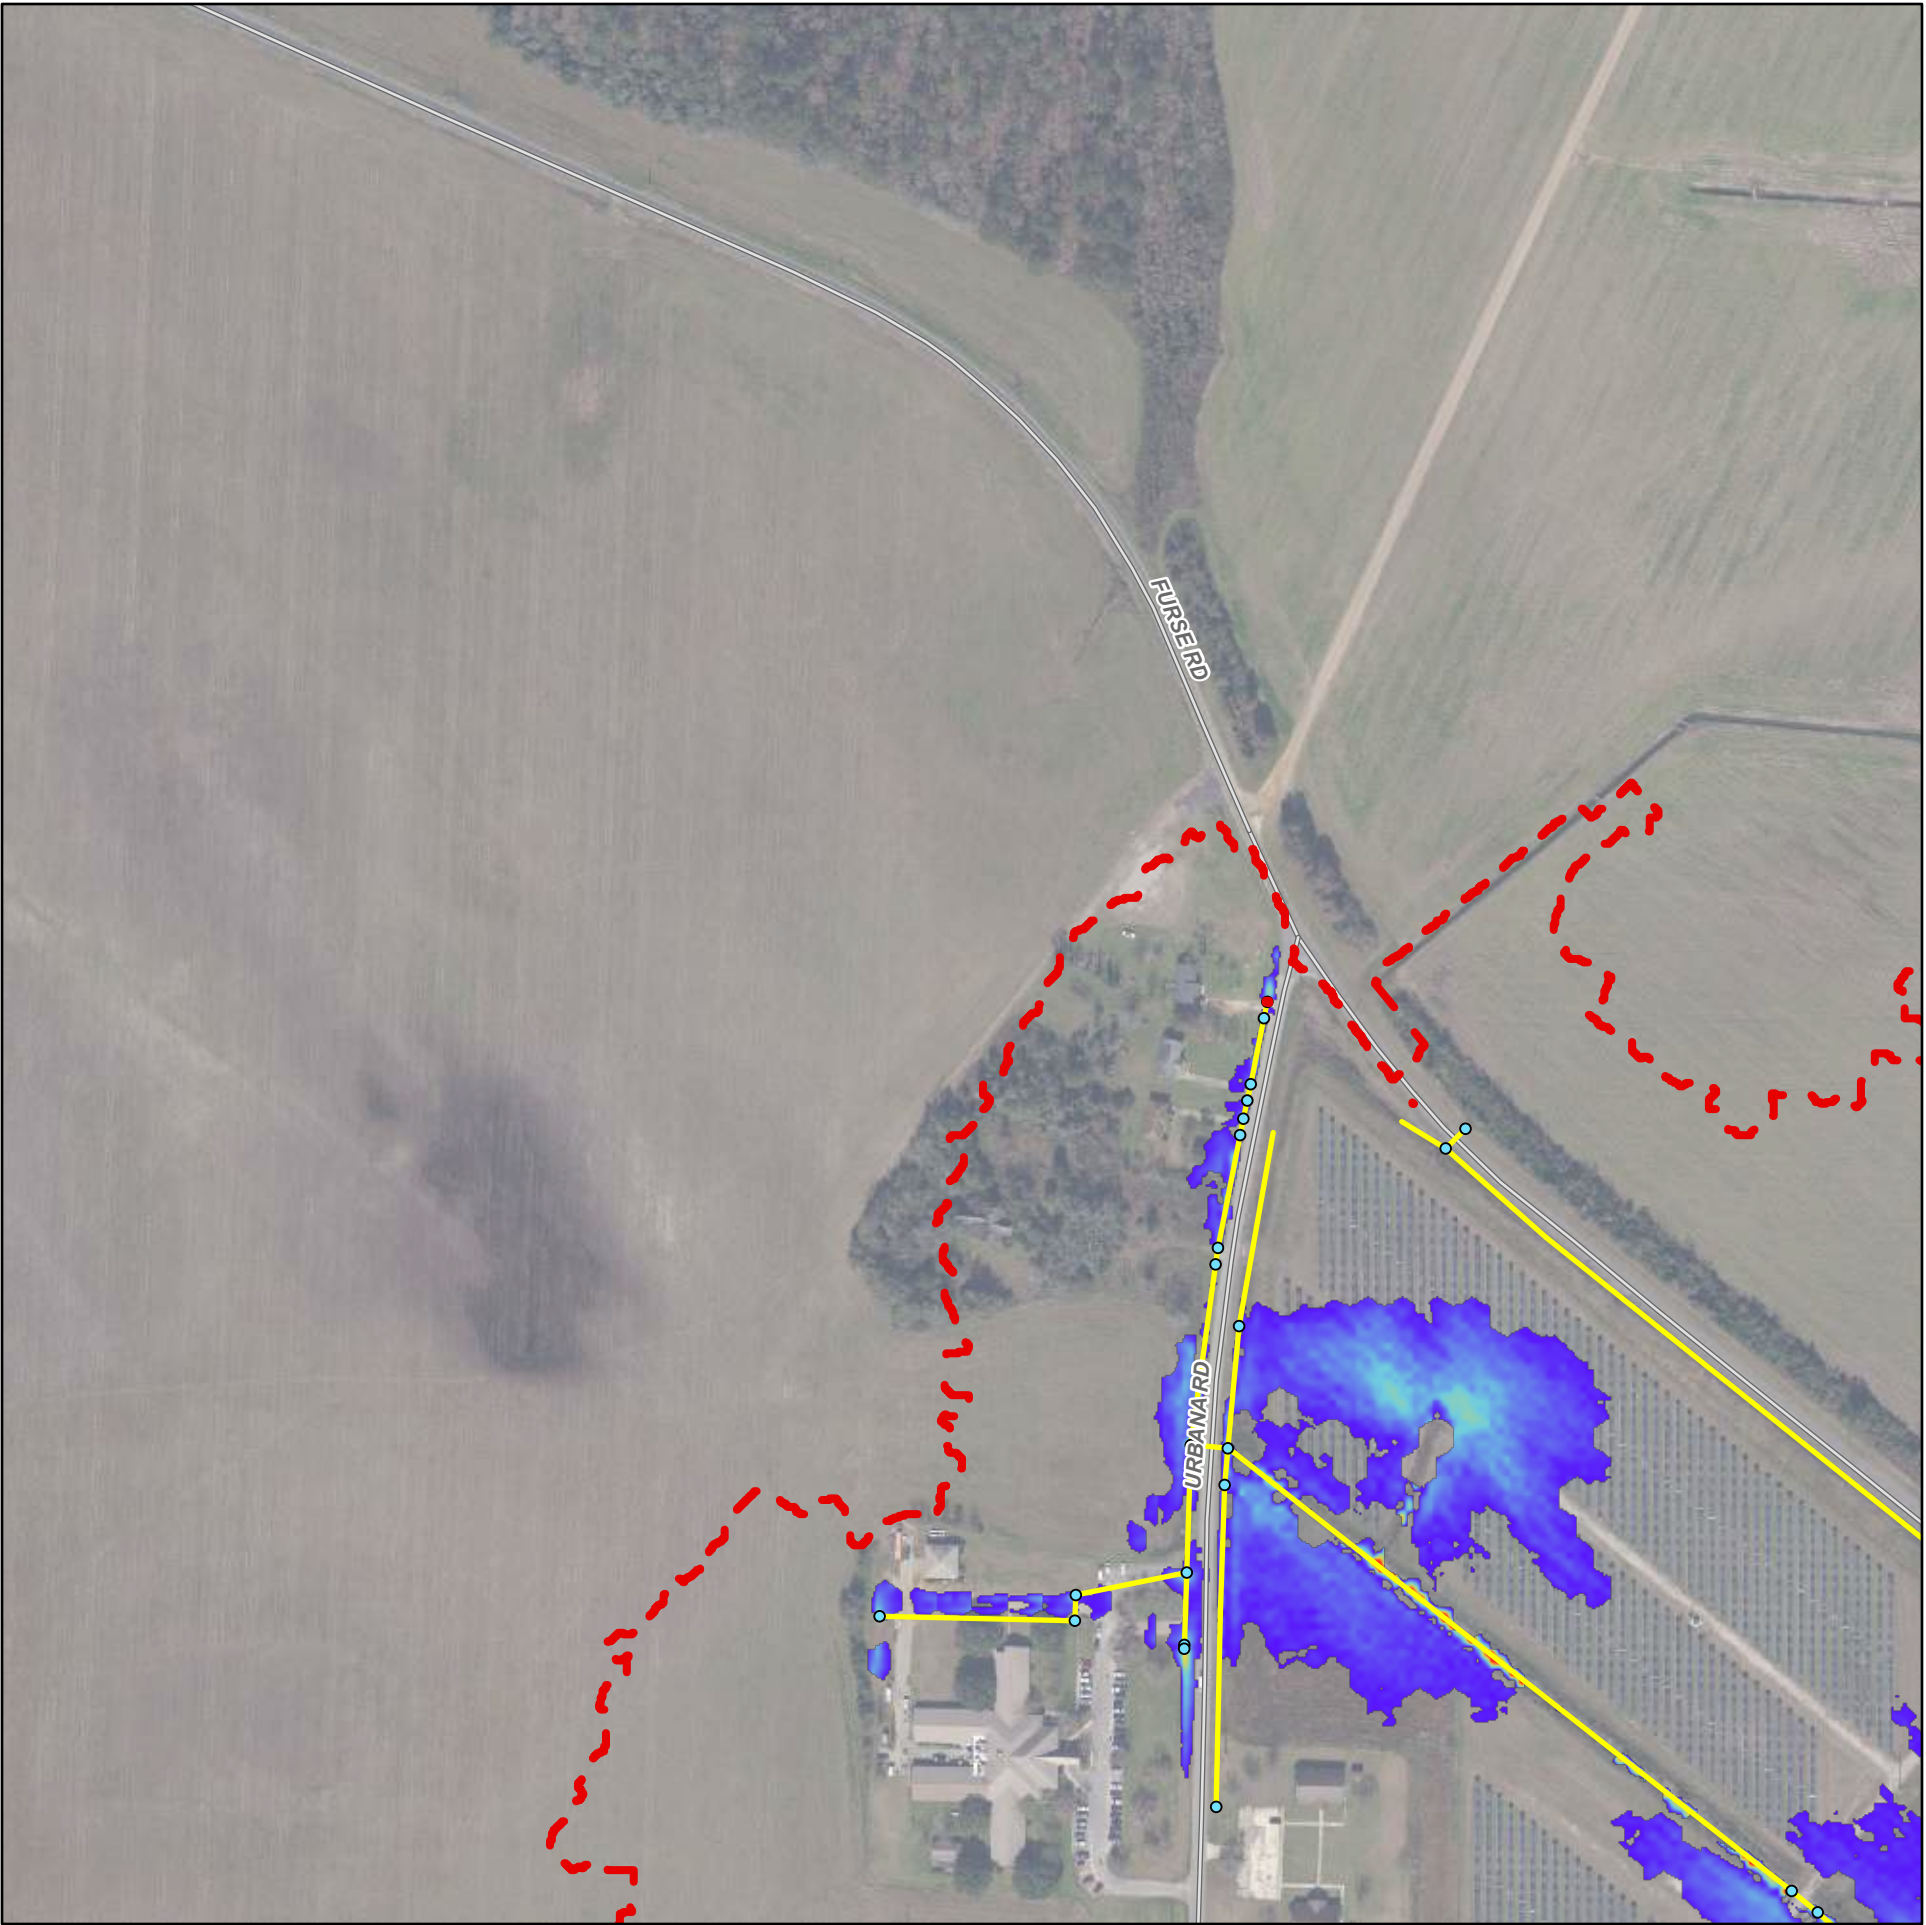
Sector A1

Existing Conditions Flood Analysis
Rainfall: 10-Year SCS Type II (5.48")
