Appendix B

Existing Conditions Flood Analysis

Town of Summerton | SC Office of Resilience
Hydrologic and Hydraulic Study

Existing Conditions Flood Analysis
Rainfall: 2-Year SCS Type II (3.59")

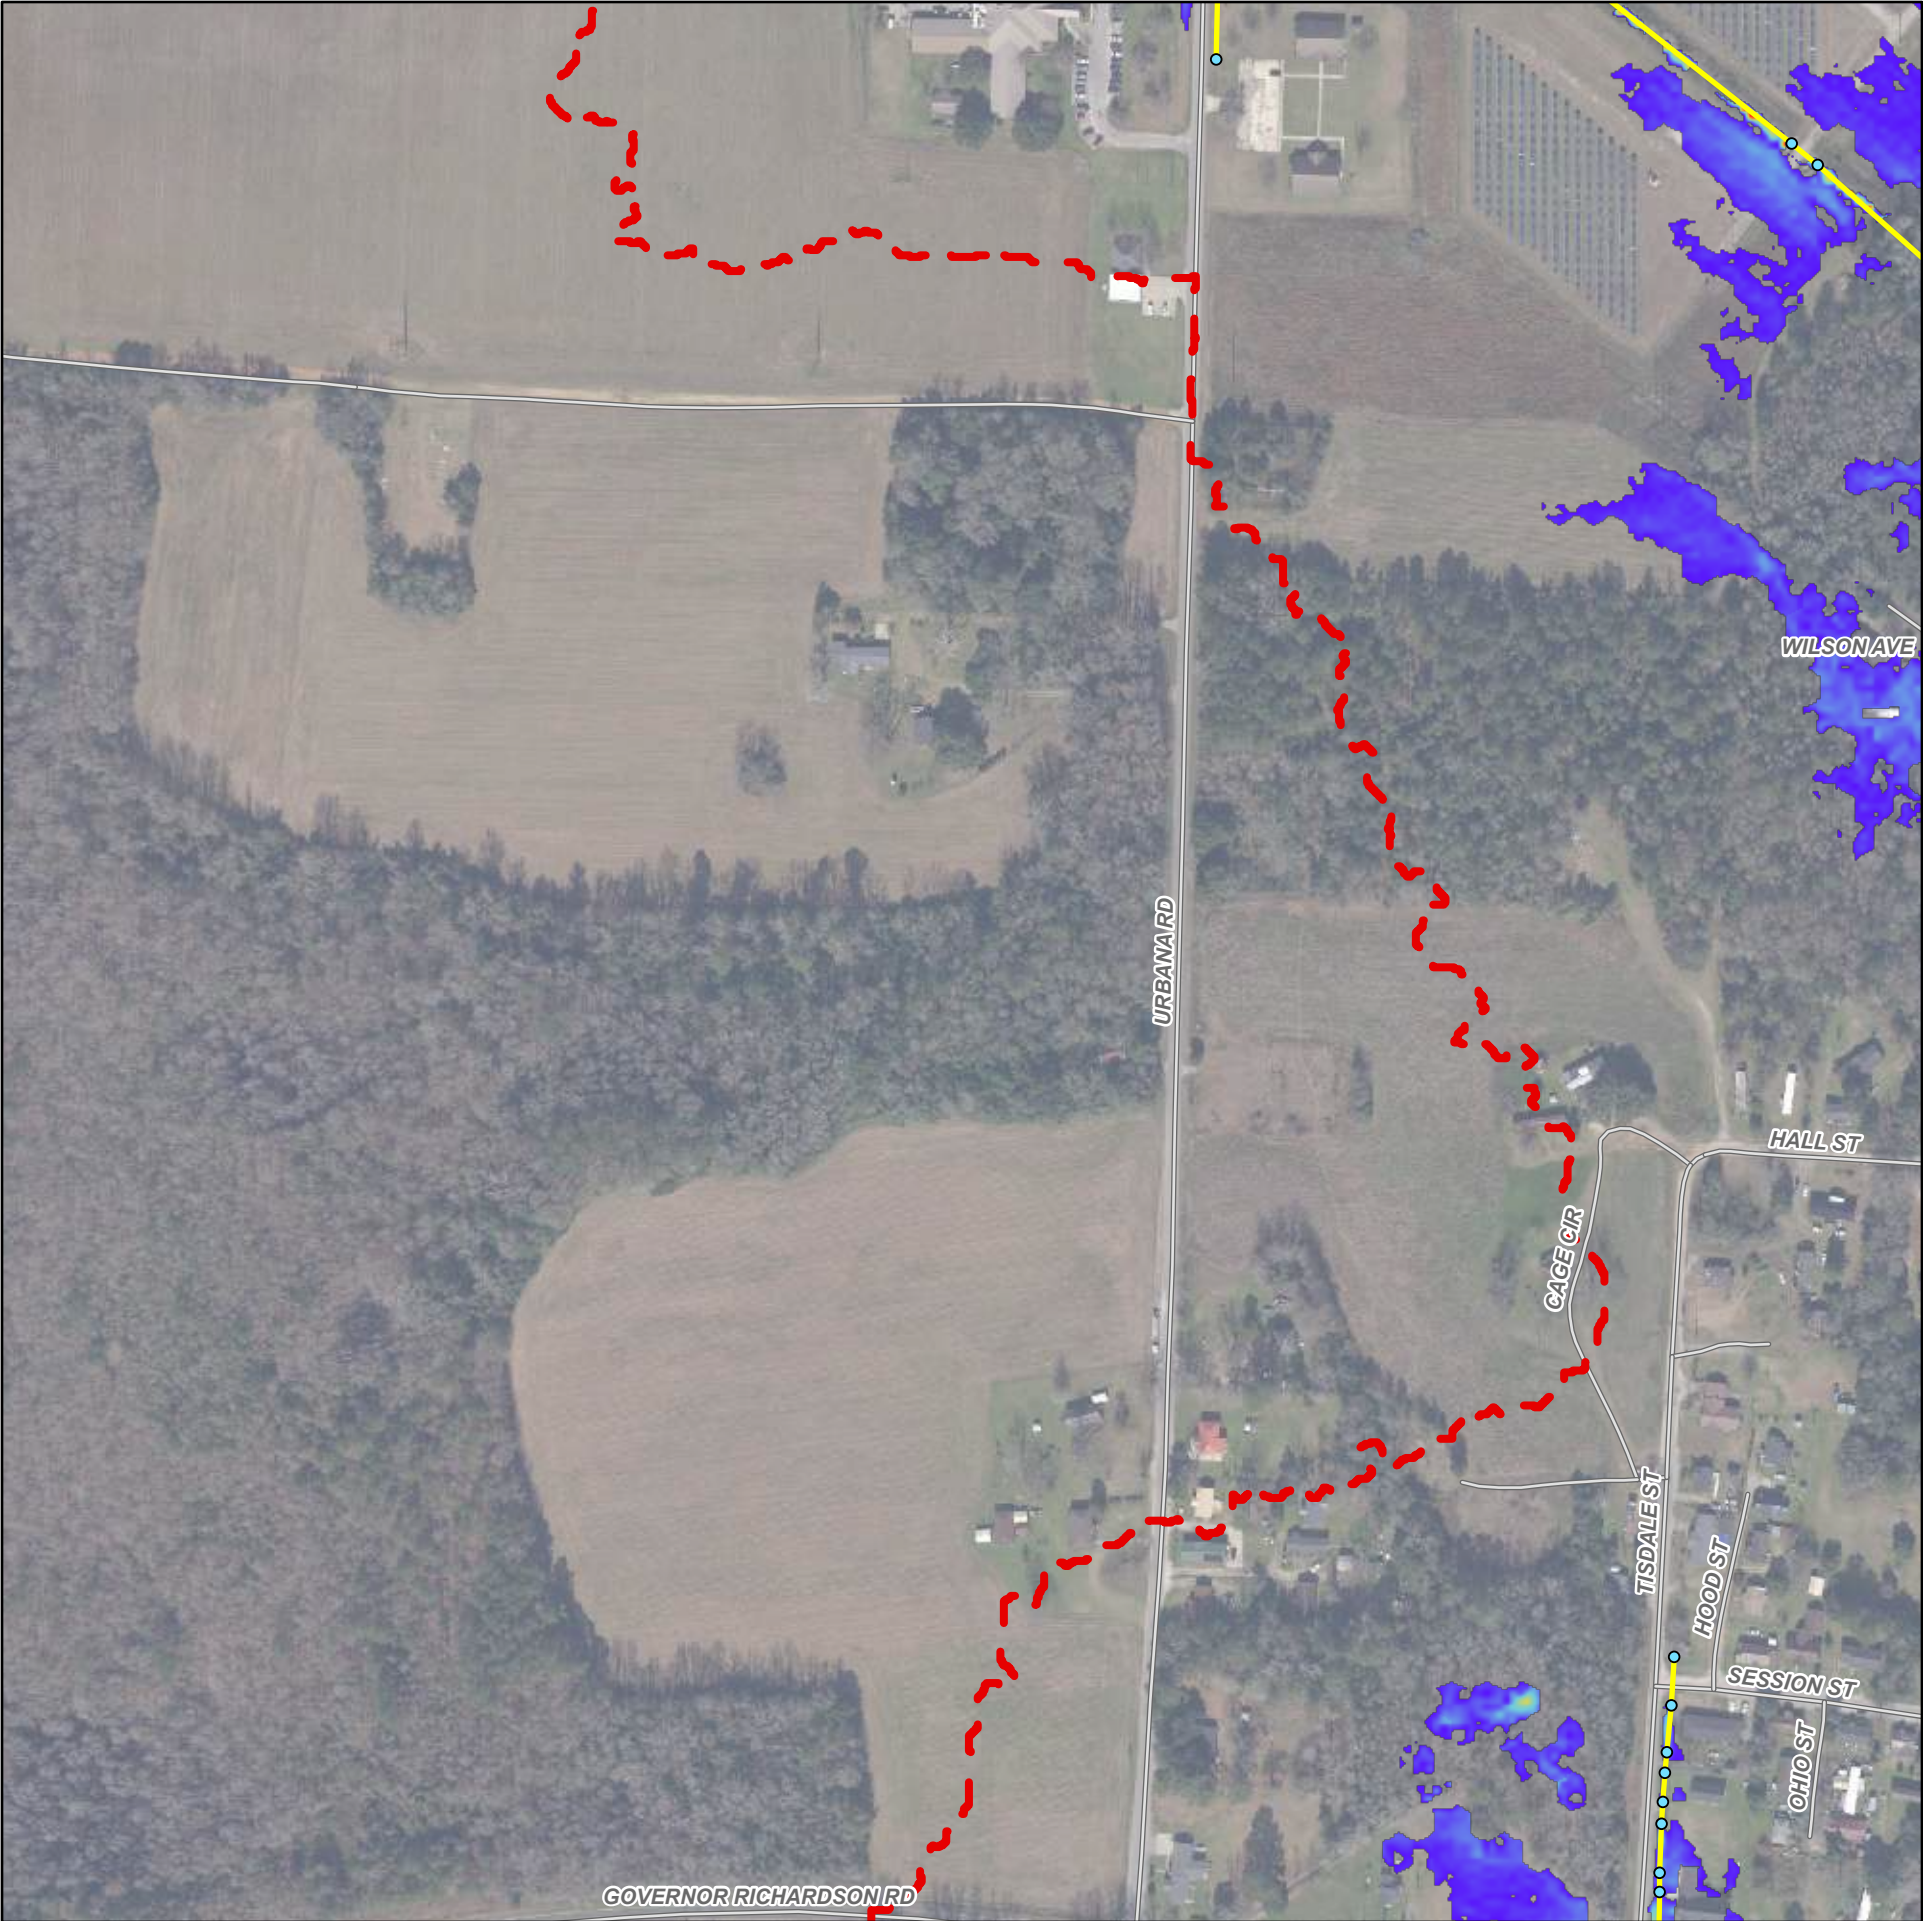
Sector A2

Existing Conditions Flood Analysis
Rainfall: 10-Year SCS Type II (5.48")

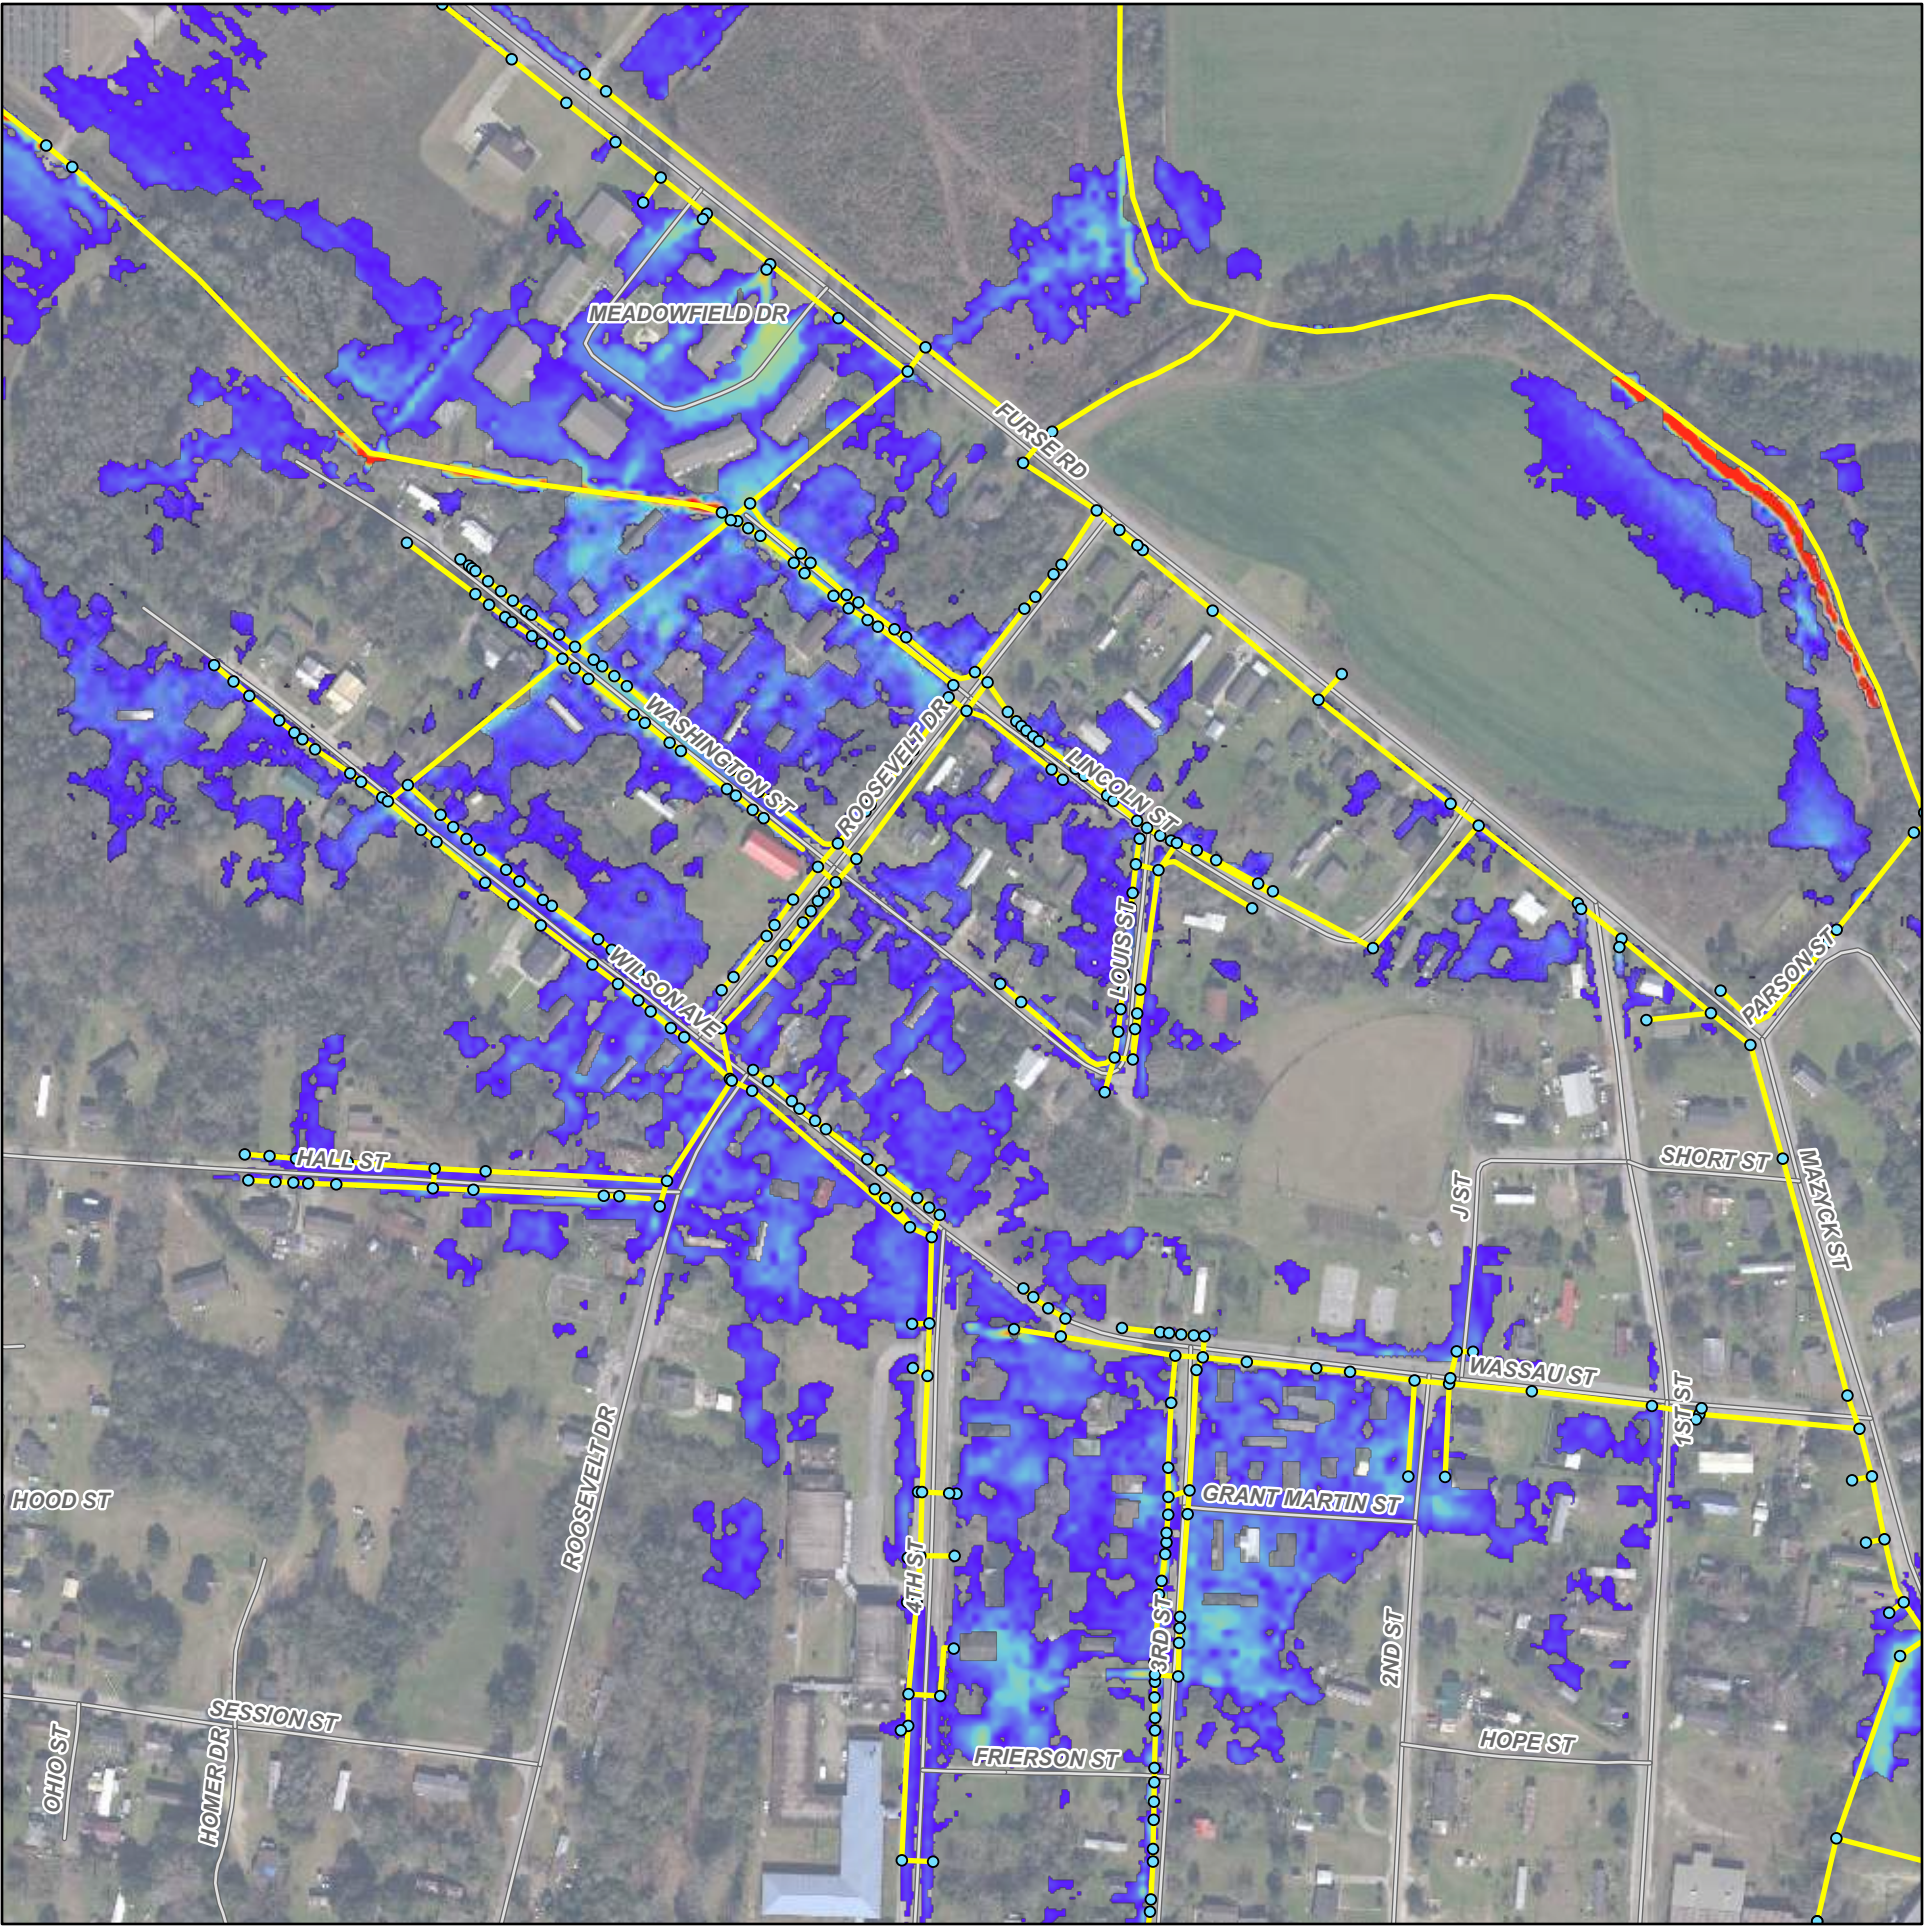
Sector B2

Existing Conditions Flood Analysis
Rainfall: 10-Year SCS Type II (5.48")

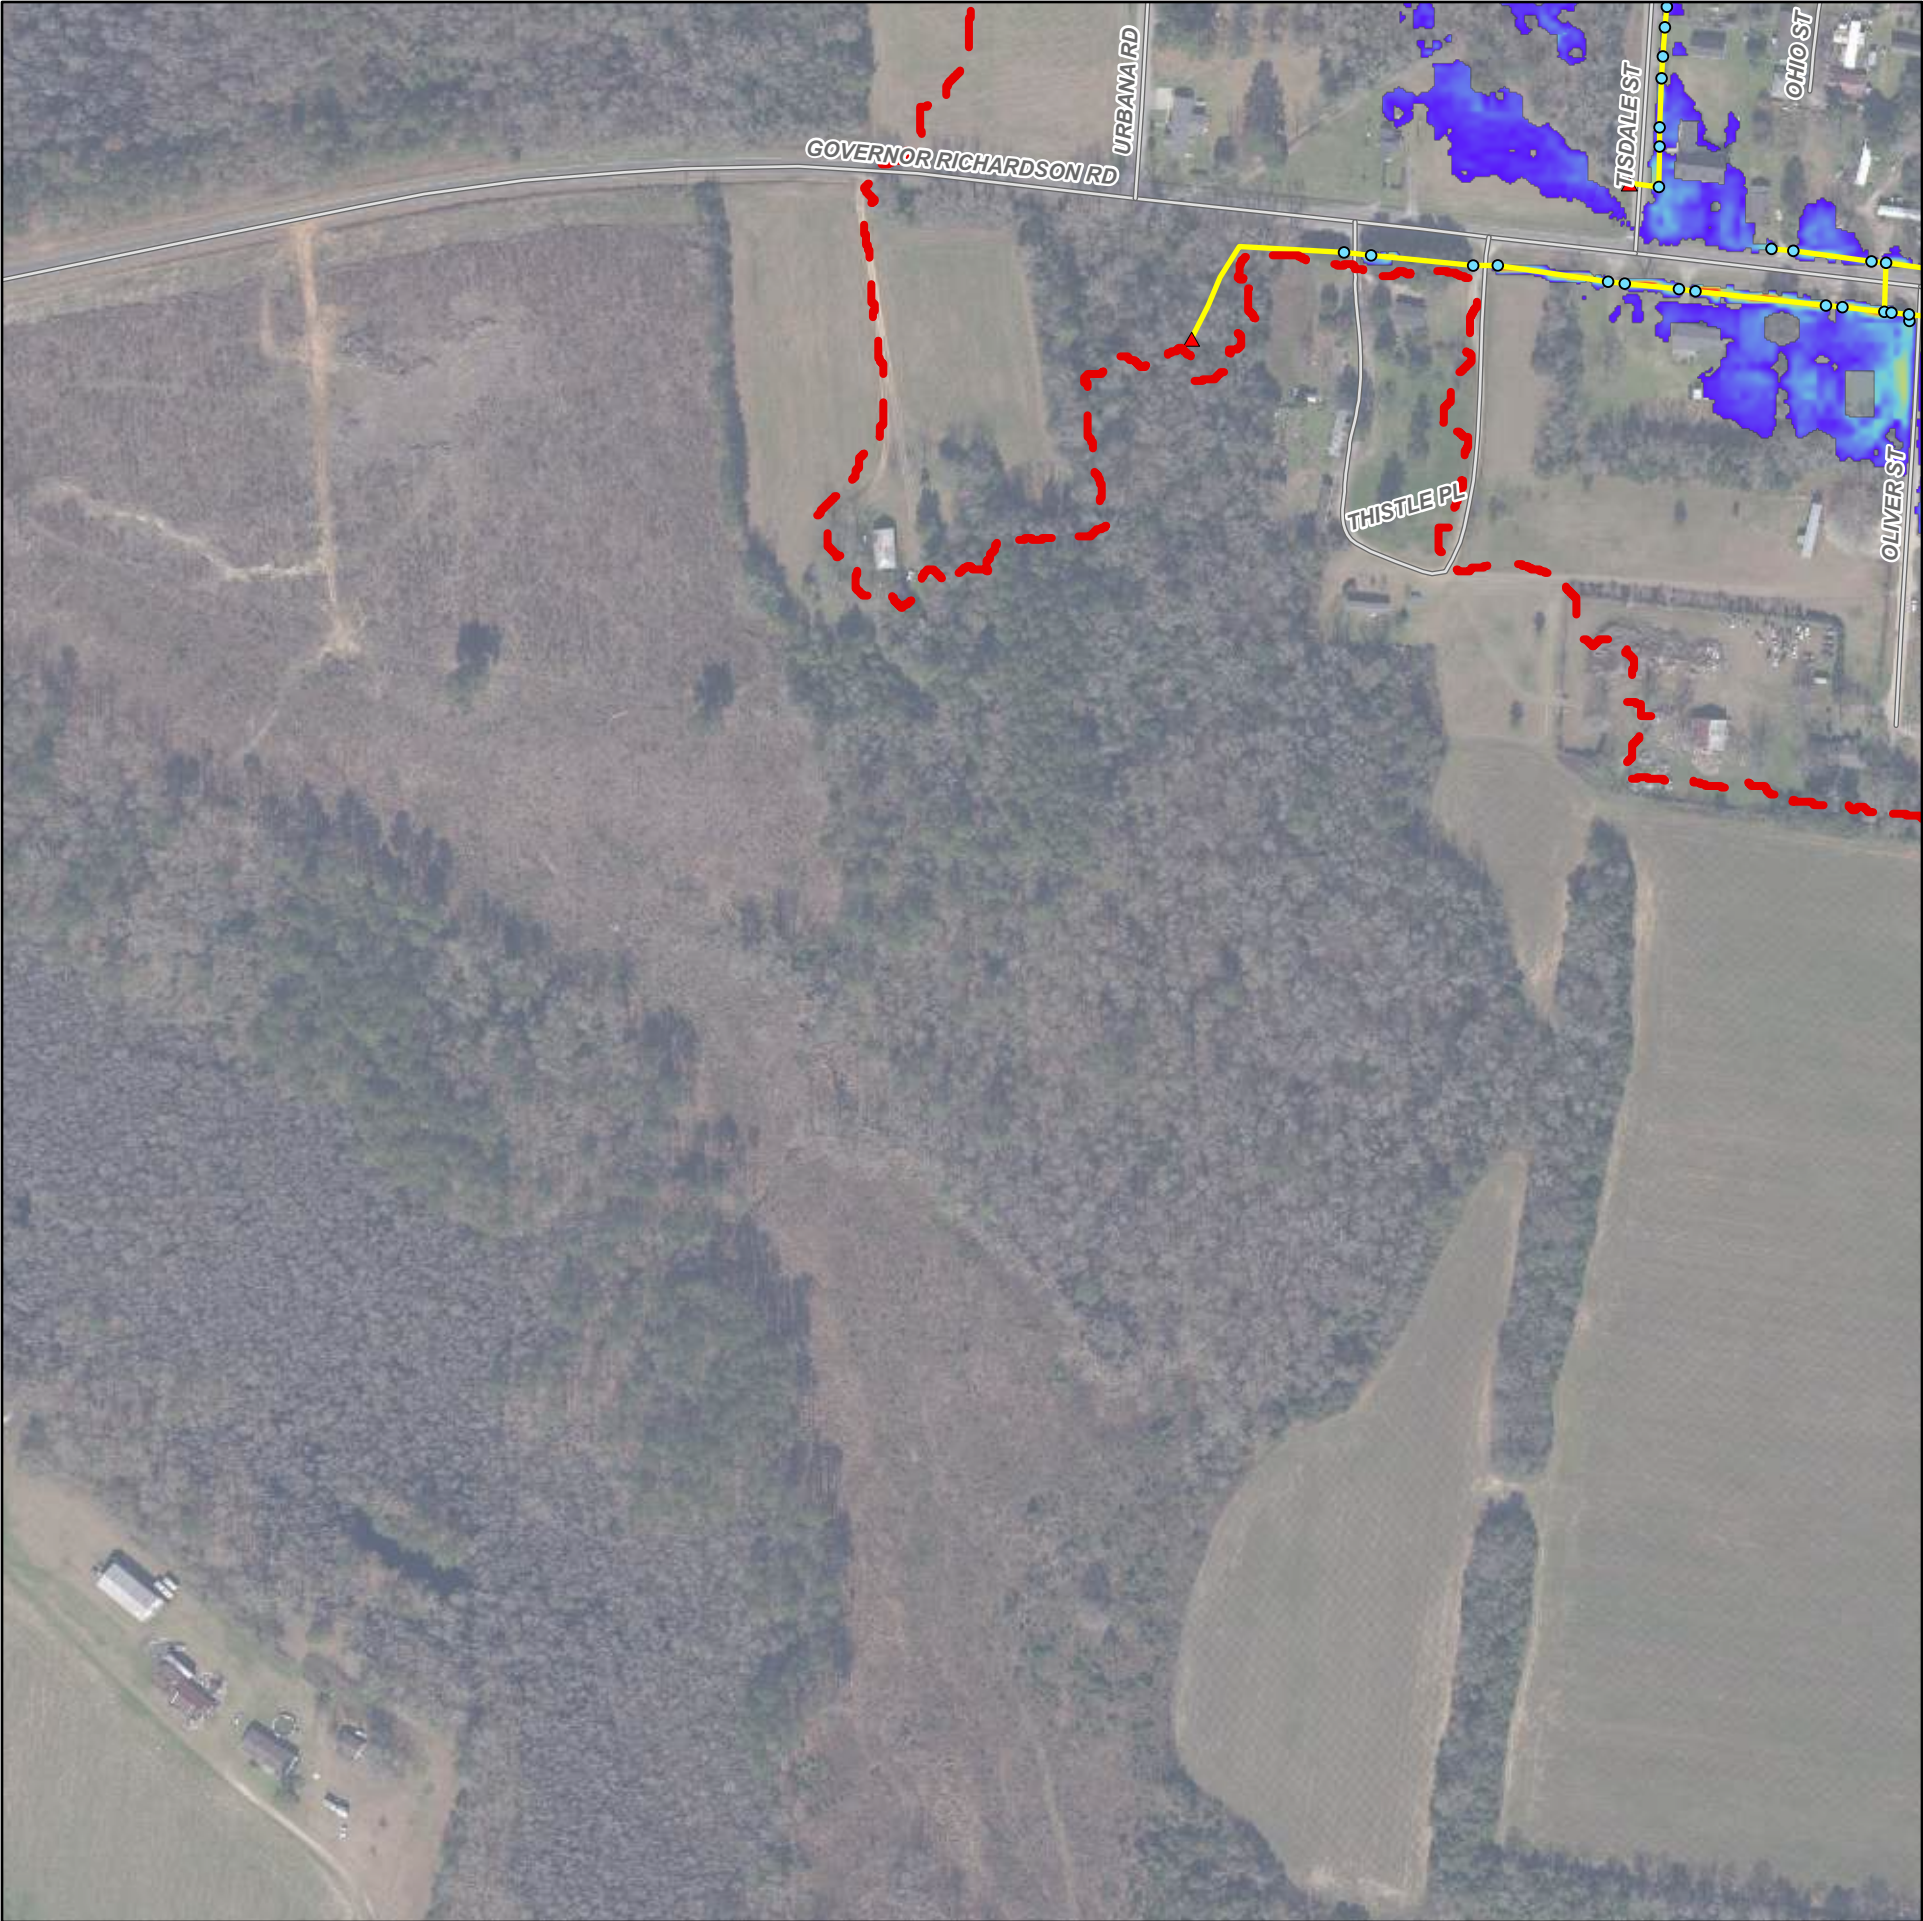
Sector B3

Existing Conditions Flood Analysis
Rainfall: 10-Year SCS Type II (5.48")

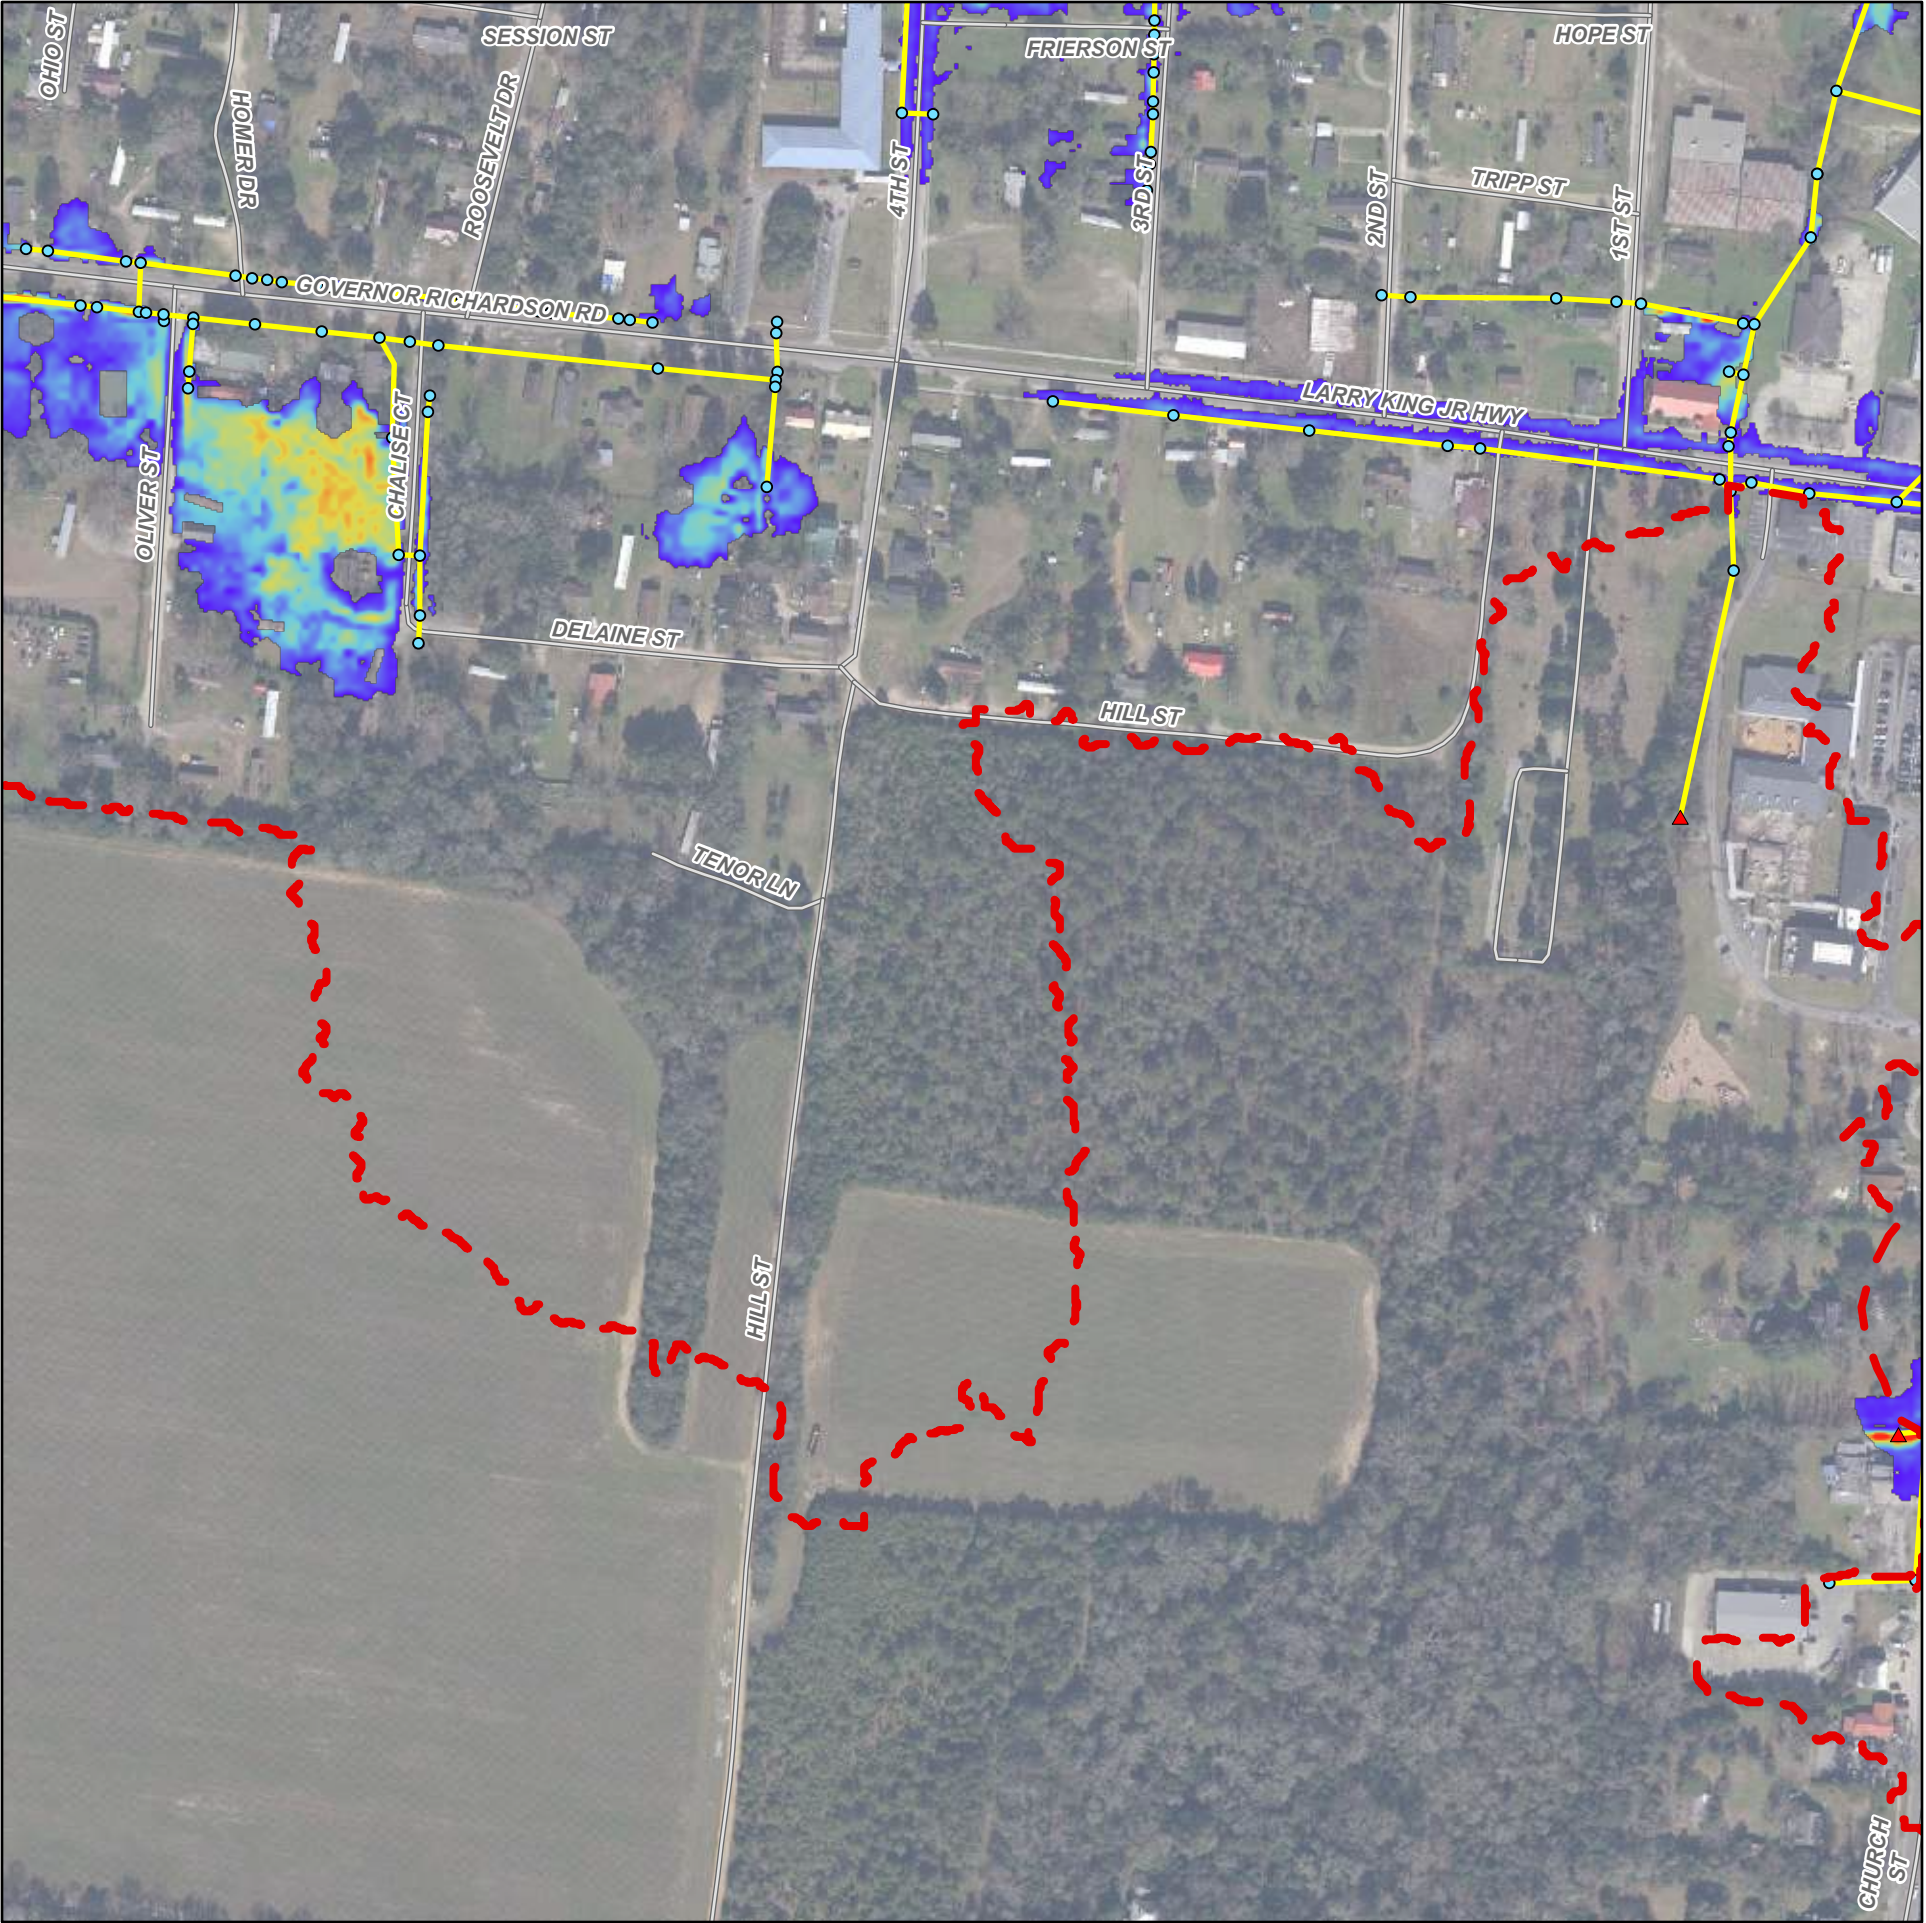
Sector C2

Existing Conditions Flood Analysis
Rainfall: 10-Year SCS Type II (5.48")

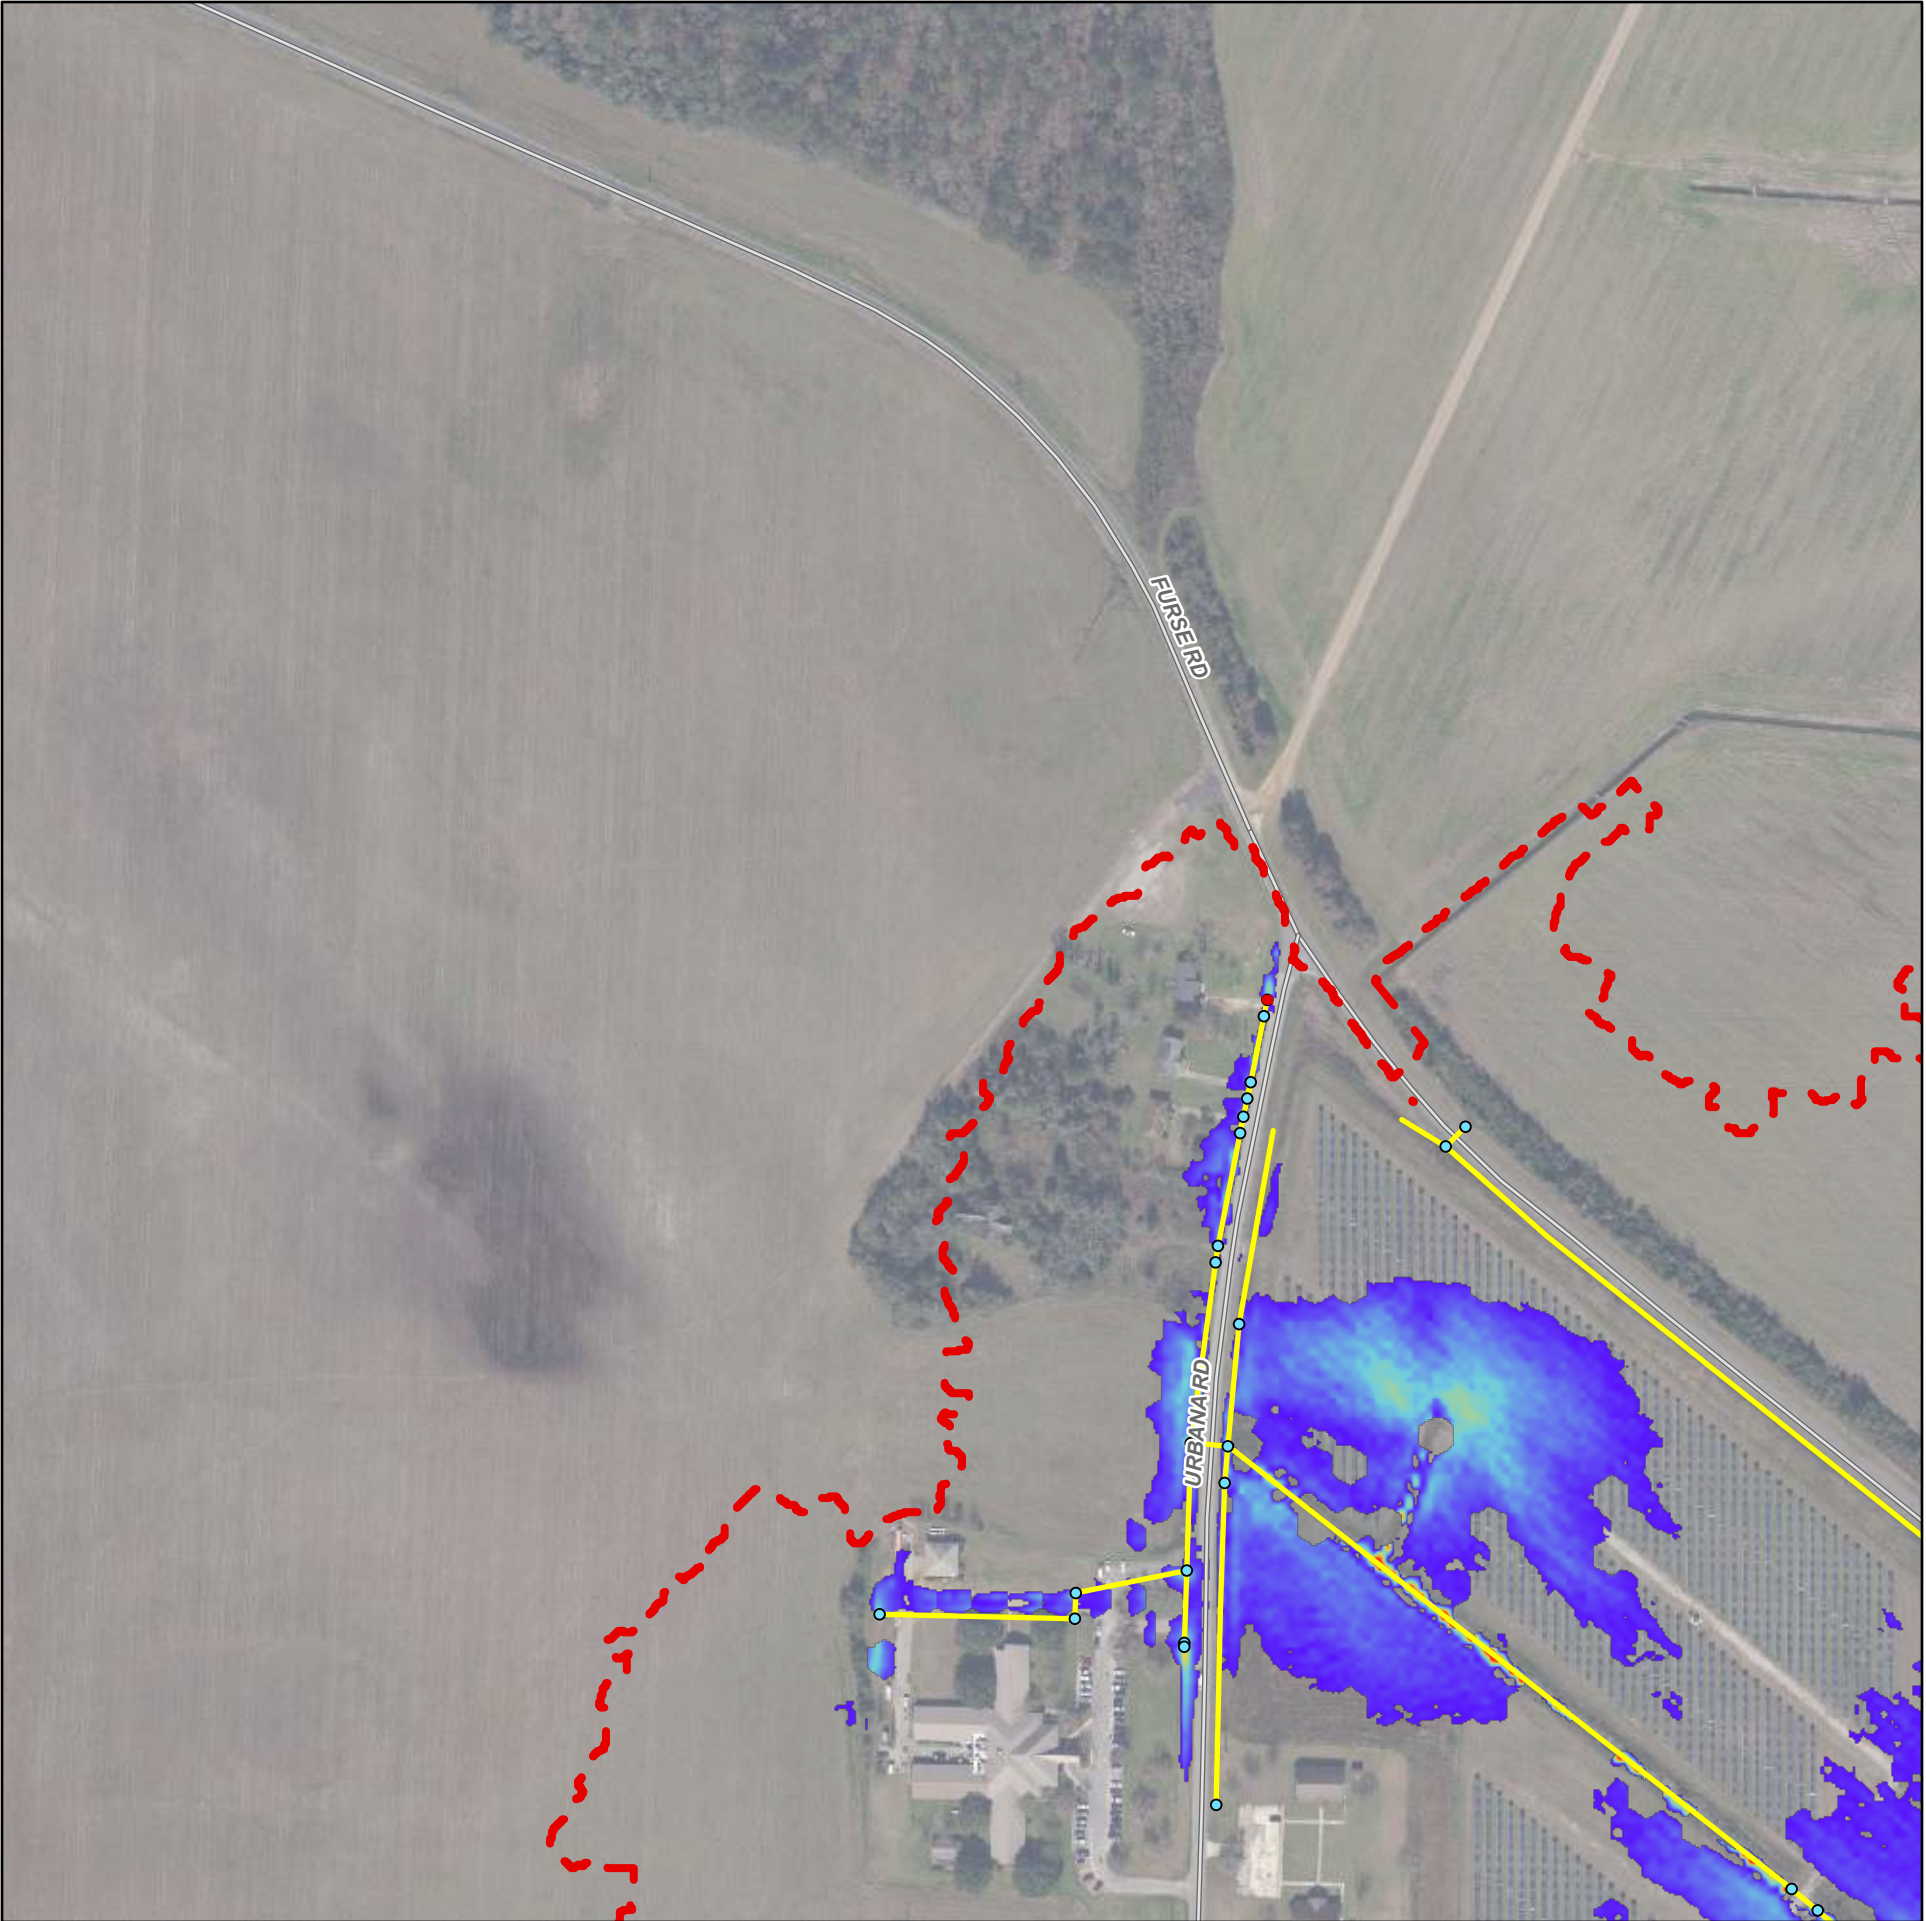
Sector C3

Existing Conditions Flood Analysis
Rainfall: 10-Year SCS Type II (5.48")
