1. Executive Summary

City of Orangeburg Stormwater Drainage Study

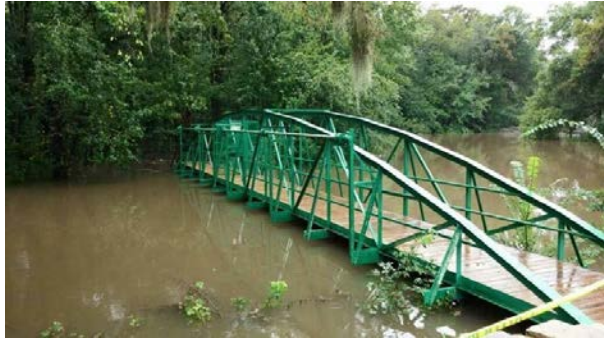
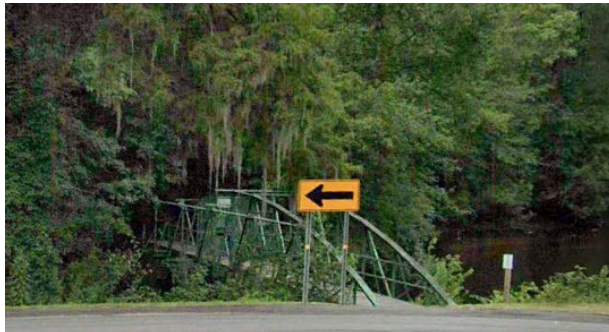
Figure 3. Edisto Memorial Gardens flooding and normal conditions

During the Historic floods of 2015, 2016, and 2018, low-lying areas of the city were inundated by flooding. Hurricane Joaquin, in 2015, caused the most extensive damage, dumping more than 10 inches of rain to the City of Orangeburg in a 48-hour period. Other parts of the county saw more than 16 inches in the same period. The North Edisto River flooded into Edisto Gardens and Spray Park, a popular recreational area adjacent to communities along the river's banks (**Figure 3**).

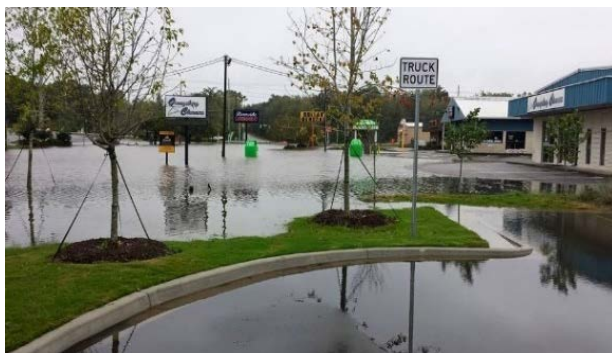
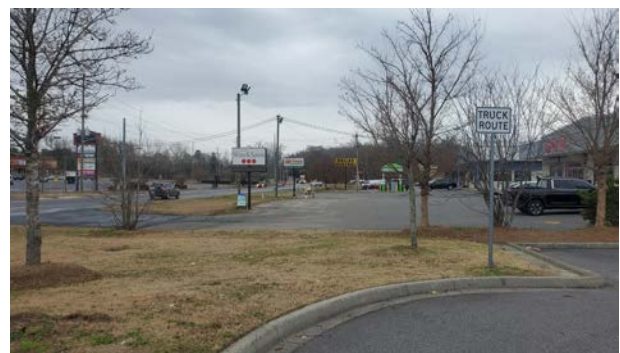
Figure 4. Stonewall Jackson Blvd flooding and during normal conditions

Low-lying areas at the intersection of Glover Street and Stonewall Jackson Boulevard also overtopped the roadway, impeding traffic and closing area businesses. **Figure 4** shows flooding and normal conditions. Several areas south of the city were also impacted as the river basins could not contain unprecedented runoff from the 1,000-year storms. US 21 bypass, Joe Jeffords Highway experienced water overtopping the road in several locations. This section of the bypass is just outside the southern limits of the study area. It conveys runoff from the central portion of the study area with very little elevation change. Frequent reports of flooding also occurred along sections of US 301, John C. Calhoun Boulevard.

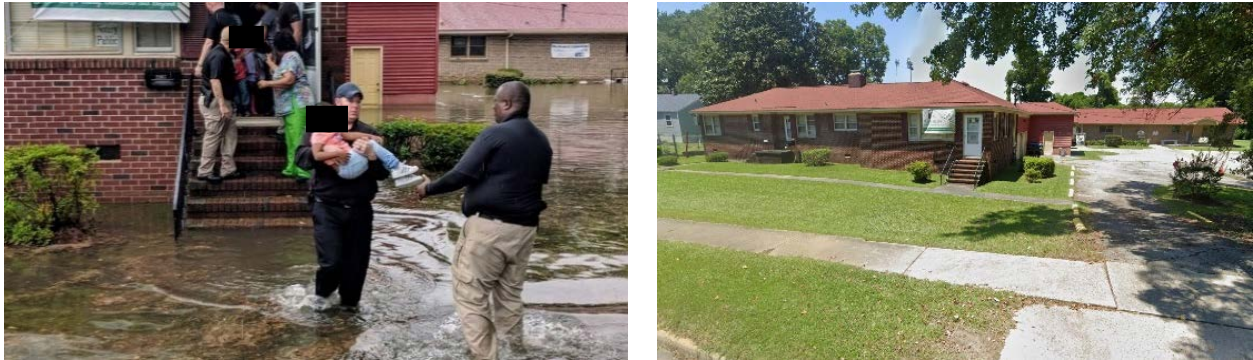
Figure 5. A Kids in Motion Learning Center flooding and during normal conditions

A Kids in Motion Learning Center, located near the intersection of Russell and US 21 Bypass also flooded due to proximity to Middle Pen Branch (**Figure 5**). Flooding across the study area caused numerous road closures and rerouting of traffic for emergency services, restricting access to distressed communities in the central and southern part of the study area.

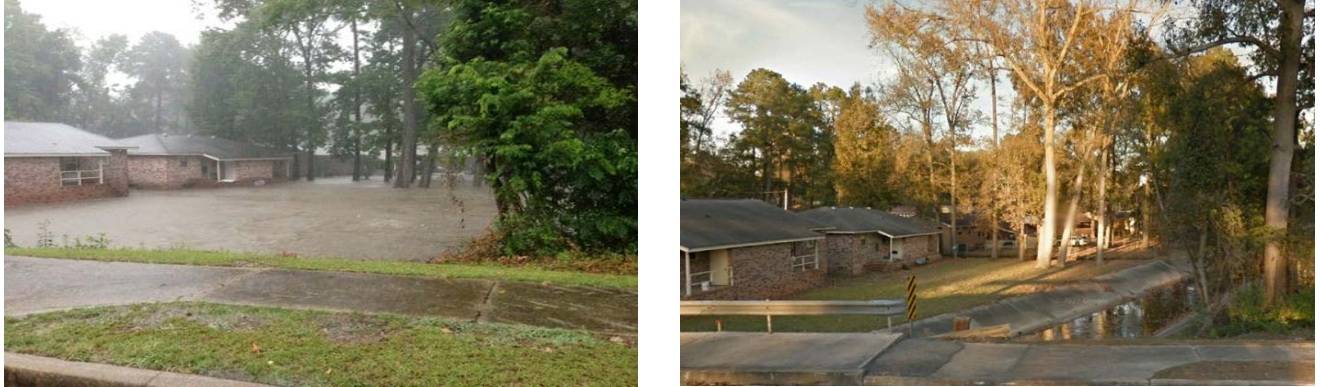
Figure 6. Sunnyside Canal during 2015 flood (left) and during normal conditions (right)

The location of Orangeburg also plays a factor in the deficiencies of the drainage infrastructure as sudden changes in elevation cause the system to flood low-lying areas in the southern portion of the study area. **Figure 6** shows Sunnyside Canal at Riverside Drive in normal and catastrophic flood conditions. The water level was 8 to 9 feet above normal conditions during the flood of 2015. Homes were inundated by flooding as the canal overflowed by nearly 3 feet. Though Sunnyside Canal is one (1) of the most critical drainage assets in the study area, the system does not have the capacity to accommodate runoff produced by this 1,000-year storm.

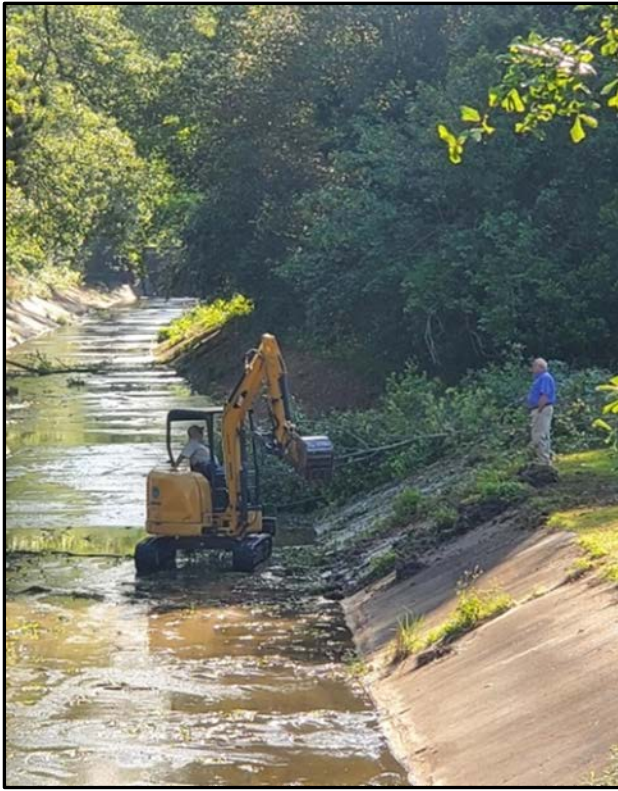
Figure 9. City of Orangeburg Public Works Department cleaning Sunnyside Canal

While performing the initial assessment of the reported sites, the City of Orangeburg Department of Public Works was observed cutting trees and removing debris from the Sunnyside Canal (**Figure 9**). This paved drainage ditch is over 3,400 feet long and carries water from the heart of Orangeburg to the North Edisto River, located on the City’s west side. This infrastructure is one (1) of the most important drainage assets in the study area.

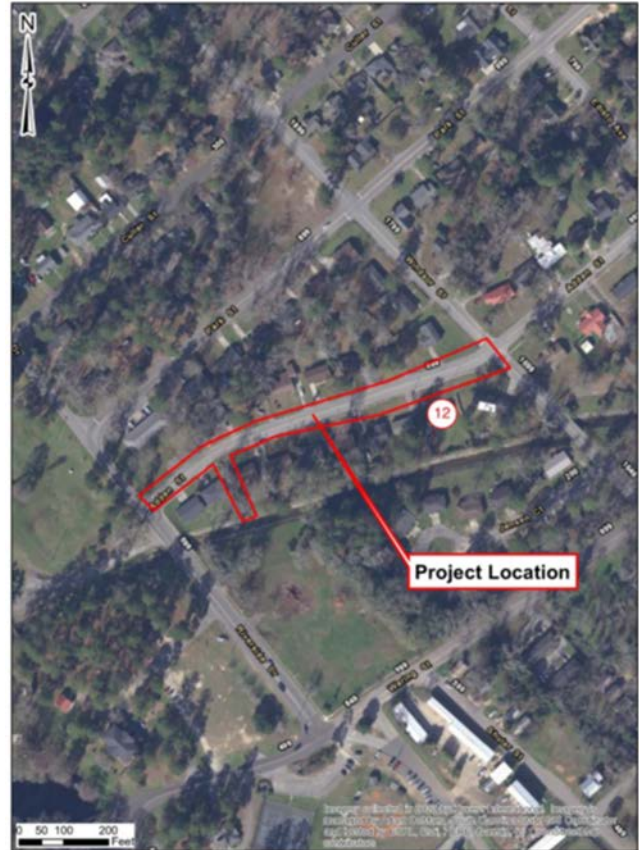
Figure 13. Adden St. Location

Figure 13 identifies the portion of Adden Street studied in this project. The existing conditions for its drainage system only accommodates a 2-to-5-year storm event. Residents report flooding during normal, everyday rain events and major downpours. The runoff from Windsor Street overtops the valley gutter along Adden Street, trapping water on residents' property. Water from Riverside Drive and properties on the north side of the neighborhood converges and ponds at the low point of Adden Street. This ponding consistently causes road closures and rerouting of traffic. Some residents are not financially able to address standing water or remove it from crawl spaces before permanent damage is caused to their homes. The standing water on private property has caused some houses in this community to be abandoned.

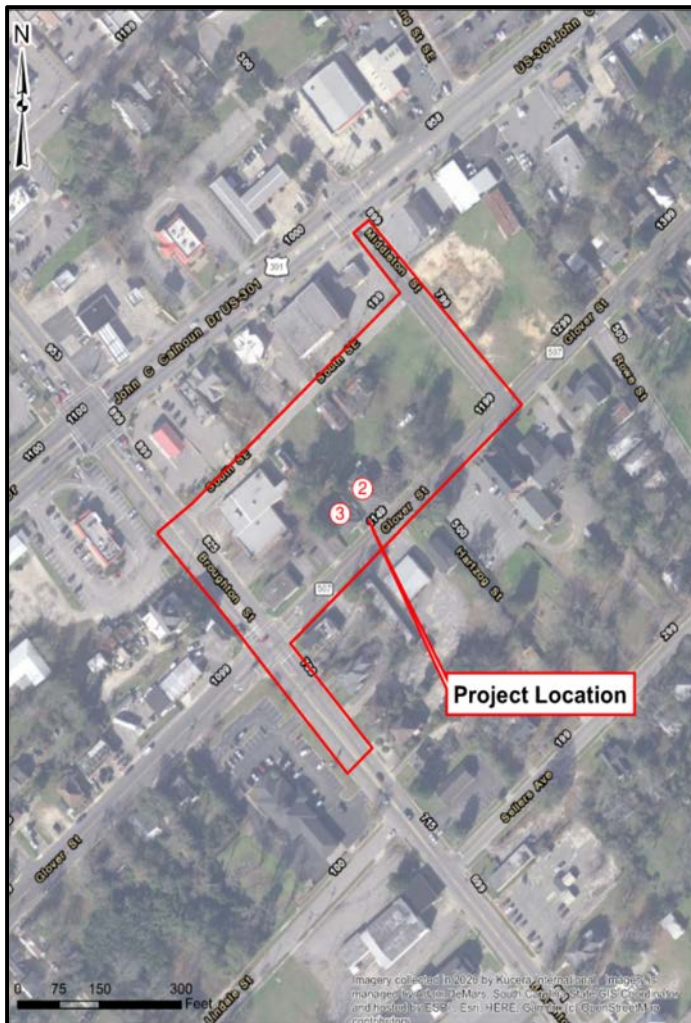
Figure 16. Glover St. Location

Figure 16 identifies the portion of Glover Street studied in this project. **Glover Street** is centrally located in the City of Orangeburg, just two (2) blocks south of US 301, John C. Calhoun Boulevard. The existing conditions do not provide adequate drainage for a 10- or 25-year storm event. Water sheds from commercial facilities on John C. Calhoun Boulevard across South Street and ponds behind the houses facing Glover Street. The water then flows through the properties on Glover Street, routinely covering the entire roadway. Complaints of routine flooding were filed by two (2) residents on Glover Street during the public information meeting. Residents deal with standing water in their yards and the roadway during heavy downpours. Recommended improvements will upgrade the existing system by adding catch basins, manholes, and new reinforced concrete pipe.

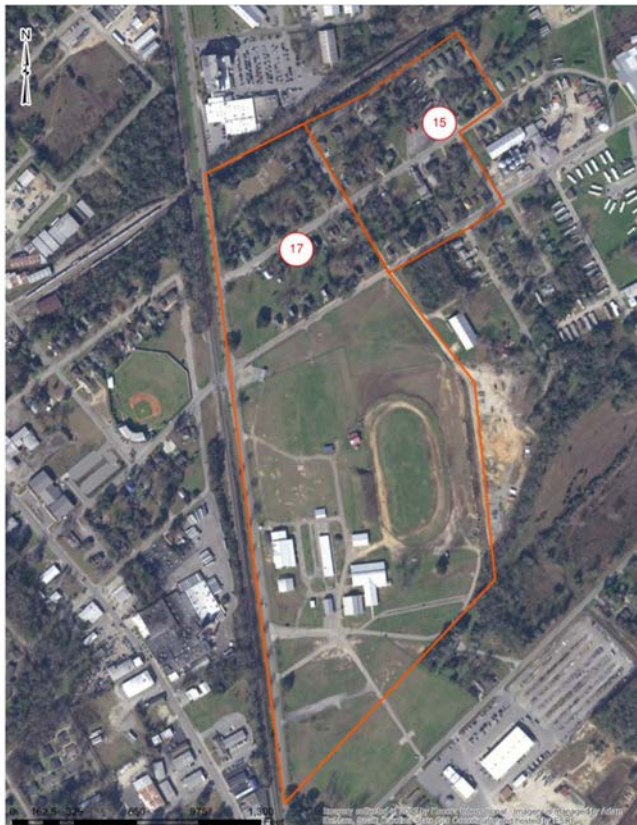
Figure 22. Bayne St. Location

Figure 22 identifies the portion of Bayne Street studied in this project. **Bayne Street** is a two-lane state-owned road. This site is located in the southern part of the City of Orangeburg, south of the railroad and just north of the county fairgrounds. This area was developed as a mill village to support the neighboring plants and other agricultural mills located within walking distance of the community. Two (2) complaints (358 and 519 Bayne Street) were addressed at this location as they both merged into the same drainage system.

The existing drainage infrastructure serving Bayne Street is undersized and outdated. Residents report numerous areas of flooding on roadways and private property. The Study Team observed terracotta pipes at several locations during initial field inspections and surveys. Flooding occurs during 10- and 25-year storm events as the existing system is not designed to accommodate runoff for these storms.

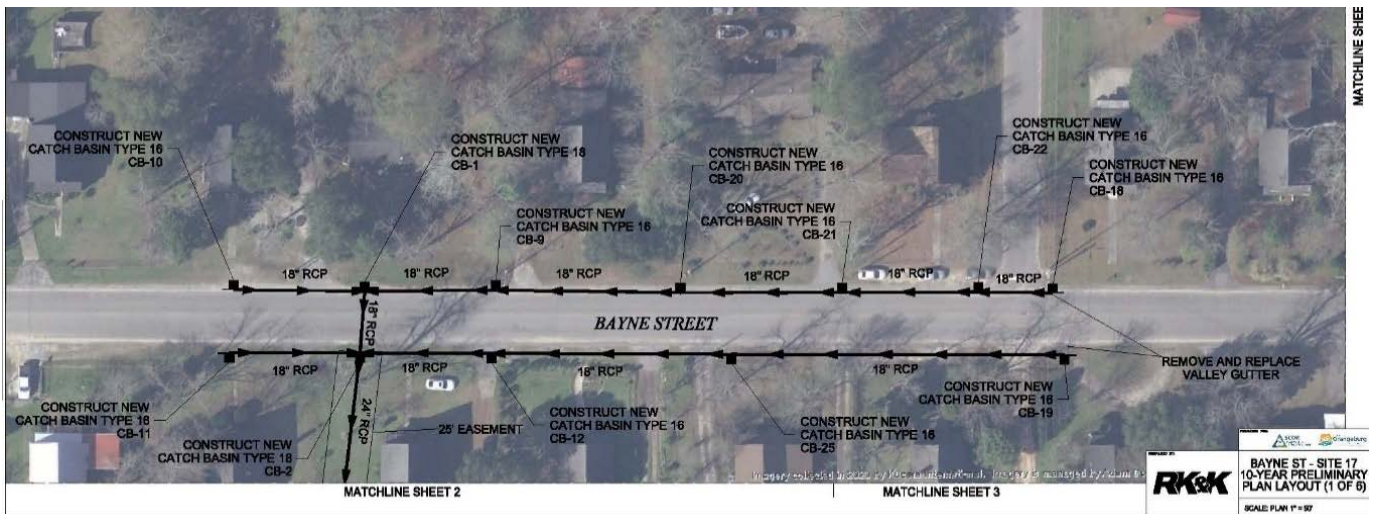
Figure 24b. Bayne Street – Proposed Improvements: Catch Basins

Site 17, in the 25-year design, adds 2,760 linear feet of new pipe and 24 catch basins. The improvements also require upgrading the existing valley gutters on Bayne Street to route water into the new catch basins. An easement will be required to move water from Bayne south to Whaley Street. New catch basins, pipes and reconstructed curb and gutter will be required on Whaley as the water crosses under the travel way through another easement to connect to the existing system on the County Fairgrounds. Coordination with the county will be required for the construction and maintenance of the recommended upgrades.

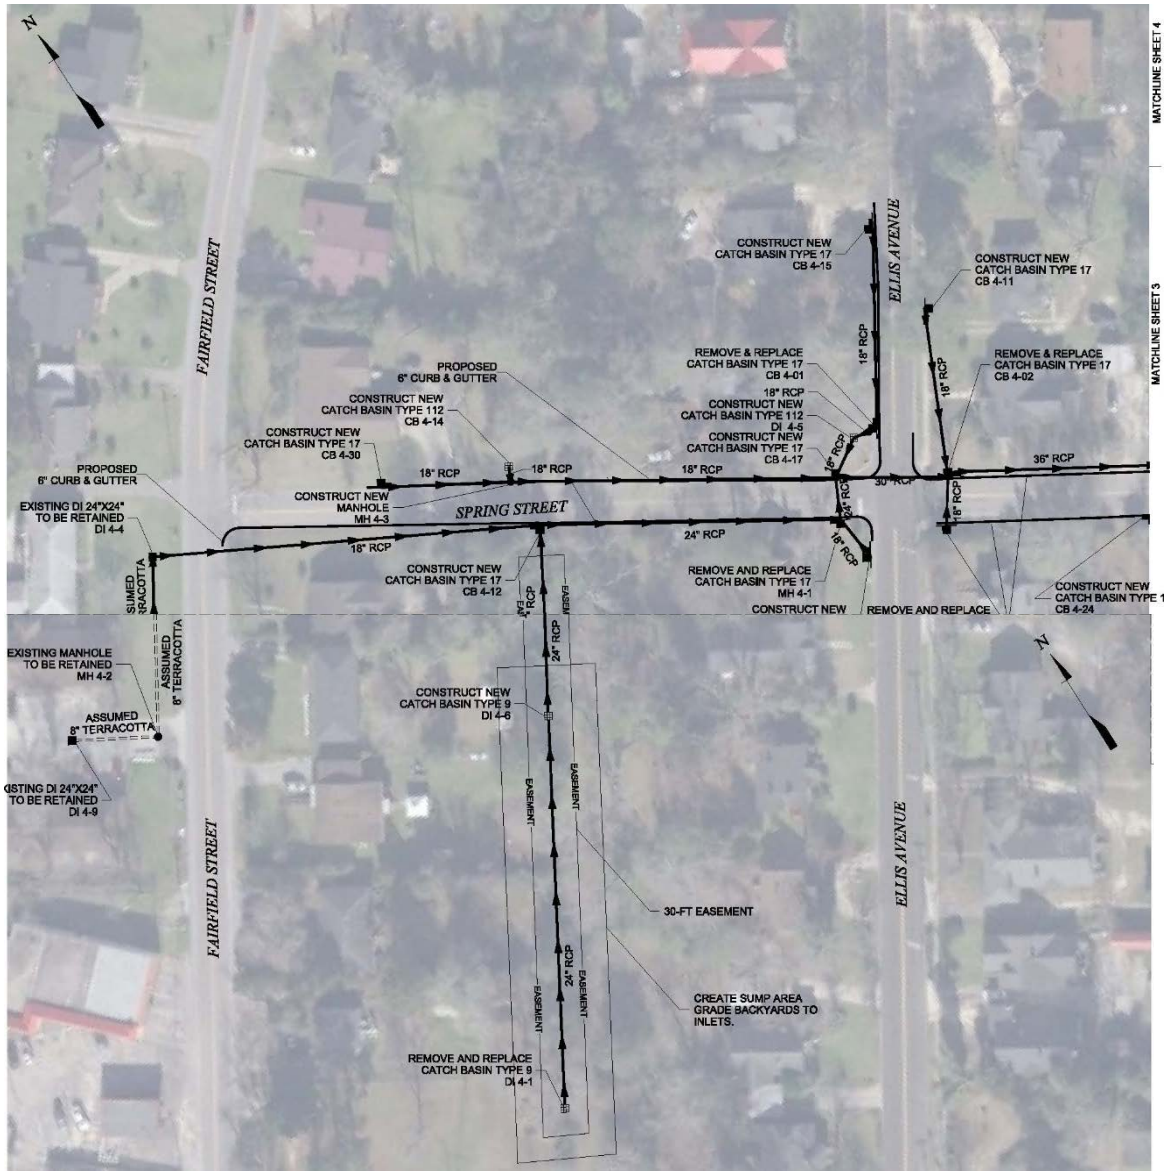
Figure 27. Ellis Avenue - Proposed Improvements

The proposed improvements to this system will require 1,514 linear feet of new pipe and 19 new catch basins. Recommended upgrades depicted in **Figure 27** include replacing the failed drainage system that lies parallel to Ellis Avenue and Fairfield Street with 24-inch reinforced concrete pipe and new catch basins. This work will require an easement to remove and upgrade the failed system surrounded by privately owned property to accommodate the increase in volume to the system. Easements will also be required at the end of the project. The portion of the system on Spring and Eutaw Street will require upgrading to install the upsized pipe.

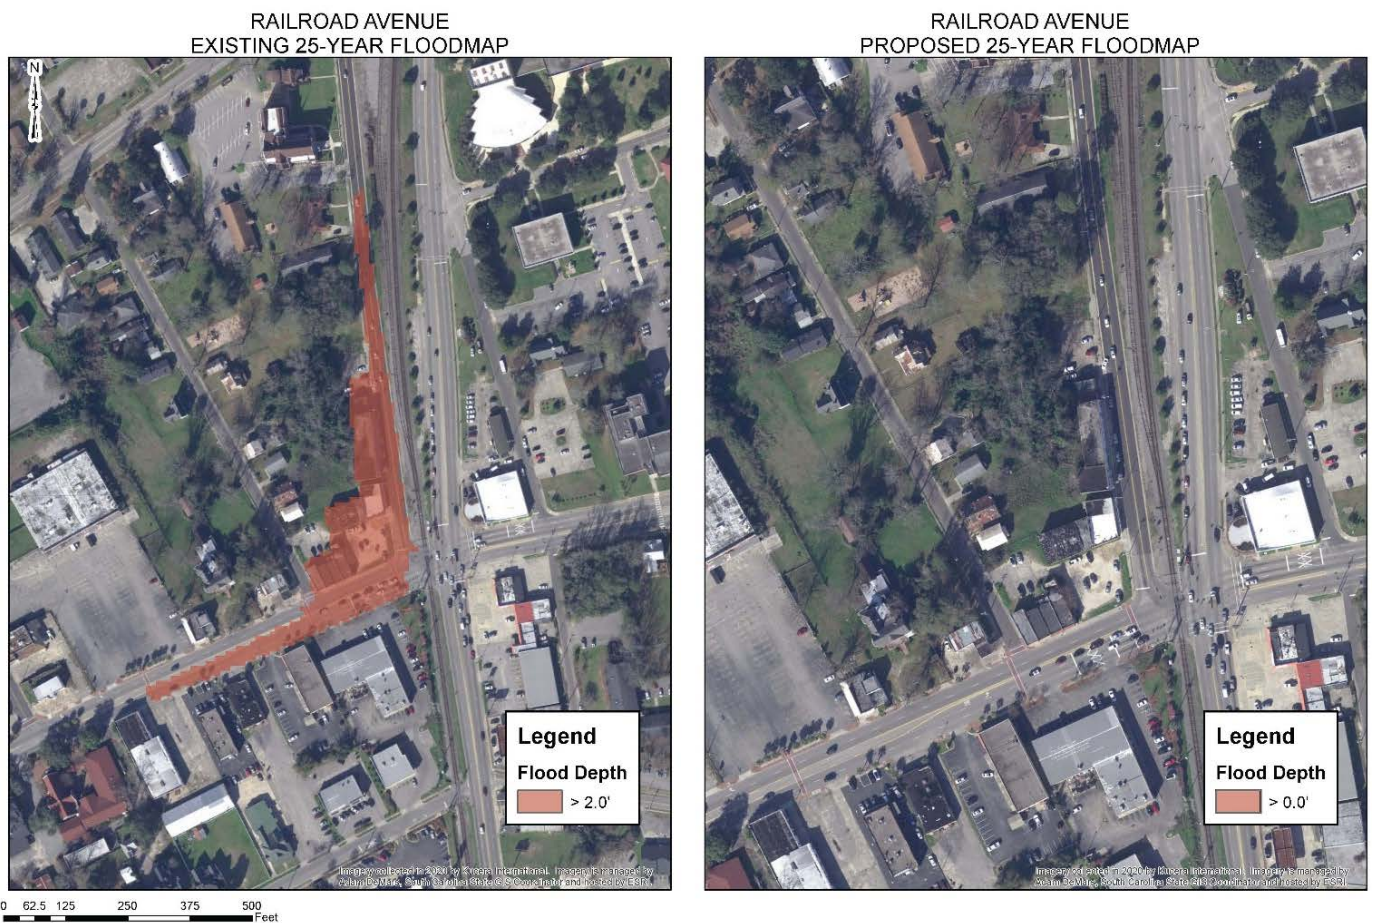
Figure 29. Railroad Corner – Existing and Proposed 25-Year Floodmaps

Figure 29 provides illustrations of the existing and proposed flood conditions during a 25-year storm event. The map of the existing condition clearly highlights the areas along Boulevard Street and Russell Street that experience flooding during heavy rains. The proposed improvements eliminate flooding for the 25-year storm event. This project site is located on a crest and sheds runoff north to Treadwell Street and south down Magnolia Street. It is important to note that water also ponds opposite Railroad Corner on Magnolia Street and other locations south of Railroad Corner. Upgrading this drainage system will reduce incidents of flooding further at these locations and provide relief to adjacent sections of John C. Calhoun Boulevard.
