1. Executive Summary

City of Orangeburg Stormwater Drainage Study

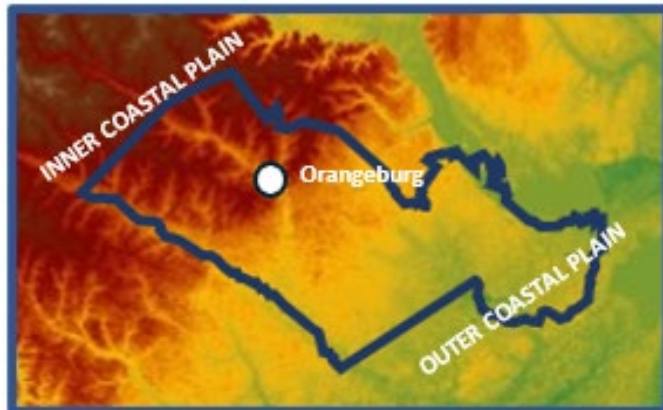
Figure 1 – Inner and Outer Coastal Plains

The study area is located at the eastern end of the Inner Coastal Plain as it transitions to the Outer Coastal Plain. The terrain in the western portion of the county sheds runoff into the North and South Edisto Rivers. The South Edisto River serves as the southern border of the county while the North Edisto River flows parallel about 13 miles to the north. The

Orangeburg County lies in a transitional geographic area of the state as illustrated in **Figure 1**.

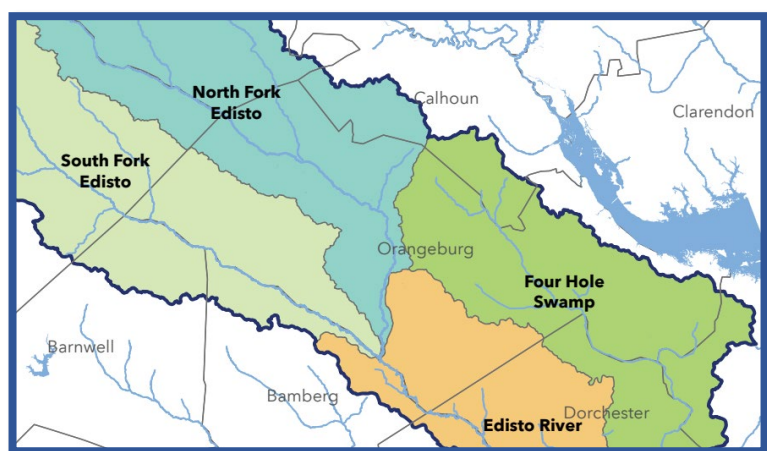
Figure 2. Orangeburg County River Basins

The towns of Springfield, Neeses, Livingston, North, Woodford, Norway, and Neese seldom report flooding issues, as the North and South Edisto River basins easily accommodate runoff from these communities. The towns sit well above flood plains, with elevations ranging from 300 to 400+ feet above sea level. The elevations change quickly protecting these communities from flooding.

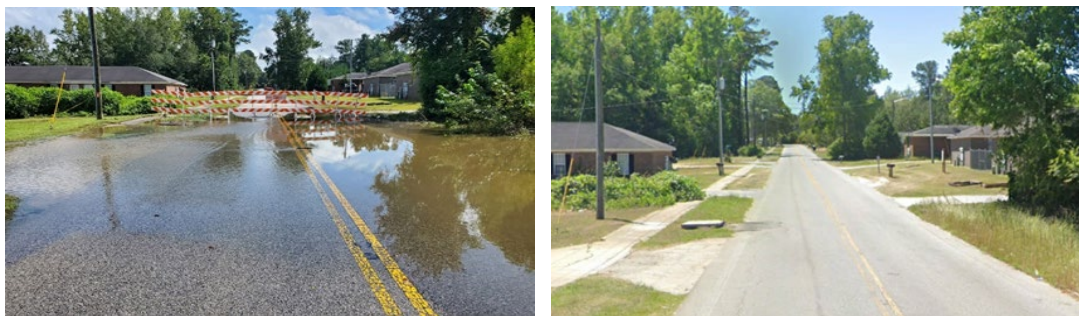
Figure 3 – Before and After Flooding on Kings Road, Orangeburg

The eastern part of Orangeburg County is the lowest portion of the county, by elevation, reporting the most problems with flooding. The area east of Interstate 26 is home to Four Hole Swamp bordering Lake Marion to the north. The towns of Elore, Santee, Vance, Holly Hill and Eutawville are all located in this section of the county. These towns experience frequent and persistent drainage issues. The terrain is exceptionally level. The elevation changes from Santee to Eutawville range from 130 ft to 113 ft above sea level. The Town of Holly Hill sits at approximately 100 ft and is located directly south of the Horse Range Creek Watershed. Due to the low and flat terrain, drainage accumulates quickly in this large basin during heavy rains. With no viable drainage outlets entire communities are inundated with flood waters. Channels are often used to move water to creeks and streams in this part of the county, but it is difficult to create the capacity required to carry the runoff for long distances. The result is persistent flooding with no cost-efficient methods of substantive relief.

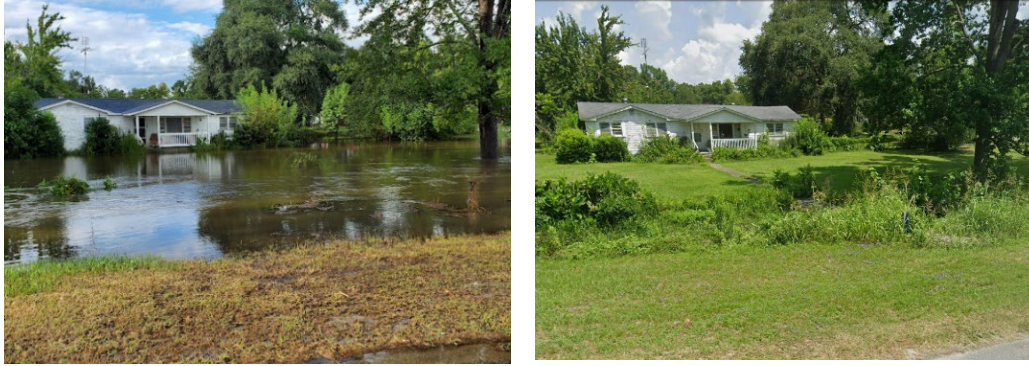
Figure 4 – Before and After Flooding on Tupelo St, Bowman

During the Historic floods of 2015 low lying areas of Orangeburg County were inundated by flood waters. Many of the communities in eastern Orangeburg County (Orangeburg, Bowman, Holly Hill and Eutawville) were flooded for days as runoff from the midlands and backwater from Four Hole Swamp and the Horse Range watershed covered large portions of eastern Orangeburg County. The county experienced more than 16 inches of rain in a 48-hour period in some areas. Adding to the catastrophic local rain event, the midlands received even more precipitation. The swollen rivers just north of Orangeburg then conveyed even more rainwater from the rolling terrain of the midlands into the level outer coastal plains of Orangeburg County.

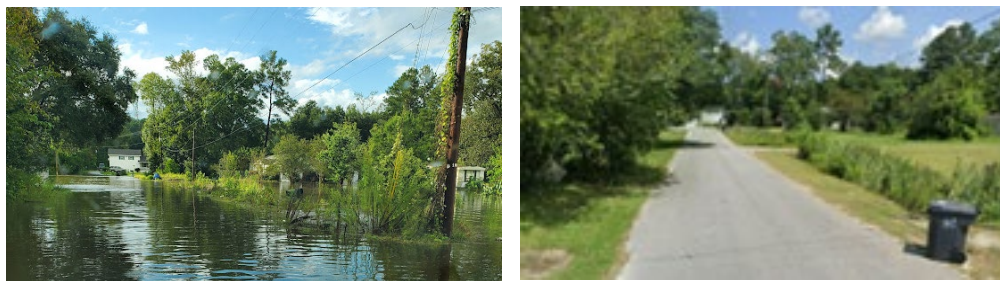
Figure 5 – Before and After Flooding on Poplar St, Bowman

Photographs below provided Orangeburg County staff, and the Times and Democrat show the severity of the flood waters on these small communities. Some residents used boats to navigate their communities and assist stranded neighbors for days after the storms. Some elderly residents were rescued from their homes and taken to safety while standing water hindered emergency services from reaching some areas in their jurisdiction.

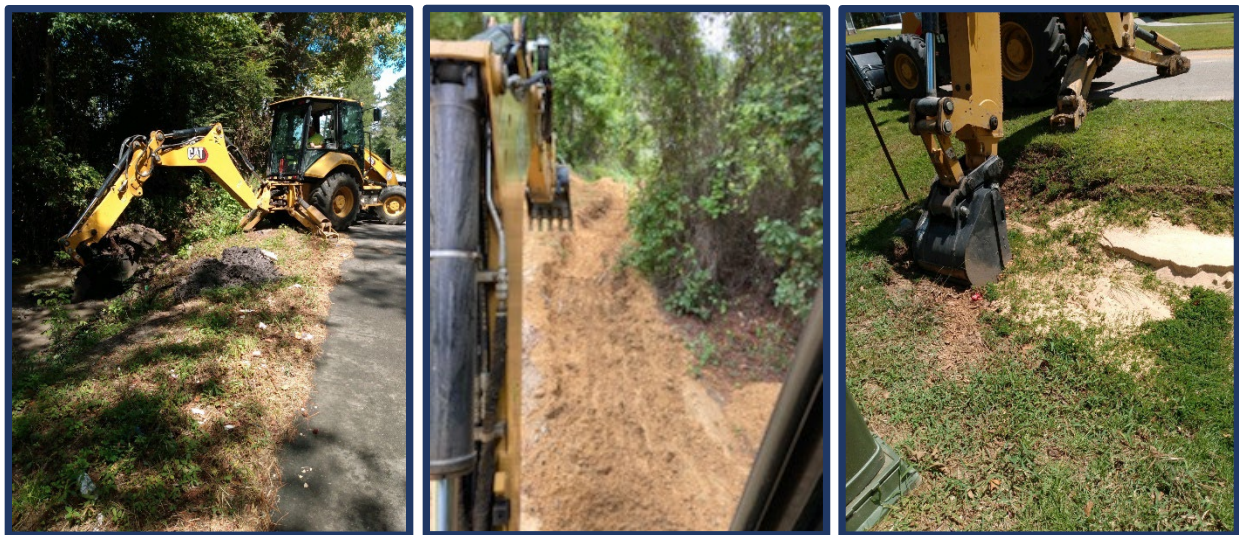
Fig 9 Public Works perform Maintenance on county ditches

Figure XX shows the Orangeburg County Public Works addressing drainage requests in the central and eastern parts of the study area. Each area shows shallow ditches that have filled with silt. County and SCDOT Maintenance crews are constantly responding to these types of requests to provide relief from flooding to residents.

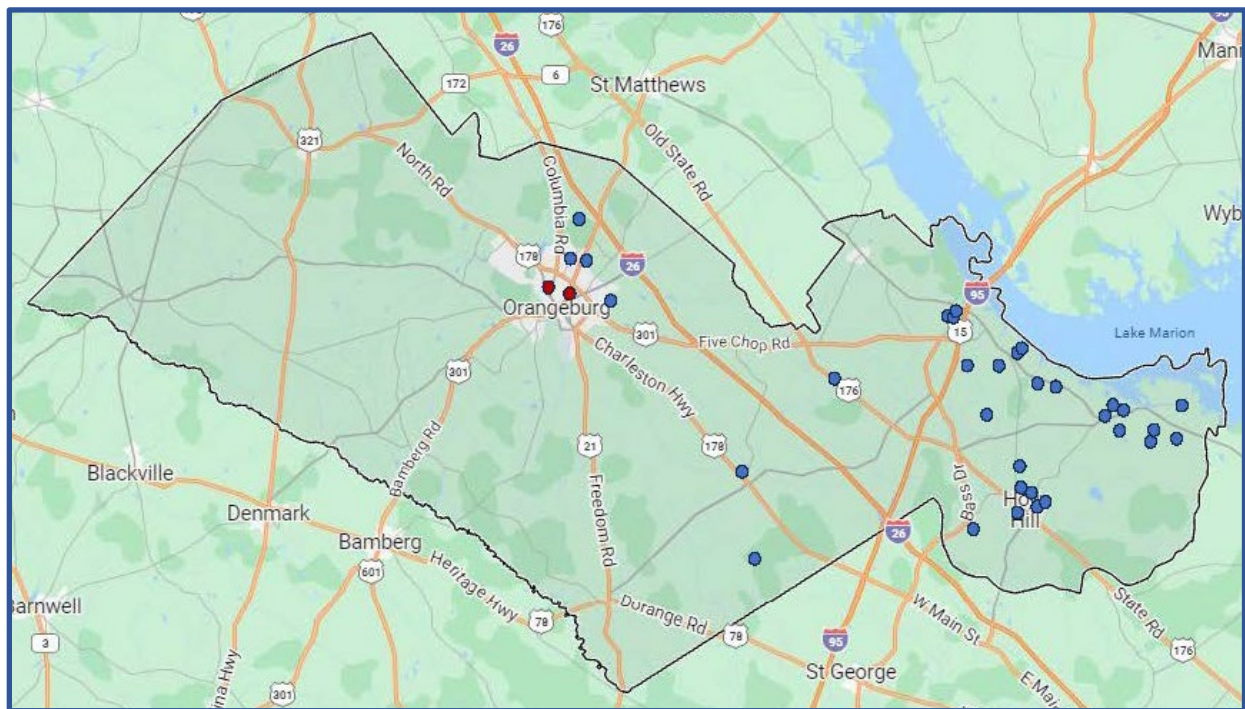
Fig 10 – Comprehensive Projects Locations Map

a. Projects Considered A total of 44 locations were reported during the 2 public information meetings and comment periods for this study. Two locations, identified in red on the map below were referred to the City of Orangeburg, but not recommended for improvements. Three sites were reported by multiple residents, reducing the number of locations investigated to 35. As **Figure 10** illustrates the sites investigated by the study team, several locations were located just outside the City of Orangeburg. The remaining sites were located from Bowman east to the towns of Santee, Holly Hill, Vance, and Eutawville. Several of the sites investigated were referred to SCDOT as maintenance issues. Due to the low and level terrain, many of the remaining sites did not present viable options for repair. For example, there were locations in Eutawville that did not have natural outlets for drainage. To remedy flooding in these areas would require construction and maintenance of trenches for thousands of feet to route the water to lower areas. Other sites were adjacent to flood plains which made them naturally susceptible to flooding with no cost-efficient means of improving the condition.

Table 5 is a comprehensive list of the projects considered for this study. Only the sites investigated by the team are identified below, corresponding to the location on the map above.

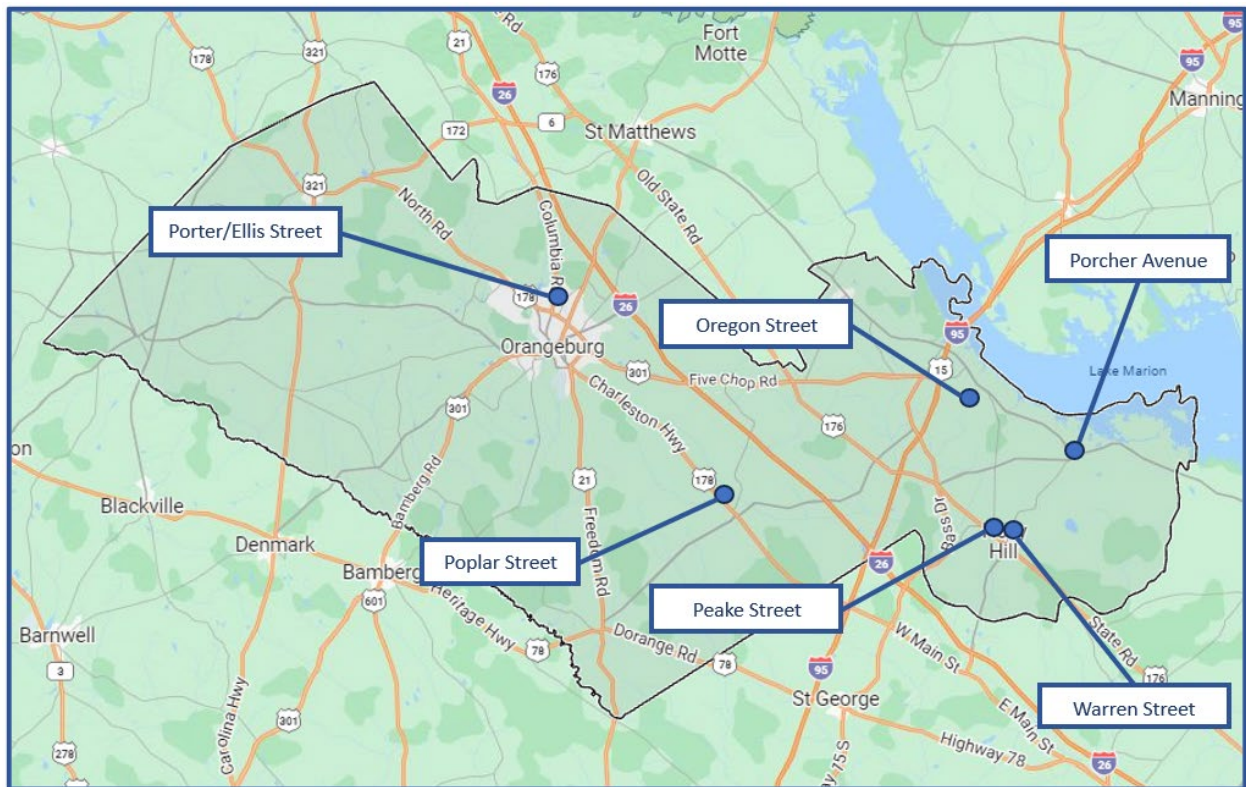
Fig 11 Location of 6 Sites Analyzed

Figure 11 is a location map for the 6 projects selected for analysis. With the exception of Porter/Ellis Street in the City of Orangeburg, the remaining 5 locations were in central and eastern portion of Orangeburg County. All the sites were located on state-maintained roads owned by SCDOT. Because these locations had existing drainage infrastructure, all sites were considered grey projects. Recommended improvements upgraded or improved existing structures. For one of the 6 sites, Porcher Avenue, an option to construct a drainage pond, but the option was not chosen because it produced a higher benefit cost ratio. To standardize

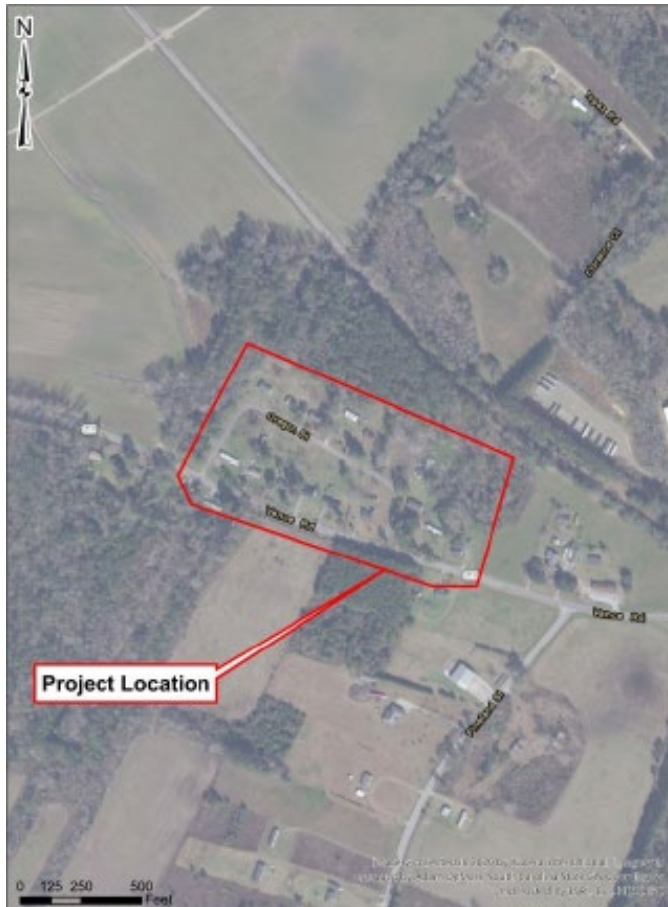
Fig 12 - Project Location - Peake St.

Oregon Street is a 2-lane road, serving a rural residential community. The project site is located just west of Vance. This small town sits in the eastern portion of Orangeburg County, less than 2 miles south of Lake Marion. The location was reported to the study team during the second public information meeting by the Mayor of Vance. Residents report flooding in this vicinity of Oregon Street during heavy rains.

runoff. The system is relieved by a 24-inch diameter crossline under Vance Road, discharging water to a wooded area to the south.

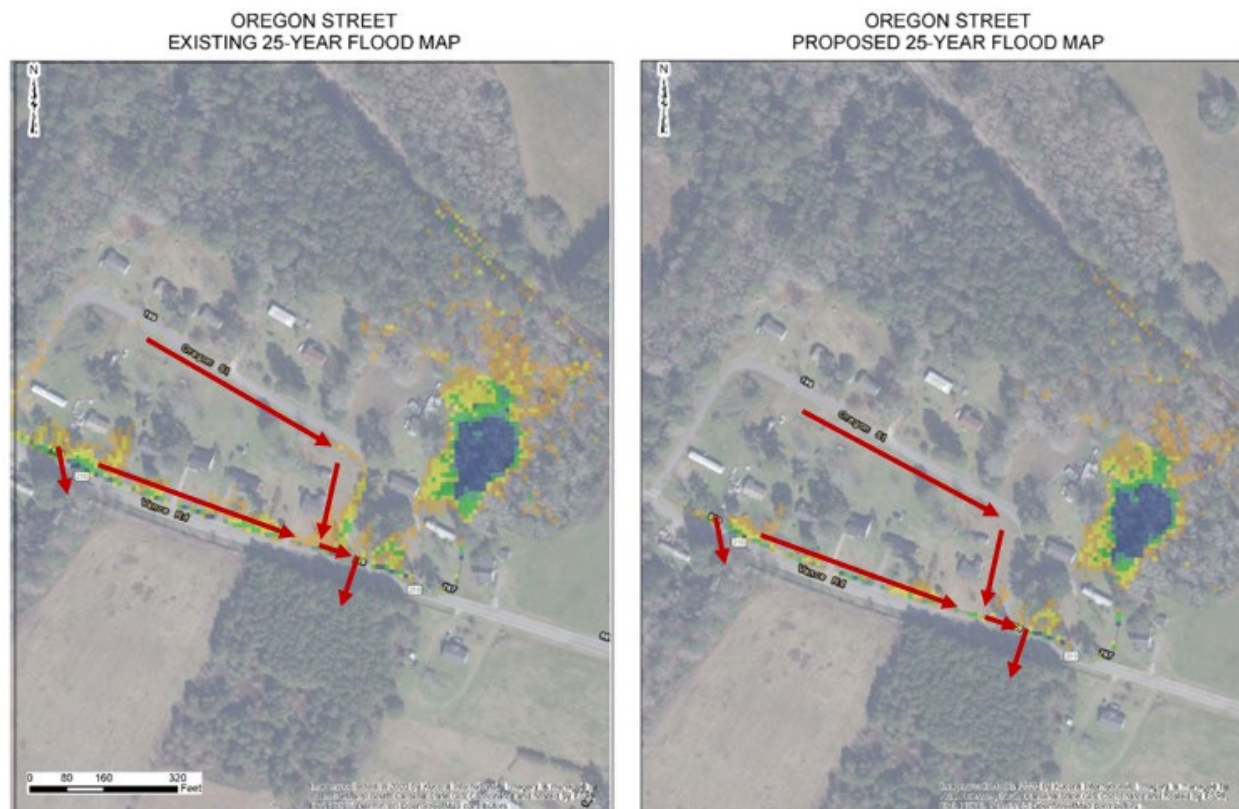
Fig 13 - Existing and Proposed Flood Map - Oregon St.

The study team calculated the benefit of proposed improvements and the cost to construct the

improvements. The resulting **benefit cost ratio** was 0.71, which falls below the minimum requirement of 1.0. A total of 14 homes received a benefit from the recommended improvements as well as upgrades to 3 SCDOT drainage structures for a calculated benefit of \$643,931. The cost to construct the project was estimated to be \$900,862. A list of the impacted homes can be viewed in (chart &.7.1). Due to the low benefit cost ratio, this project is not recommended to compete for funding through CDBG mitigation. However, funding and resources from local stakeholders could be used to be applied to provide relief to residents in this community.

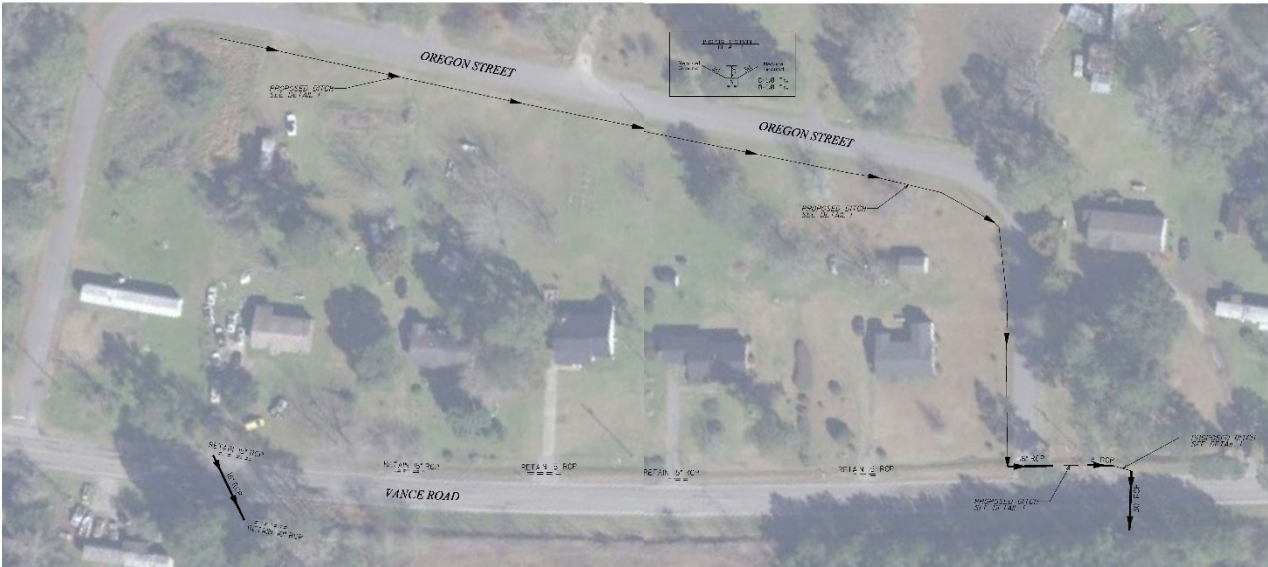
Fig 14 Proposed Plans – Oregon St.

While this project reduces flooding for residents, it can be constructed with minimal **risks** and easily maintained. This project could be constructed in 3 to 4 months. With the replacement of 3 crosslines and widening of the existing ditch lines, utility coordination would be critical to the success of this project and the contractor's ability to adhere to a timely construction schedule. Figure 7.3., the proposed project plans, demonstrate the simplicity of the recommended improvements. (A set of plans is located in the appendix of this report.) The long-term risks of

the existing condition are public safety concerns, due to roadway flooding on Oregon Street and the long-term effects of water standing on residential property. The proposed project eliminates flooding in the 25-year storm event. **Table10** summarizes the project risks.

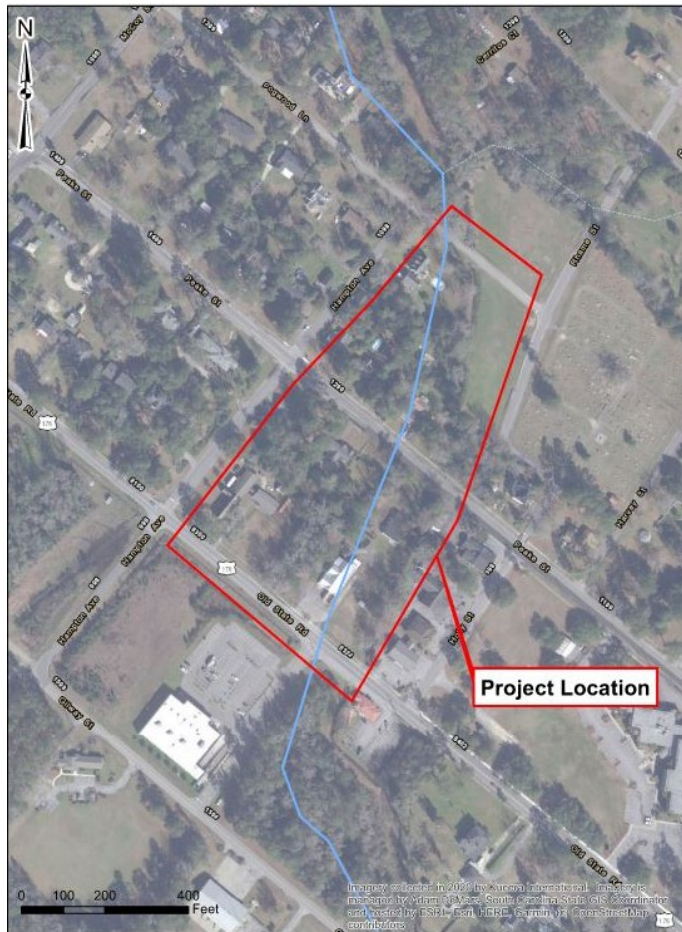
Fig 15 Project Location - Peake St.

Peake Street is in the town of Holly Hill, located in eastern Orangeburg County. Reports of flooding at this location were received from Orangeburg County staff and residents during the second public information conducted for this study. In the current condition, an undersized culvert conveys water from Home Branch Creek under Peake Street. This creek flows south through Holly Hill serving a drainage area of over six square miles to the north. Water backs up at the current Peake Street site during 10-year storm events. The crossing is currently served by three 48" reinforced concrete pipes.

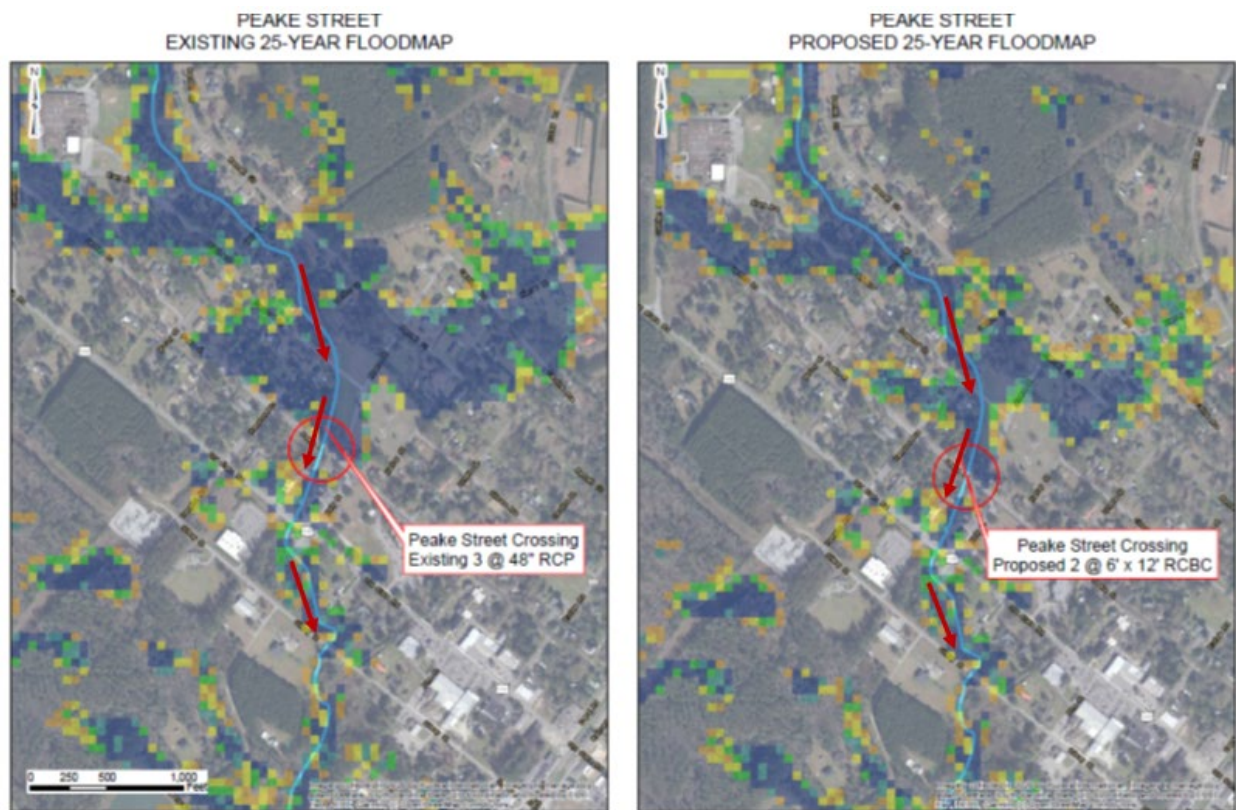
Fig 16 Existing and Proposed 25-year Flood Map - Peake St.

the city limits and further upstream by replacing the existing reinforced concrete pipes with 2 box culverts. This upgrade conveys water produced in the 25-year storm. The reduction in flooding is illustrated in **figure 15**, the existing and proposed 25-year flood maps. The solution does not fully resolve the issue of flooding, as the capacity of culverts downstream from Peake Street are constricted to avoid flooding the City's wastewater plant. A close examination of the existing and proposed flood map does show a significant reduction in flooding in the areas upstream of the project site.

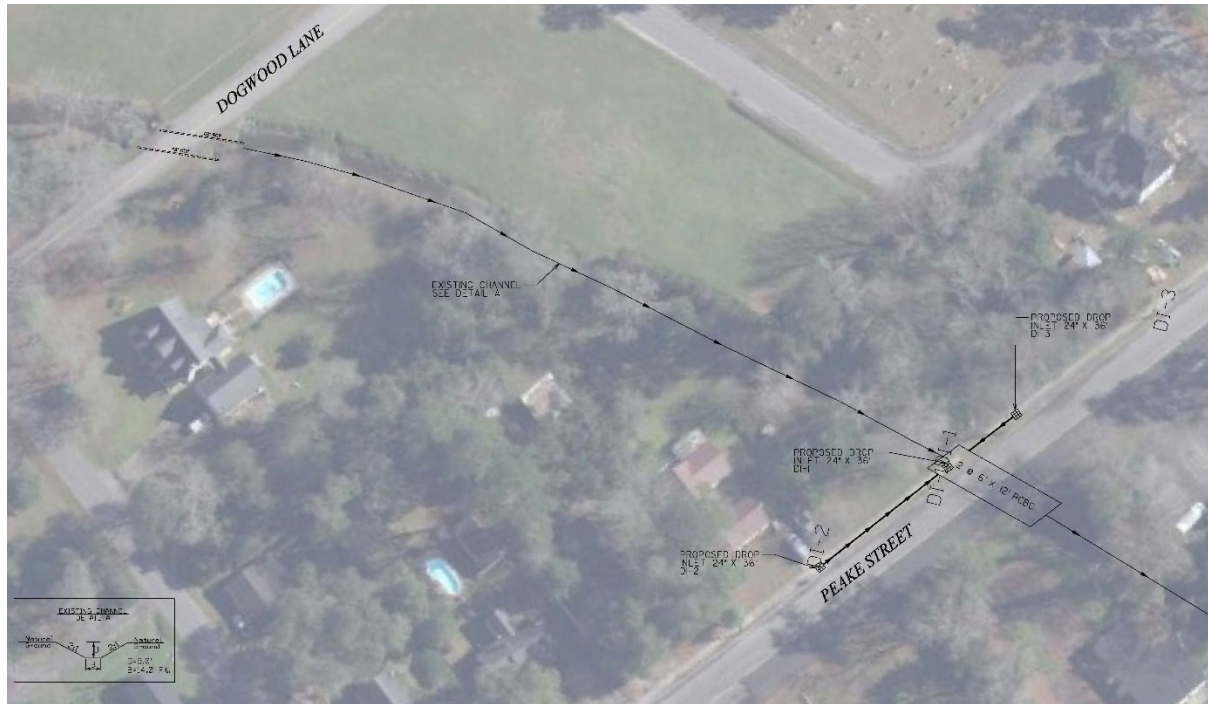
Fig 17 Proposed Project Plans - Peake Street

The study team recommends upgrading the existing RCP culverts with 2 (6'x12') concrete culvert pipes. A diagram of the proposed improvements is illustrated in **figure 17**. The new box culvert widened channel and new drop inlets along the north shoulder of Peake Street provide immediate relief from flooding for the town's residents.

The solution, however, presented a new risk. The capacity of the system is limited by the location of the City's wastewater facility just south of the project site. No other options were explored for this location, as new right of way was not available and rerouting the stream was not deemed a viable option. The risk table below summarizes the impact of constructing the recommended improvements. While this project produced an acceptable benefit cost ratio, and improved the towns drainage issues, the increased runoff downstream presents and increased risk of flooding to the town's wastewater facility.

The proposed construction improvements replace an existing double barrel culvert. The project would require an encroachment permit from SCDOT. A NEPA document would not be required but could be considered to inform the public of the impending improvements and benefits of the project prior to construction. Because the project is located in a flood zone, a Conditional Letter of Map Revision (CLOMR) will be required from FEMA. Additionally, utility relocations may be necessary as the proposed culvert is larger than the existing pipes.

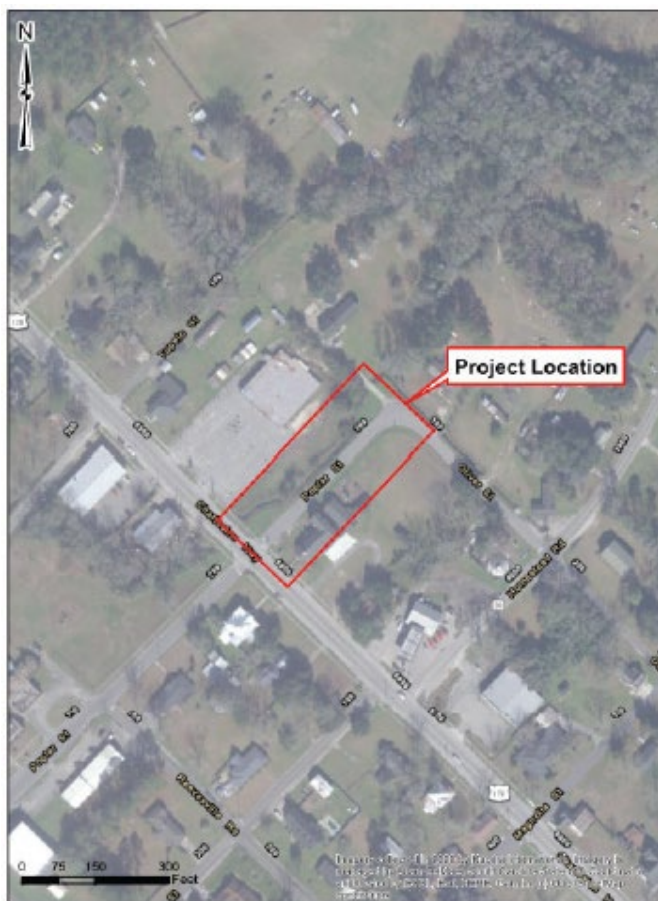
Fig 18 Project location – Poplar Street

Poplar street is located in the town limits of Bowman. This Town is located in central Orangeburg County. The site reported to the study team for review is a culvert under a private driveway at the corner on Poplar Street and Oliver Street. The project is located along Even Branch Creek, which is designated as a FEMA Zone AE floodplain. The stream serves as the primary drainage system for the Town of Bowman connecting to Cow Castle Creek on eastern side of the town.

The study team analysed Even Branch from the existing culverts under US 178, Charleston Highway to the culvert located at Homestead Road. Both locations have 6x6 box culverts to convey water through the Even Branch. However, the existing culvert located between the 2 boxes is a 54 inch reinforced concrete pipe. The size of this culvert creates a pinch point in the system causes water to back up on the inlet side on of the culvert flooding Poplar and Oliver Street, The adjacent homes and the neighboring church.

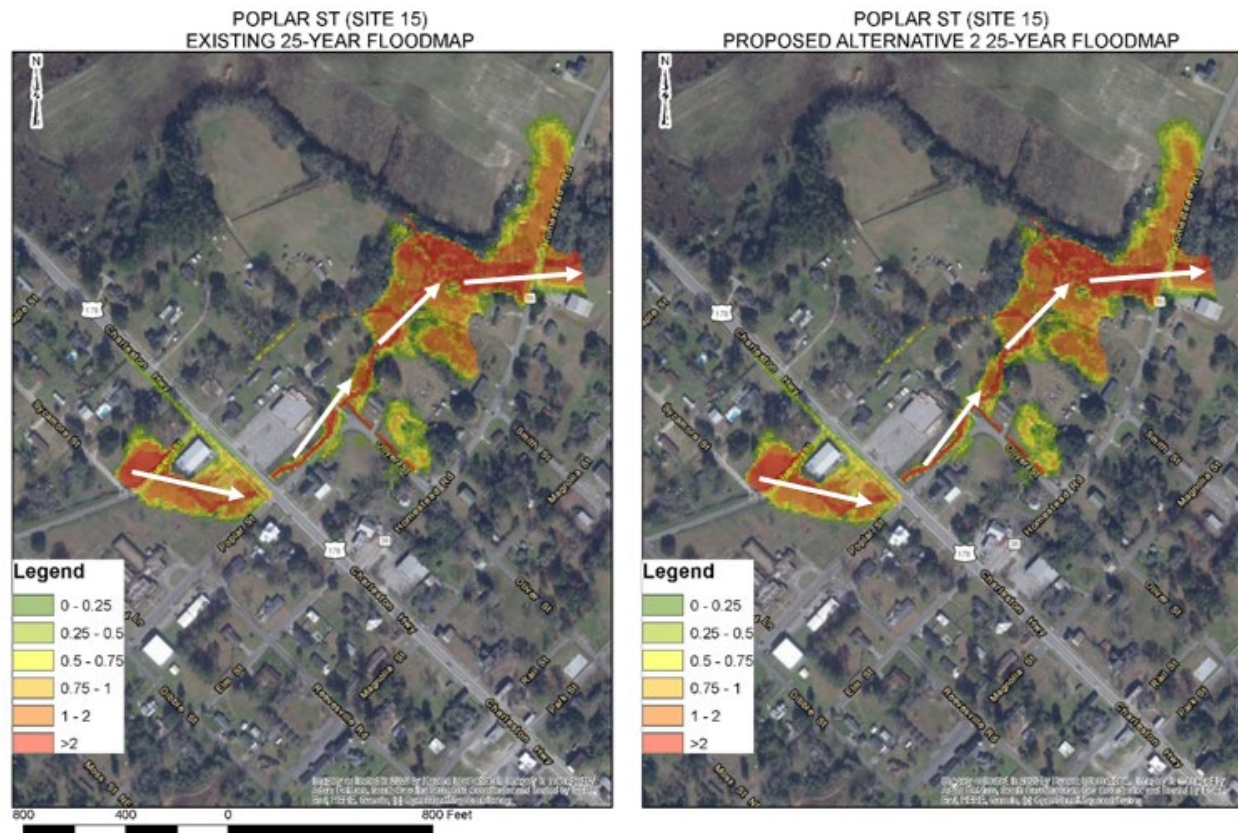
Fig 19 Existing and Proposed Flood Map - Poplar St.

In viewing the existing and 25 year storm flood maps, replacing the culvert reduces the impact of flooding in the vicinity of the project site. It is important to note, that SCDOT was contacted by the study team. Local officials with the agency have worked with County and Town Administrators to address drainage issues in the Town of Bowman. Analysis shows that upsizing the culvert at Homestead Road could greatly decrease the back water in the study area. Since there are no homes located between Homestead and Even Branch's confluence with Cow Castle, this would be a viable option to provide additional relief to the town and the proposed project site on Poplar Street.

flooding of the roadway. Additional riprap is also recommended with the improvements to reduce scour at bend of the chanel. **Alternative 2** also replaces the existing culvert with a 10x6 culvert and relocates the two utility lines that current obstruct flow on the inlet side of the existing culvert. This will eliminate overtopping in the 10 year event and remove the utilities

from the flow line of the stream. **Alternative 3** creates a new driveway at the end of Tuepelo Street to access the residence on Poplar Street from the rear of the property. If approved, this option would create a no-build scenario and the undersized culvert could be removed to create a free flow condition.

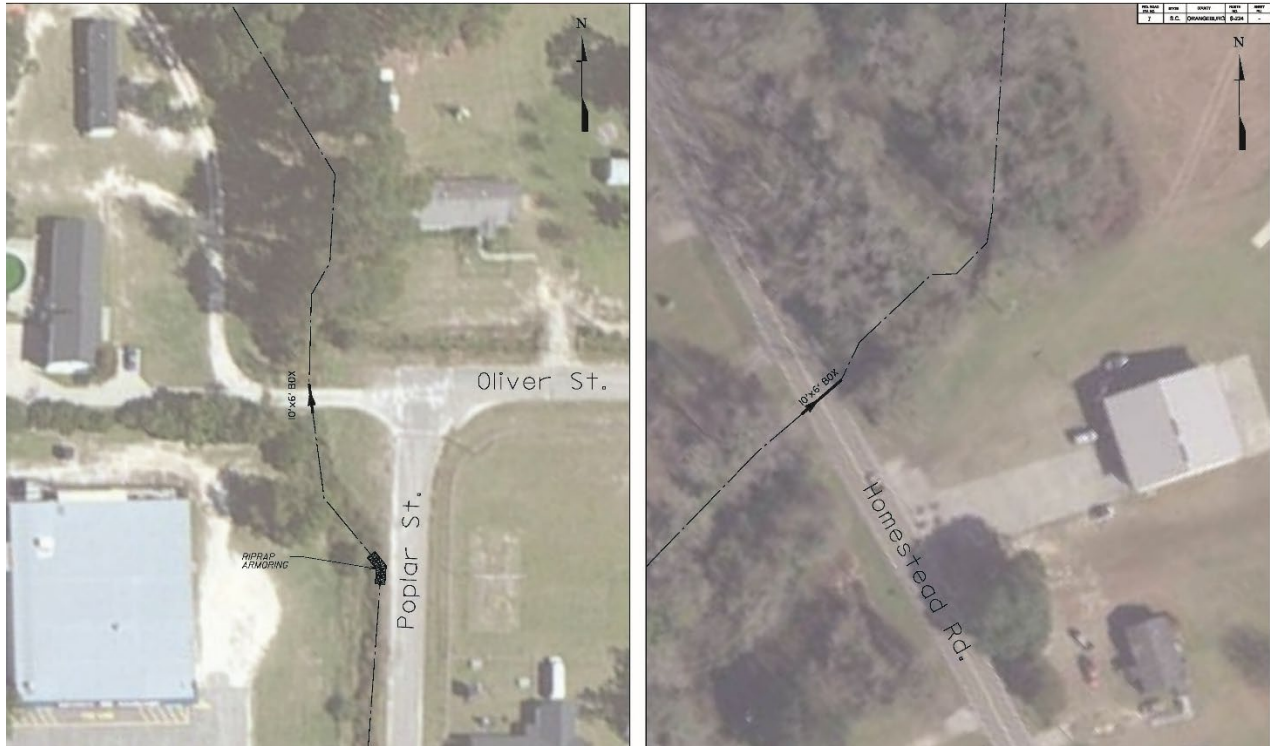
Fig 20 Proposed Project Plans - Poplar Street

The Study Team recommends Alternative 1. The resulting project will eliminate roadway flooding in the 10 and 25 year storm events and require relocation of the utilities to by owners. The **benefit cost ratio** for this project is 1.18. Estimated costs of the project is \$212,774 with a calculated benefit of \$251,774. With addition resources from Orangeburg County and SCDOT, the project BCA could be increased and flooding could be reduced further.

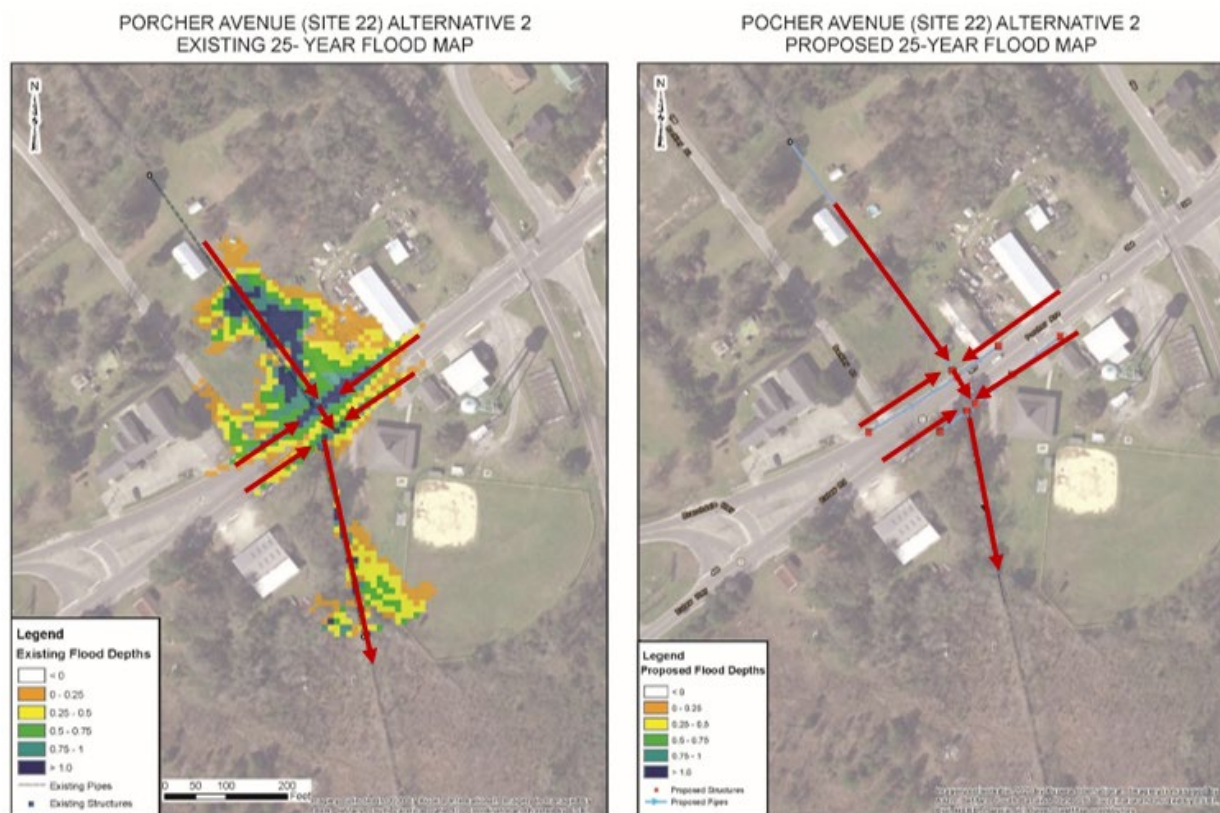
Fig 22 Existing and Proposed Flood Map – Porcher Avenue

Figure 7.1 illustrates the flood reduction resulting from the recommended improvements. In the 25-year flood event, the new system completely eliminates roadway flooding and a large area of standing water to the north of the project.

The study team recommends Alternative 2. This option produced a BCA of 2.14 which was slightly higher than Alternative 1 at 1.88. While both options eliminate flooding below the 25-year event, the cost of purchasing property to construct the pond and the required maintenance cost made Alternative 1 a less desirable option.

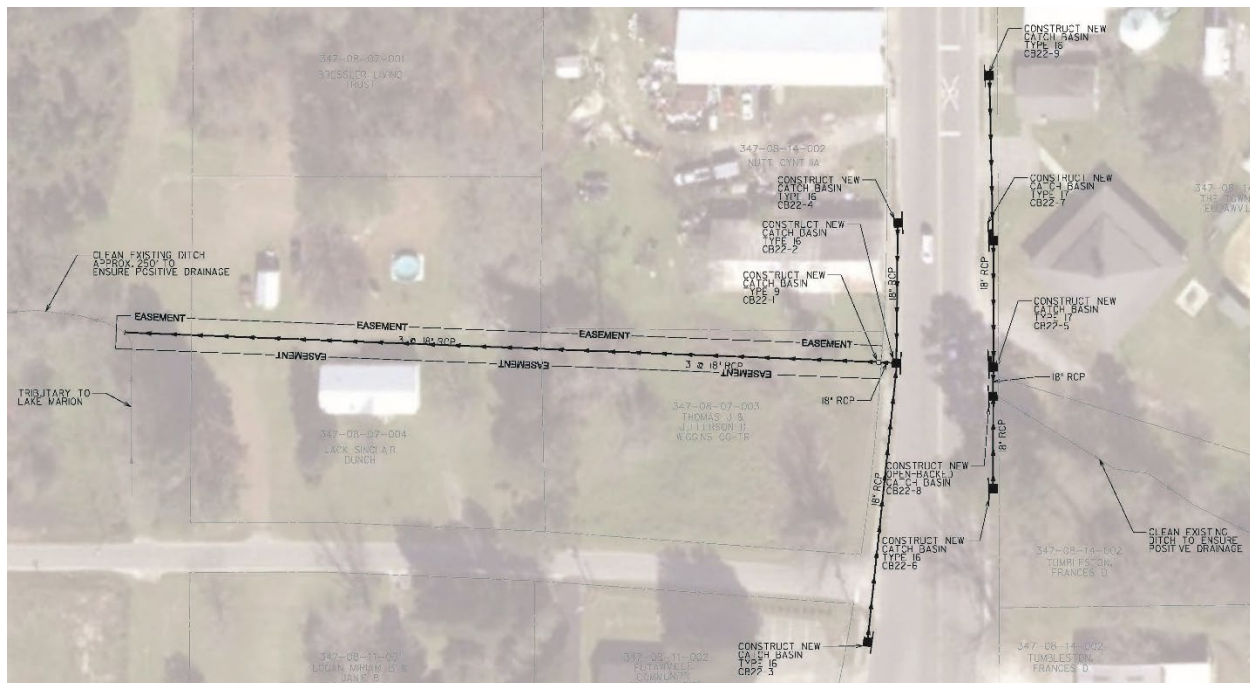
Fig 23 Existing and Proposed Flood Map – Porcher Avenue

Figure 7.1. is a schematic of the **proposed plans for this project**. Risks associated with this project are moderate to minimal. The location of the project during construction could impact traffic flow, access to emergency services, existing utilities, and essential businesses. The completed project will route runoff into an area already prone to flooding. The community has a terrain consistent with the rest of eastern Orangeburg County. It is very flat, lacking a hydraulic gradient that moves water efficiently.

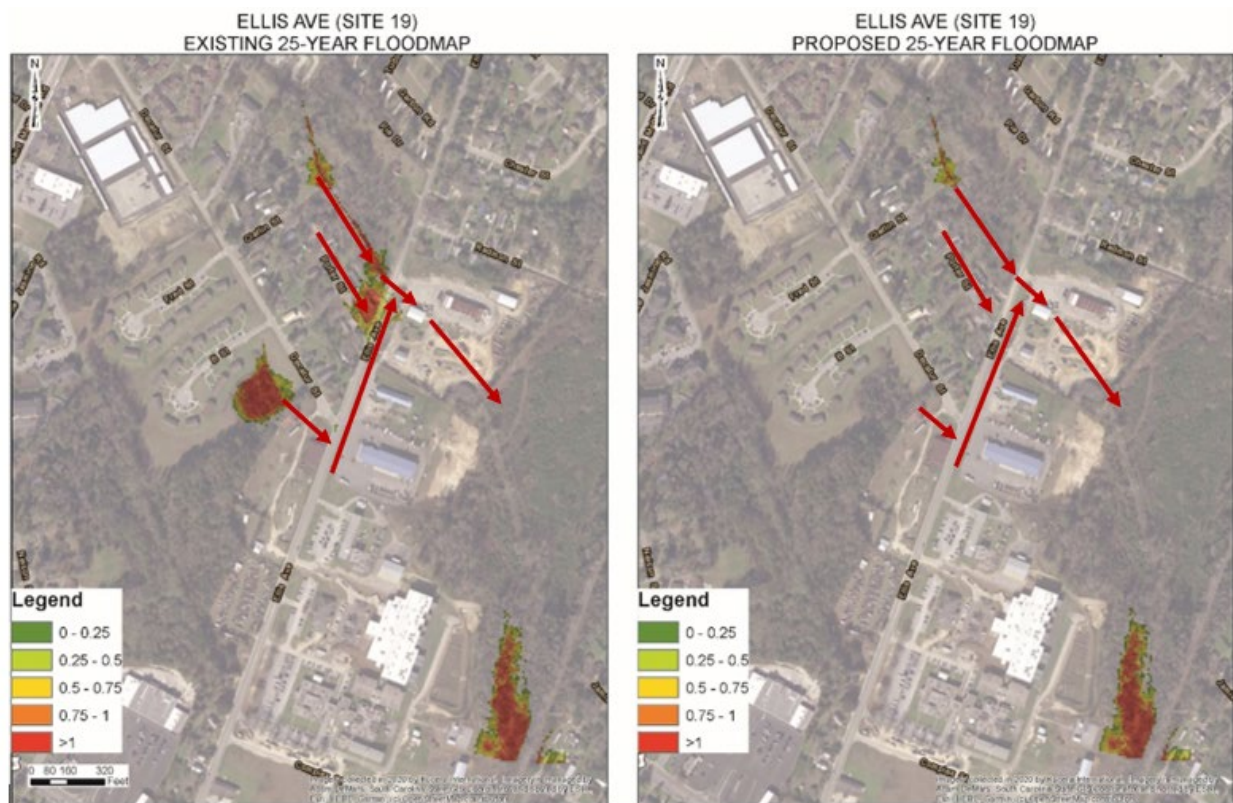
Fig 25 Existing and Proposed Flood Map – Ellis and Porter Street

alternative would eliminate water standing on the roadway by providing increased capacity and inlets to the system. It would also reduce the backup of water passing under Ellis and through the closed system in at the County Maintenance Office. **Alternative 2** would simply upgrade the system's capacity by upsizing the sections of the pipe and the adjoining catch basins. Analysis shows that the surface water was negligible south of the intersection of Ellis and Porters seen on the Flood Map developed for the site.

The study team recommends Alternative 1. This project produced a **benefit cost ratio** of 3.43 which was the highest value in the study. The total benefit was \$5,865,265 with a construction cost of \$1,711,258. The **low to moderate income percentage** for the site was 49.06, just under the threshold of 50%. The **social vulnerability index** was 0.4402. There were 9 properties that received a direct benefit because of the recommended improvements. Those locations are listed in **Table 20** below.

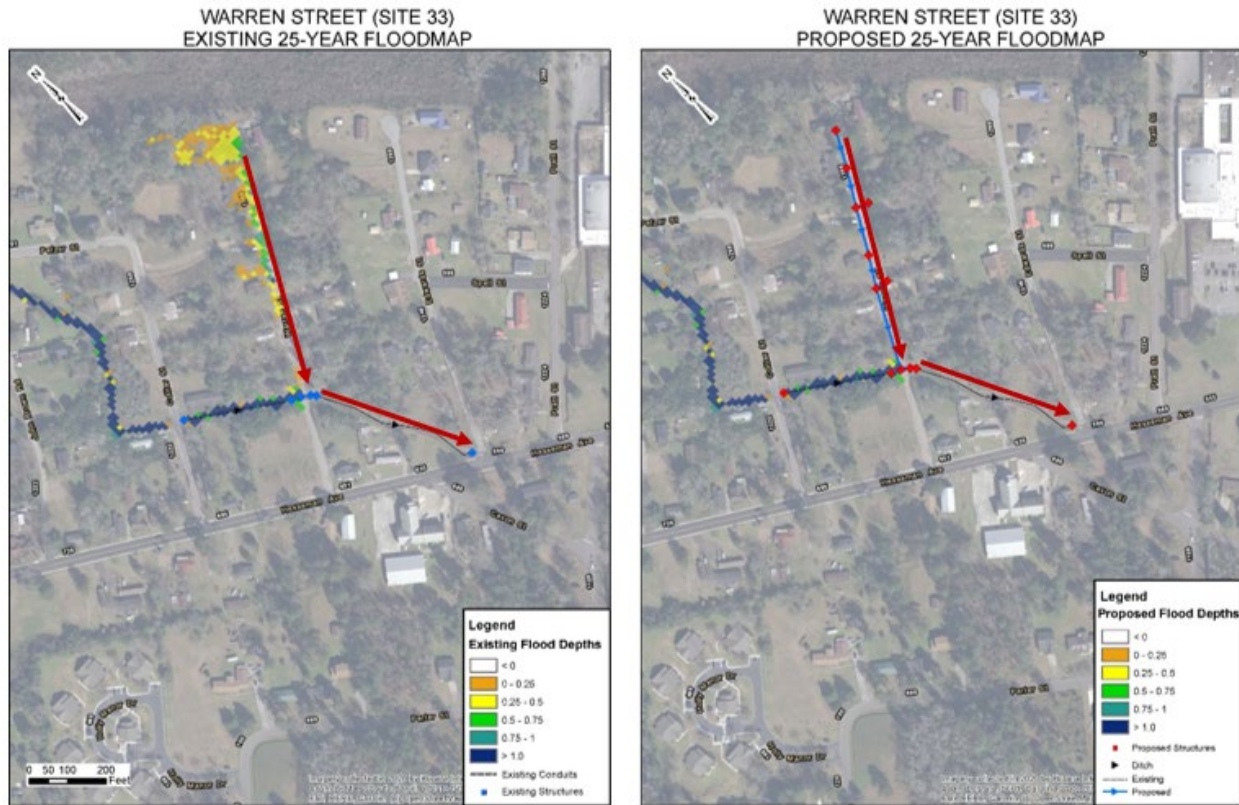
Fig 28 Existing and Proposed Flood Map – Warren St.

upgraded drainage system will add 7 additional catch basin and 525 linear feet of new pipe to Warren Street. These improvements will collect runoff from the roadway and discharge into an established tributary to Briner Branch that crosses Warren Street before the intersection with Hesseman Street.
